Ashville's WRRF Project

Construction in Photos

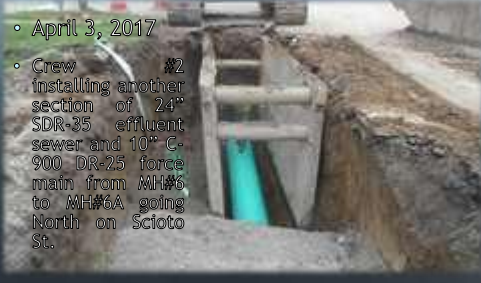
- April 3, 2017
- Crew #2 installing another section of 24" SDR-35 effluent sewer and 10" C-900 DR-25 force main from MH#6 to MH#6A going North on Scioto St.

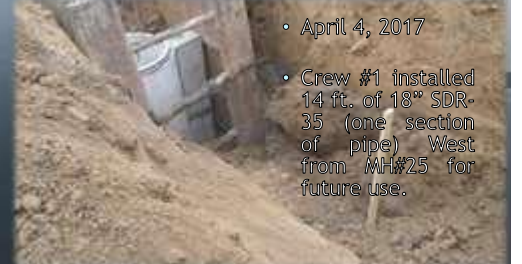
- April 4, 2017
- Crew #1 installed 14 ft. of 18" SDR-35 (one section of pipe) West from MH#25 for future use.

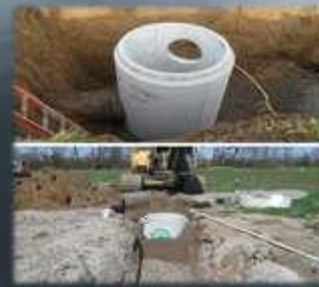
- April 4, 2017
- Crew #1 set Storm MH#3 installed 82 ft. of 18" SDR-35 storm sewer and set storm MH#2 at the intersection of Lexington and Station St.

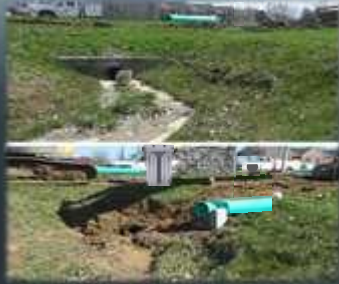
- April 5, 2017
- Crew #2 installed 50 ft. 18" SDR-35 storm sewer from MH#2 to HW#1 and set HW#1.

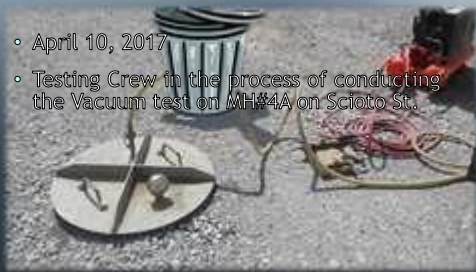
- April 10, 2017
- Testing Crew in the process of conducting the Vacuum test on MH#4A on Scioto St.

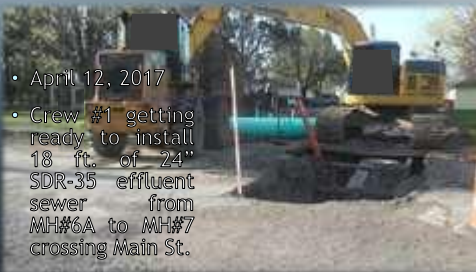
- April 12, 2017
- Crew #1 getting ready to install 18 ft. of 24" SDR-35 effluent sewer from MH#6A to MH#7 crossing Main St.

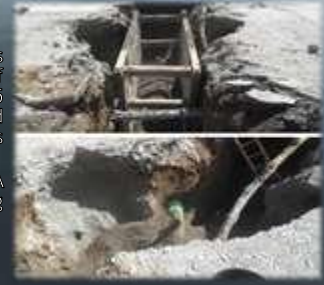
- April 12, 2017
- Crew #1 has installed 14ft. of 24" SDR-35 effluent sewer and made the repairs to a 12" clay storm sewer from MH#6A to MH#7 crossing Main St.

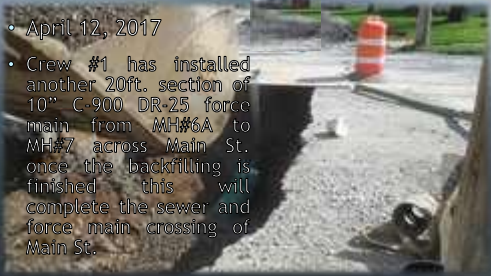
- April 12, 2017
- Crew #1 has installed another 20ft. section of 10" C-900 DR-25 force main from MH#6A to MH#7 across Main St. once the backfilling is finished this will complete the sewer and force main crossing of Main St.

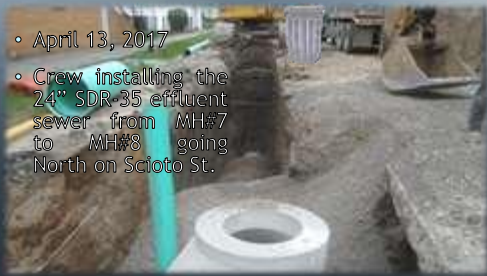
- April 13, 2017
- Crew installing the 24" SDR-35 effluent sewer from MH#7 to MH#8 going North on Scioto St.

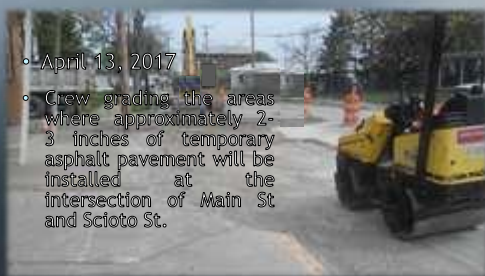
- April 13, 2017
- Crew grading the areas where approximately 2-3 inches of temporary asphalt pavement will be installed at the intersection of Main St and Scioto St.

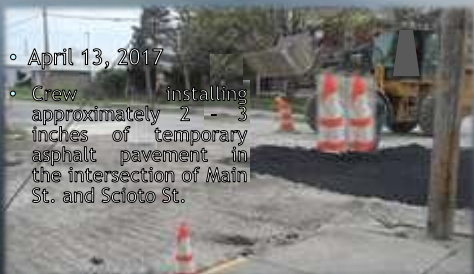
- April 13, 2017
- Crew installing approximately 2 - 3 inches of temporary asphalt pavement in the intersection of Main St. and Scioto St.

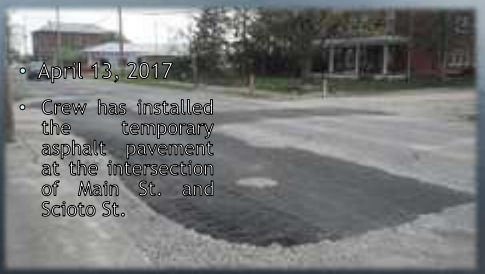
- April 13, 2017
- Crew has installed the temporary asphalt pavement at the intersection of Main St. and Scioto St.

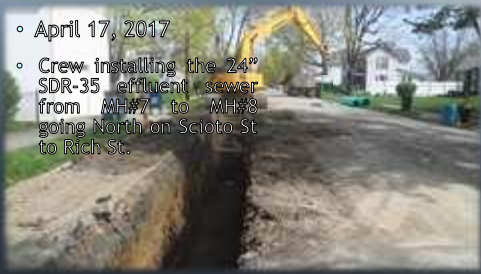
- April 17, 2017
- Crew installing the 24" SDR-35 effluent sewer from MH#7 to MH#8 going North on Scioto St. to Rich St.

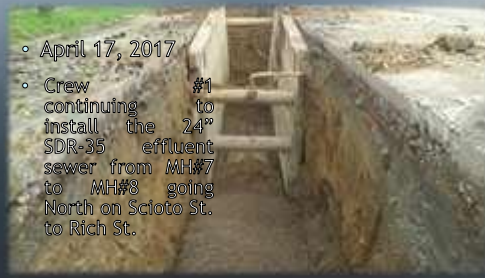
- April 17, 2017
- Crew #1 continuing to install the 24" SDR-35 effluent sewer from MH#7 to MH#8 going North on Scioto St. to Rich St.

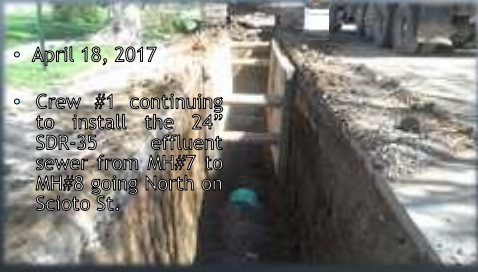
- April 18, 2017
- Crew #1 continuing to install the 24" SDR-35 effluent sewer from MH#7 to MH#8 going North on Scioto St.

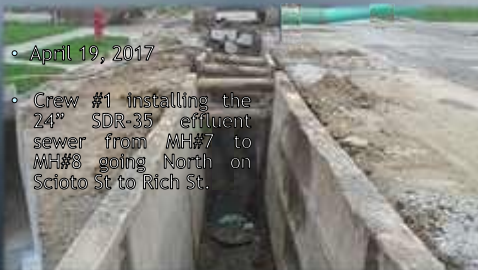
- April 19, 2017
- Crew #1 installing the 24" SDR-35 effluent sewer from MH#7 to MH#8 going North on Scioto St to Rich St.

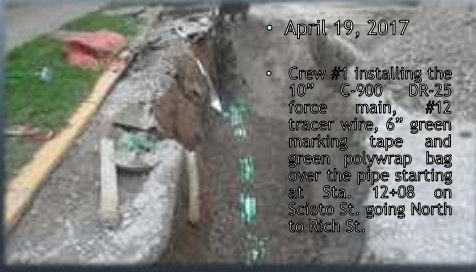
- April 19, 2017
- Crew #1 installing the 10" C-900 DR-25 force main, #12 tracer wire, 6" green marking tape and green polywrap bag over the pipe starting at Sta. 12+08 on Scoto St. going North to Rich St.

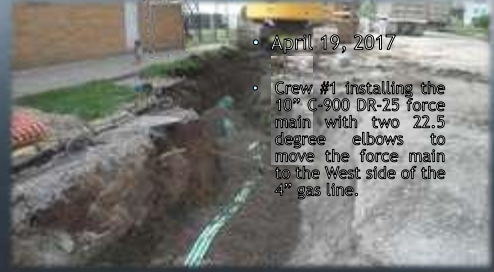
- April 19, 2017
- Crew #1 installing the 10" C-900 DR-25 force main with two 22.5 degree elbows to move the force main to the West side of the 4" gas line.

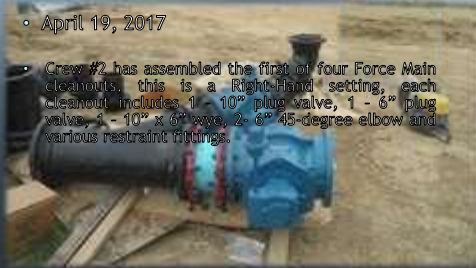
- April 19, 2017
- Crew #2 has assembled the first of four Force Main cleanouts. this is a Right-Hand setting, each cleanout includes 1 - 10" plug valve, 1 - 6" plug valve, 1 - 10" x 6" wye, 2 - 6" 45-degree elbow and various restraint fittings.

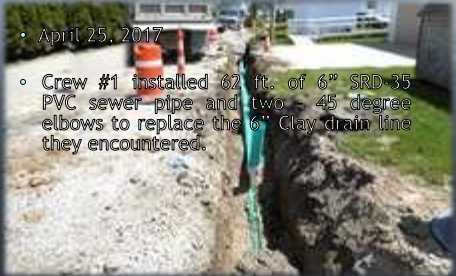
- April 25, 2017
- Crew #1 installed 62 ft. of 6" SDR 35 PVC sewer pipe and two - 45 degree elbows to replace the 6" Clay drain line they encountered.

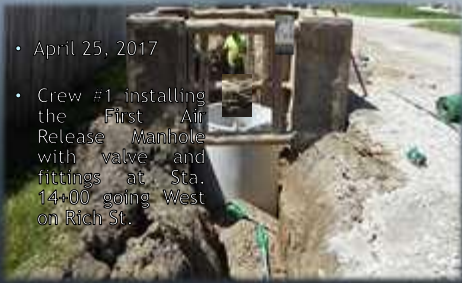
- April 25, 2017
- Crew #1 installing the First Air Release Manhole with valve and fittings at Sta. 14+00 going West on Rich St.

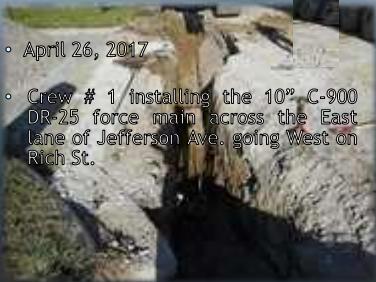
- April 26, 2017
- Crew #1 installing the 10" C-900 DR-25 force main across the East lane of Jefferson Ave. going West on Rich St.

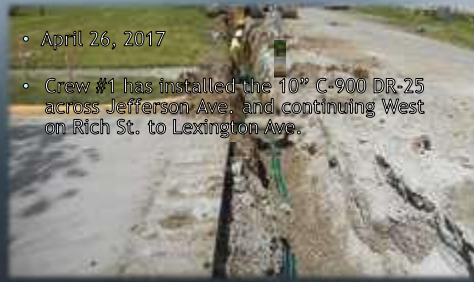
- April 26, 2017
- Crew #1 has installed the 10" C-900 DR-25 across Jefferson Ave. and continuing West on Rich St. to Lexington Ave.

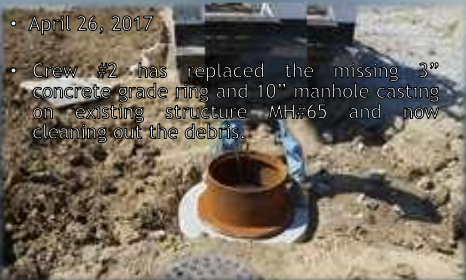
- April 26, 2017
- Crew #2 has replaced the missing 3" concrete grade ring and 10" manhole casting on existing structure MH#65 and now cleaning out the debris.
