# Construction in Photos

February 1 - 28, 2017

Water Resource Recovery Department  
Village of Ashville  
Ashville's Water Resource Recovery Facility  
Part B - Job No: 60440011

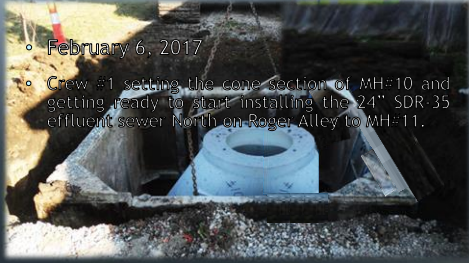
- February 6, 2017
- Crew #1 setting the cone section of MH#10 and getting ready to start installing the 24" SDR-35 effluent sewer North on Roger Alley to MH#11.

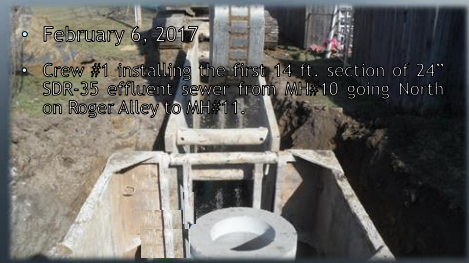
- February 6, 2017
- Crew #1 installing the first 14 ft. section of 24" SDR-35 effluent sewer from MH#10 going North on Roger Alley to MH#11.

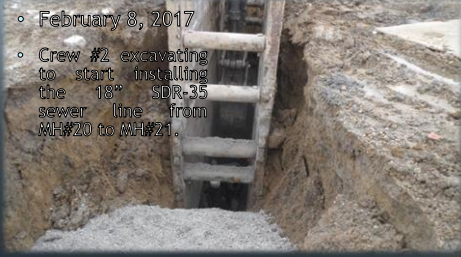
- Crew #2 excavating to start installing the 18" SDR-35 sewer line from MH#20 to MH#21.

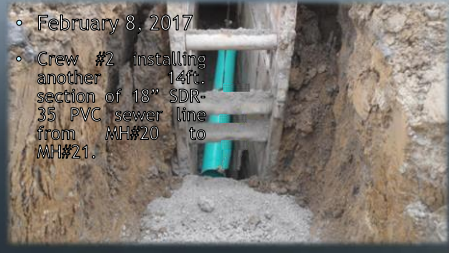
- Crew #2 installing another 14ft. section of 18" SDR-35 PVC sewer line from MH#20 to MH#21.

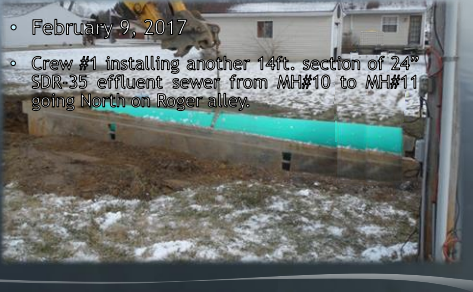
- February 9, 2017
- Crew #1 installing another 14ft. section of 24" SDR-35 effluent sewer from MH#10 to MH#11 going North on Roger alley.

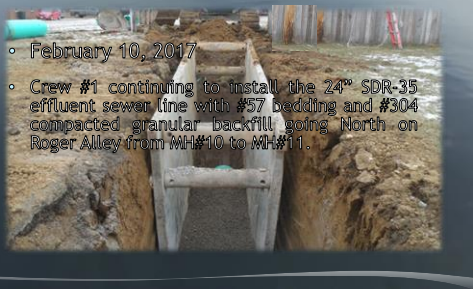
- February 10, 2017
- Crew #1 continuing to install the 24" SDR-35 effluent sewer line with #57 bedding and #304 compacted granular backfill from MH#10 to MH#11.

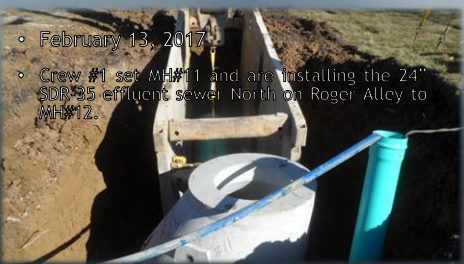
- February 13, 2017
- Crew #1 set MH#11 and are installing the 24" SDR-35 effluent sewer North on Roger Alley to MH#12.

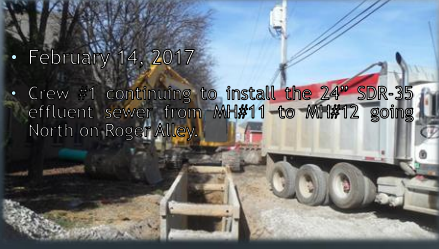
- February 14, 2017
- Crew #1 continuing to install the 24" SDR-35 effluent sewer from MH#11 to MH#12 going North on Roger Alley.

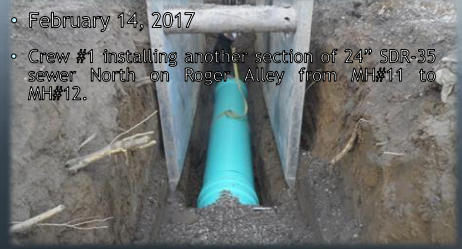
- February 14, 2017
- Crew #1 installing another section of 24" SDR-35 sewer North on Roger Alley from MH#11 to MH#12.

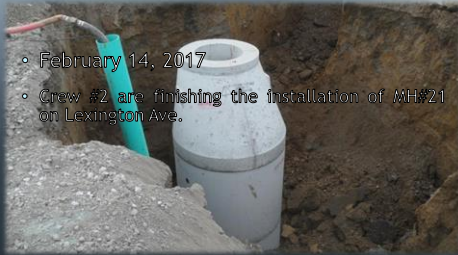
- February 14, 2017
- Crew #2 are finishing the installation of MH#21 on Lexington Ave.

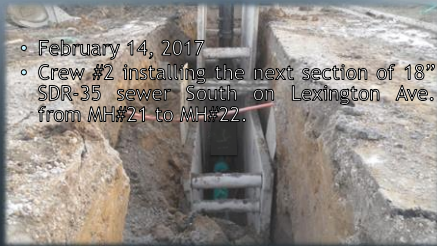
- February 14, 2017
- Crew #2 installing the next section of 18" SDR-35 sewer South on Lexington Ave. from MH#21 to MH#22.

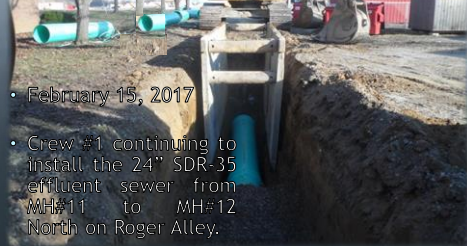
- February 15, 2017
- Crew #1 continuing to install the 24" SDR-35 effluent sewer from MH#11 to MH#12 North on Roger Alley.

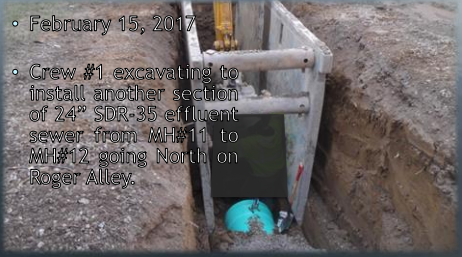
- February 15, 2017
- Crew #1 excavating to install another section of 24" SDR-35 effluent sewer from MH#11 to MH#12 going North on Roger Alley.

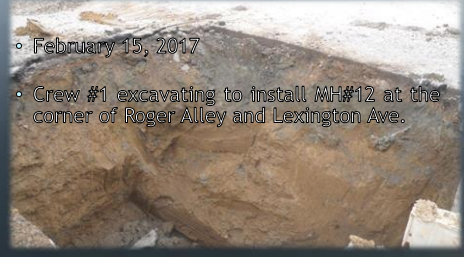
- February 15, 2017
- Crew #1 excavating to install MH#12 at the corner of Roger Alley and Lexington Ave.

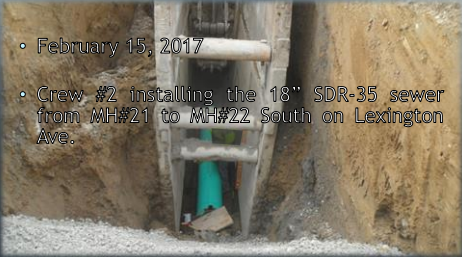
- February 15, 2017
- Crew #2 installing the 18" SDR-35 sewer from MH#21 to MH#22 South on Lexington Ave.

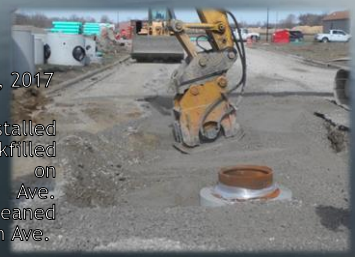
- February 16, 2017
- Crew #2 installed and backfilled MH#22 on Lexington Ave. and then cleaned up Lexington Ave.

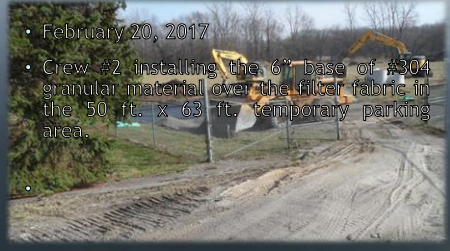
- February 20, 2017
- Crew #2 installing the 6" base of #304 granular material over the filter fabric in the 50-ft. x 63-ft. temporary parking area.

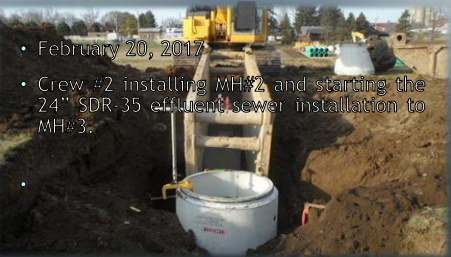
- February 20, 2017
- Crew #2 installing MH#2 and starting the 24" SDR-35 effluent sewer installation to MH#3.

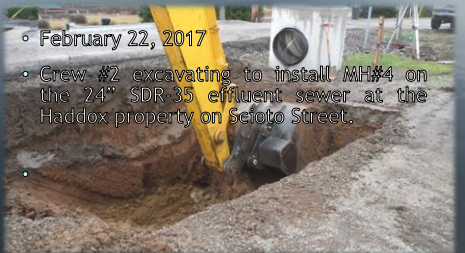
- February 22, 2017
- Crew #2 excavating to install MH#4 on the Haddox property on Seloto Street.

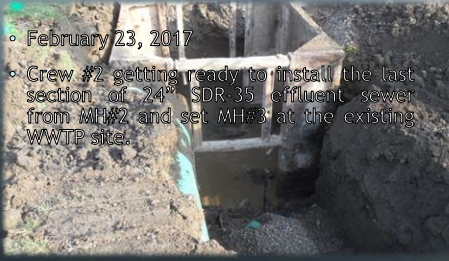
- February 23, 2017
- Crew #2 getting ready to install the last section of 24" SDR-35 effluent sewer from MH#2 and set MH#3 at the existing WWTP site.

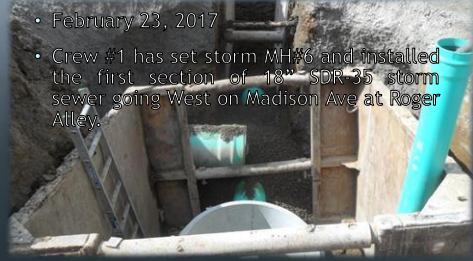
- February 23, 2017
- Crew #1 has set storm MH#6 and installed the first section of 18" SDR-35 storm sewer going West on Madison Ave at Roger Alley.

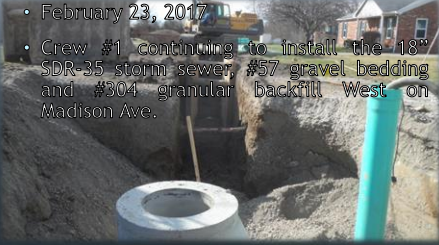
- February 23, 2017
- Crew #1 continuing to install the 18" SDR-35 storm sewer, #57 gravel bedding and #304 granular backfill West on Madison Ave.

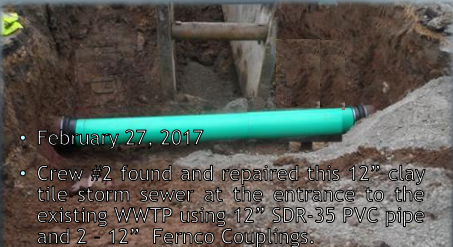
- February 27, 2017
- Crew #2 found and repaired this 12" clay tile storm sewer at the entrance to the existing WWTP using 12" SDR-35 PVC pipe and 2 - 12" Femco Couplings.
