Construction in Photos

January 16 - 31, 2017

Water Resource Recovery Department Village of Ashville Ashville's Water Resource Recovery Facility Part B

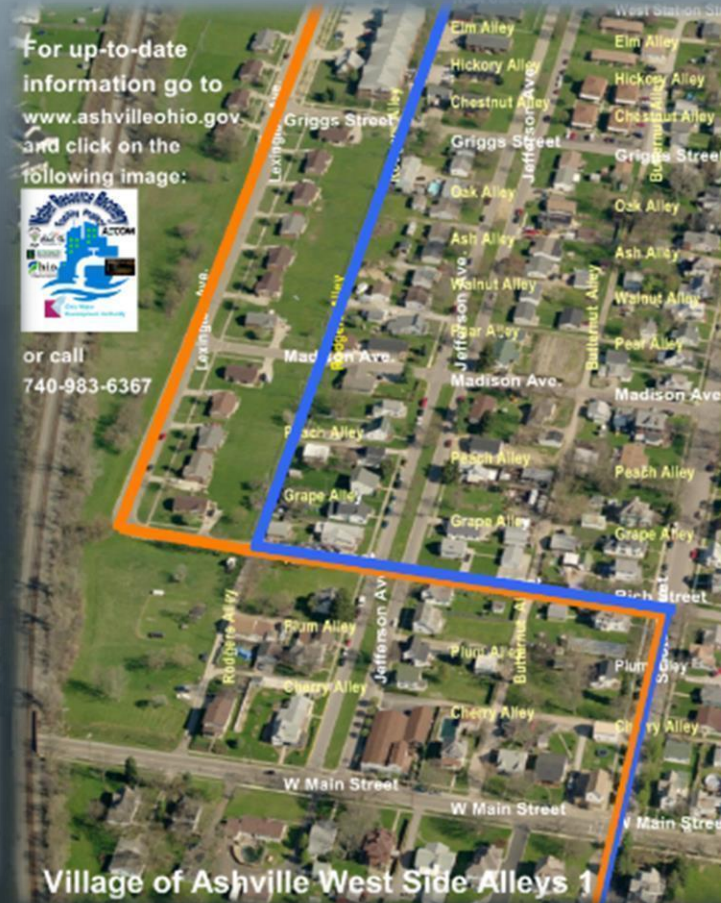
Village of Ashville West Side Alleys 1

Effluent Line

- January 2-13 mobilization & materials
- January 16 or 18 construction begins at Scioto & Rich Street (MH 8)
- January 29 Rich Street & Rodger Alley (MH 9A)
- January 23 or 26 Lexington Avenue & May Street (just south of MH 18 at MH 20)
- February 14 Rodger Alley & Madison Avenue (MH 10)
- February 22 Rodger Alley & Griggs Street (MH 11)
- March 1 Rodger Alley & West Station Street (MH 12)

Force Main

- February 21 Rich Street & Scioto Street
- March 5 Rich Street & Lexington Avenue
- March 12 Lexington Avenue & Madison Avenue
- March 19 Lexington Avenue & Griggs Street
- March 26 Lexington Avenue & West Station Street

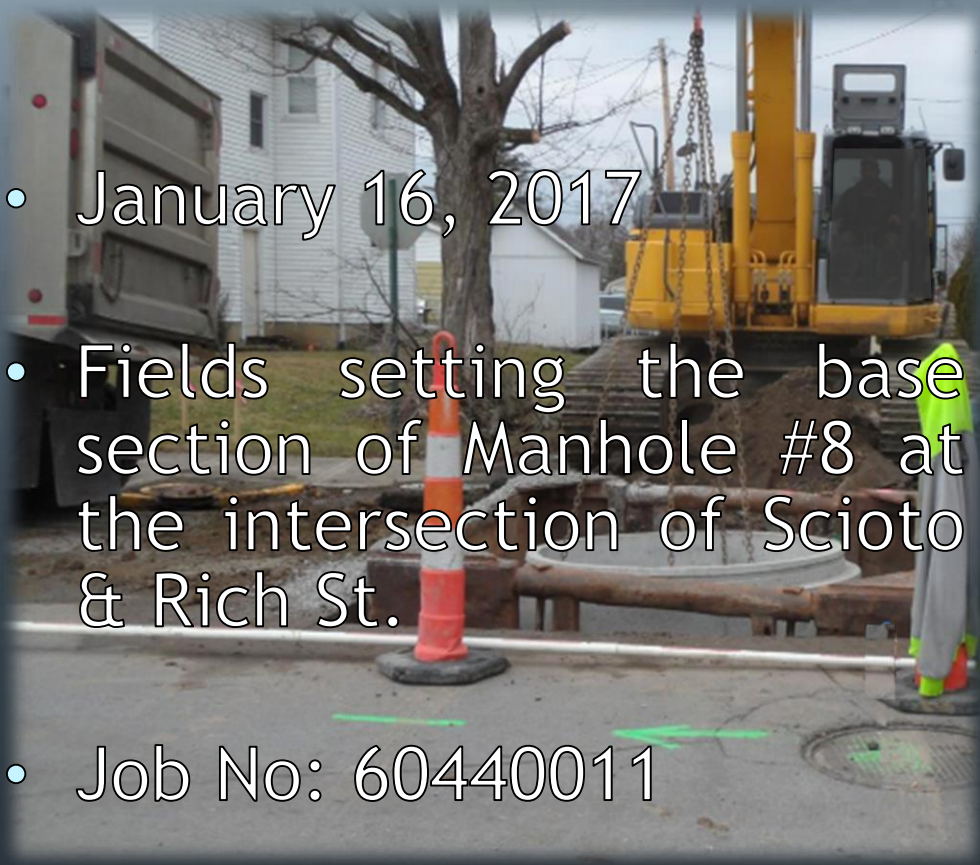
- January 16, 2017
- Fields setting the base section of Manhole #8 at the intersection of Scioto & Rich St.
- Job No: 60440011

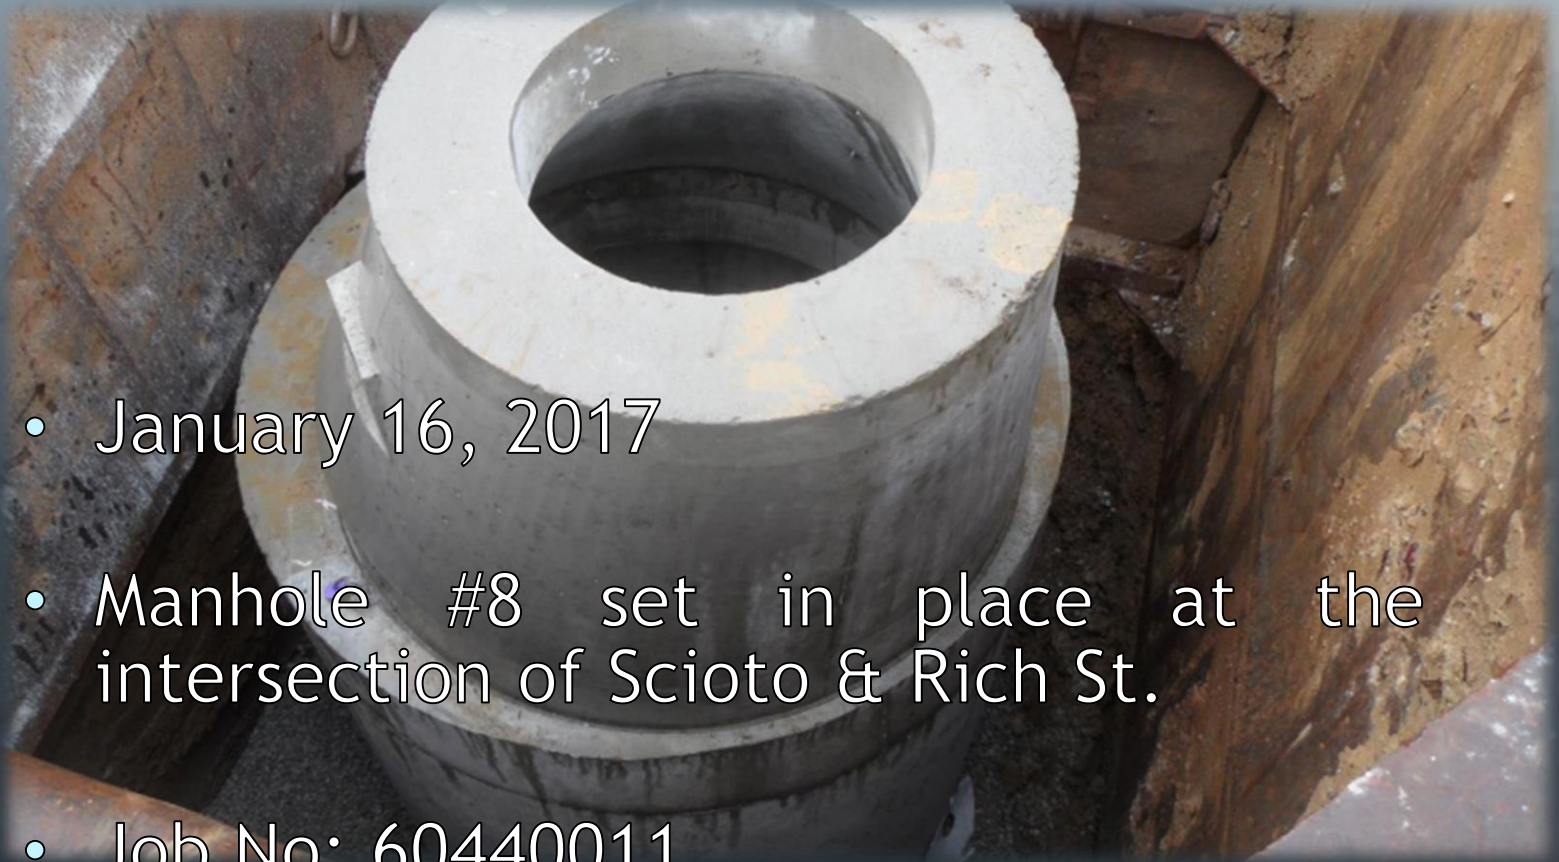
- January 16, 2017
- Manhole #8 set in place at the intersection of Scioto & Rich St.
- Job No: 60440011

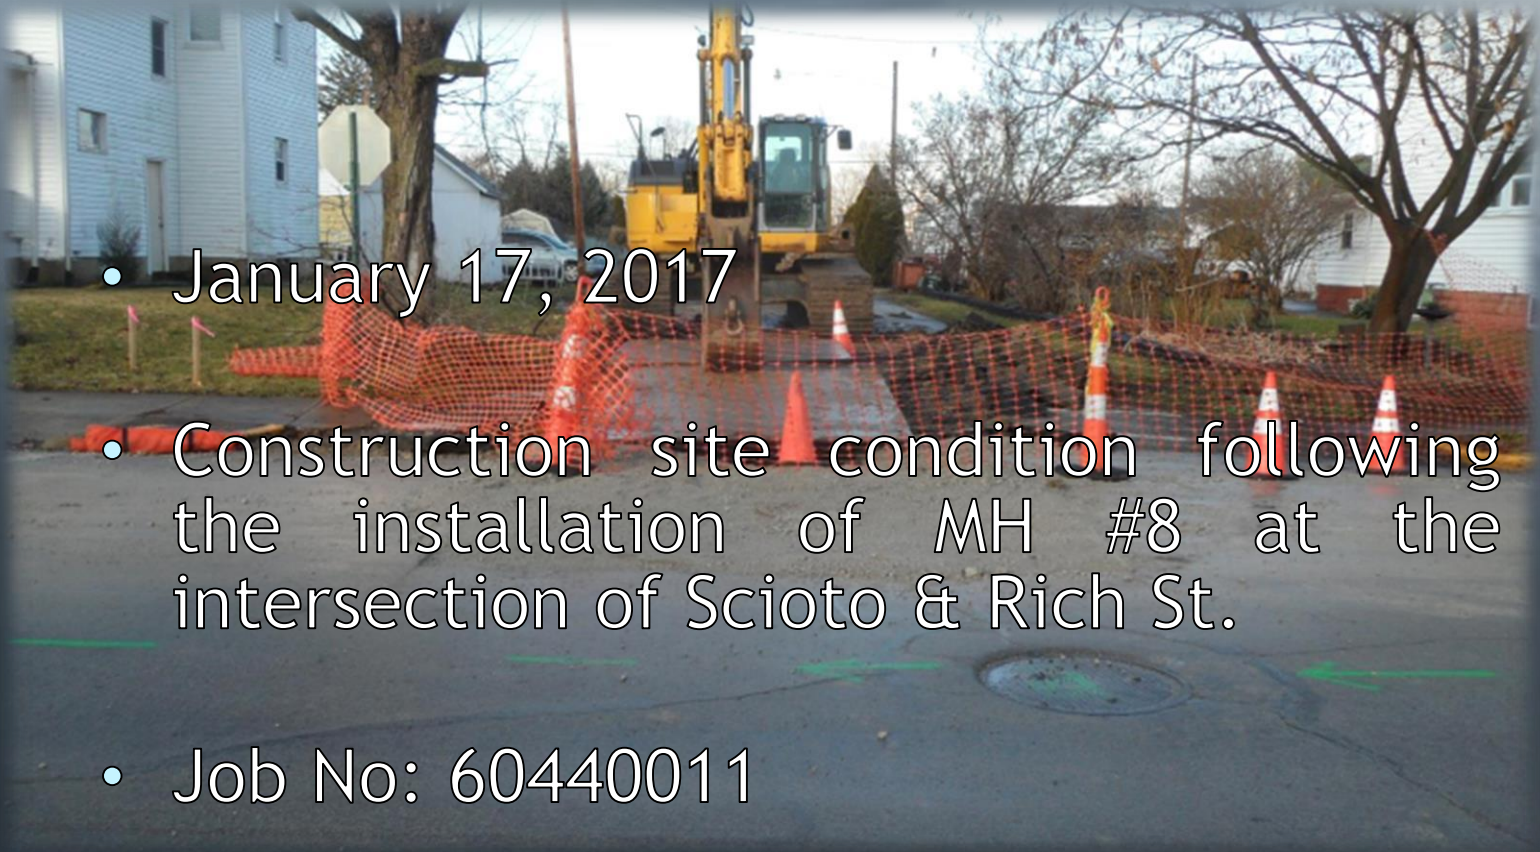
- January 17, 2017
- Construction site condition following the installation of MH #8 at the intersection of Scioto & Rich St.
- Job No: 60440011

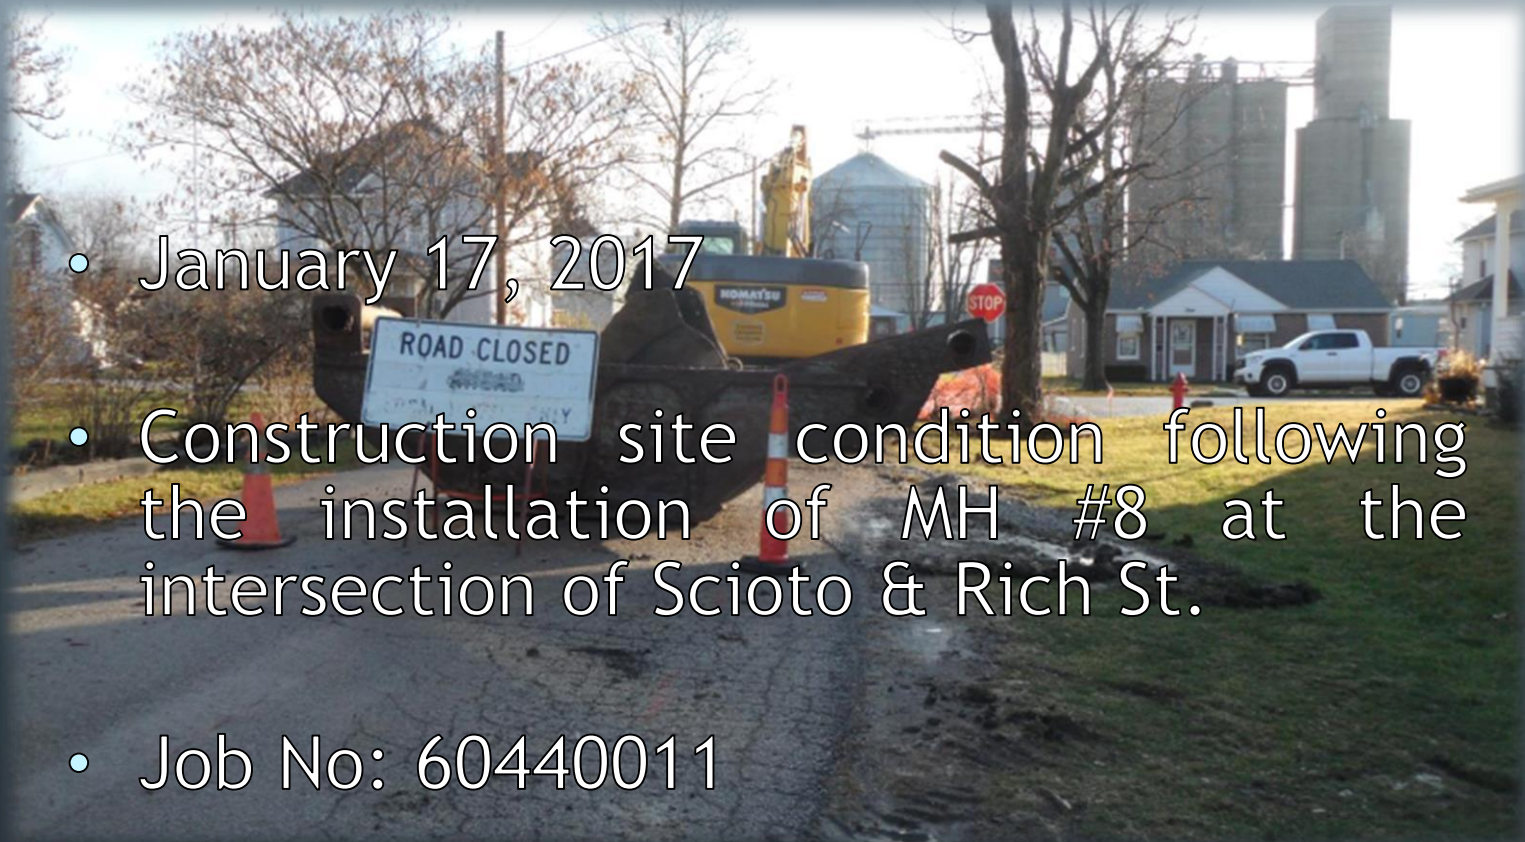
- January 17, 2017
- Construction site condition following the installation of MH #8 at the intersection of Scioto & Rich St.
- Job No: 60440011

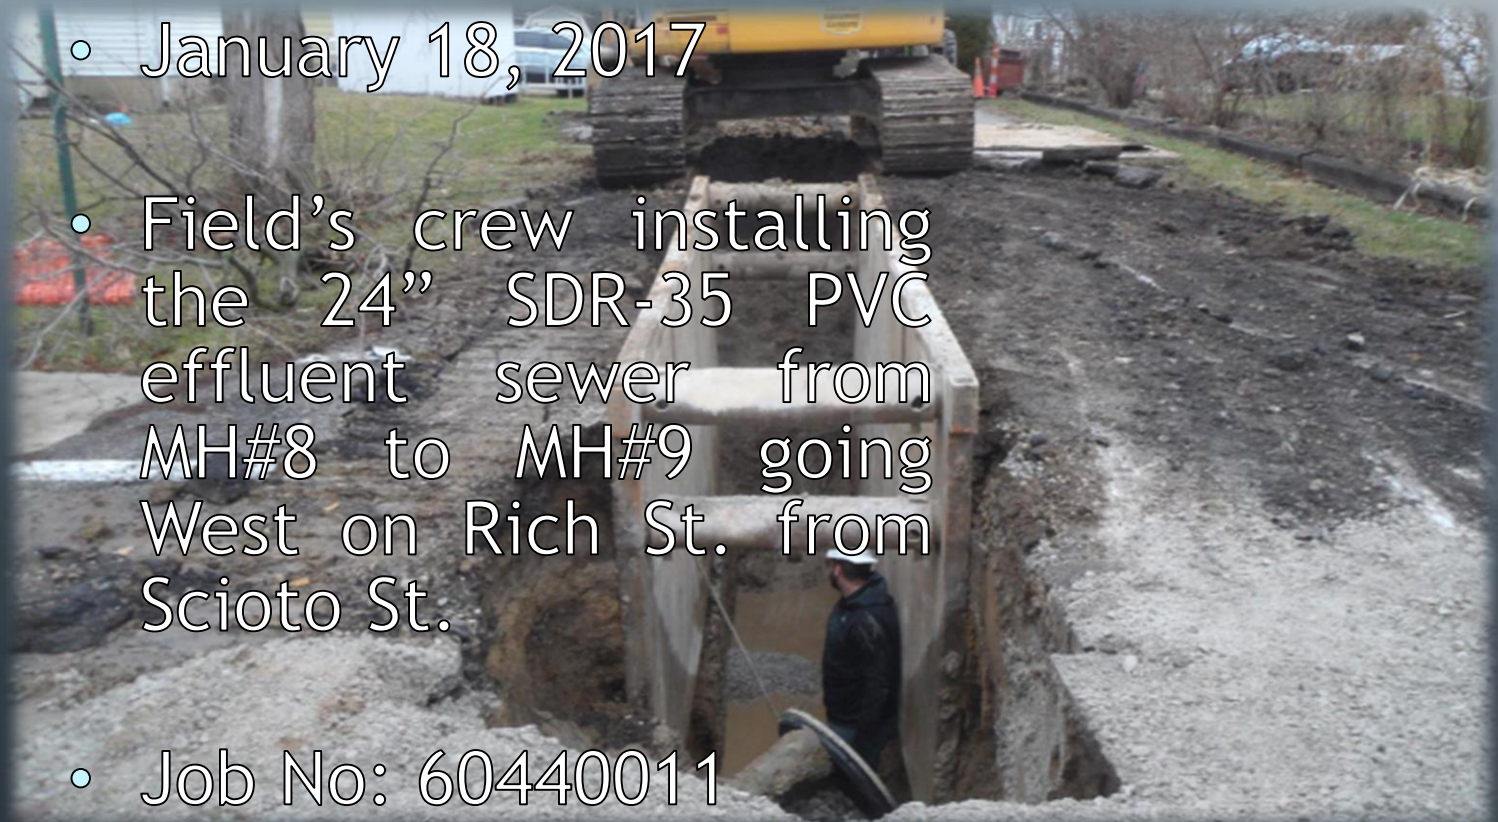
- January 18, 2017
- Field's crew installing the 24" SDR-35 PVC effluent sewer from MH#8 to MH#9 going West on Rich St. from Scioto St.
- Job No: 60440011

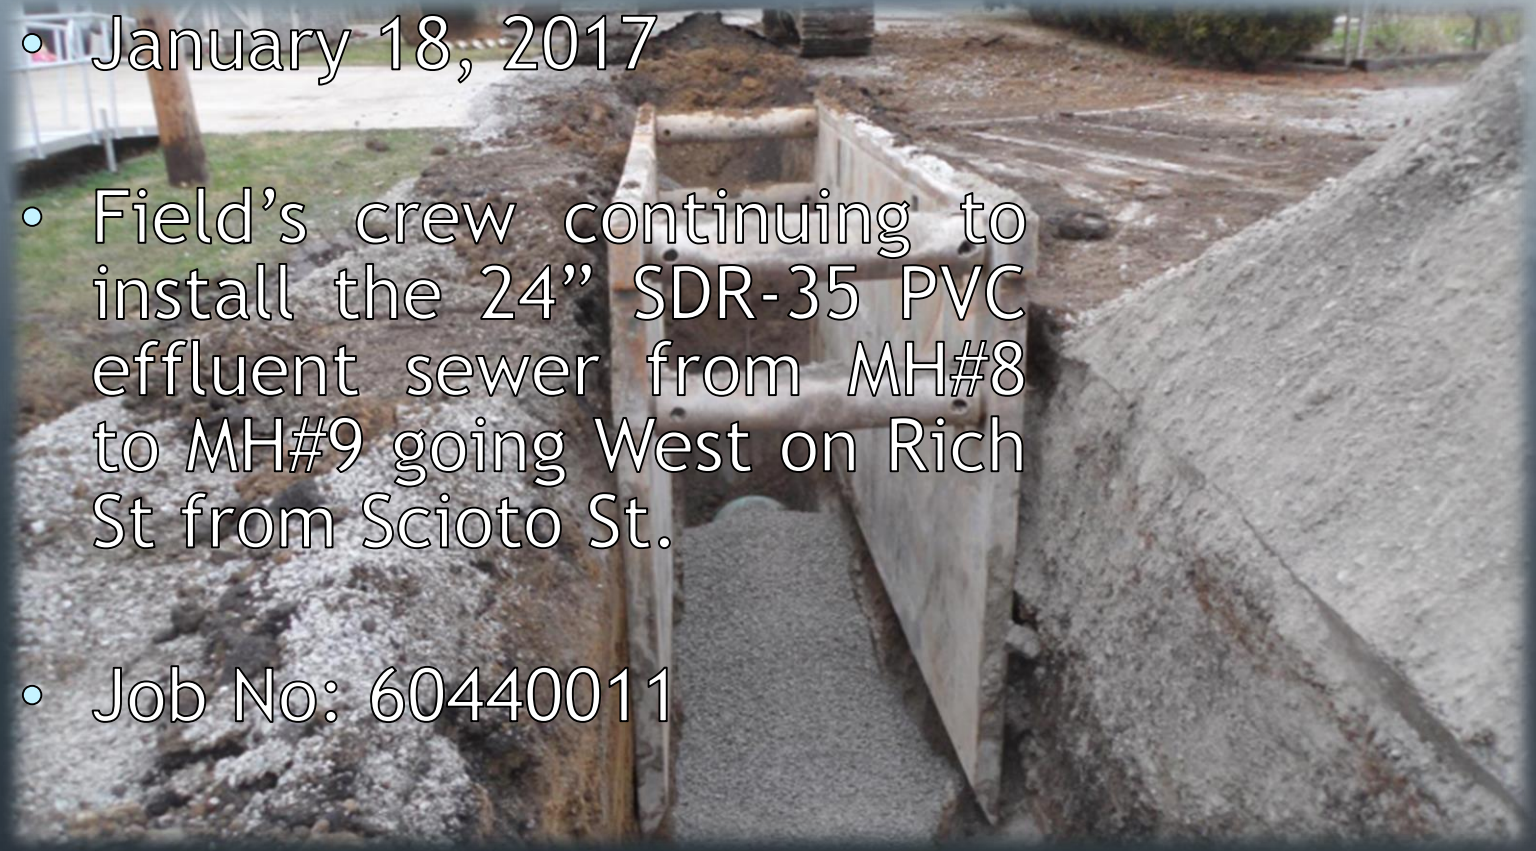
- January 18, 2017
- Field's crew continuing to install the 24" SDR-35 PVC effluent sewer from MH#8 to MH#9 going West on Rich St from Scioto St.
- Job No: 60440011

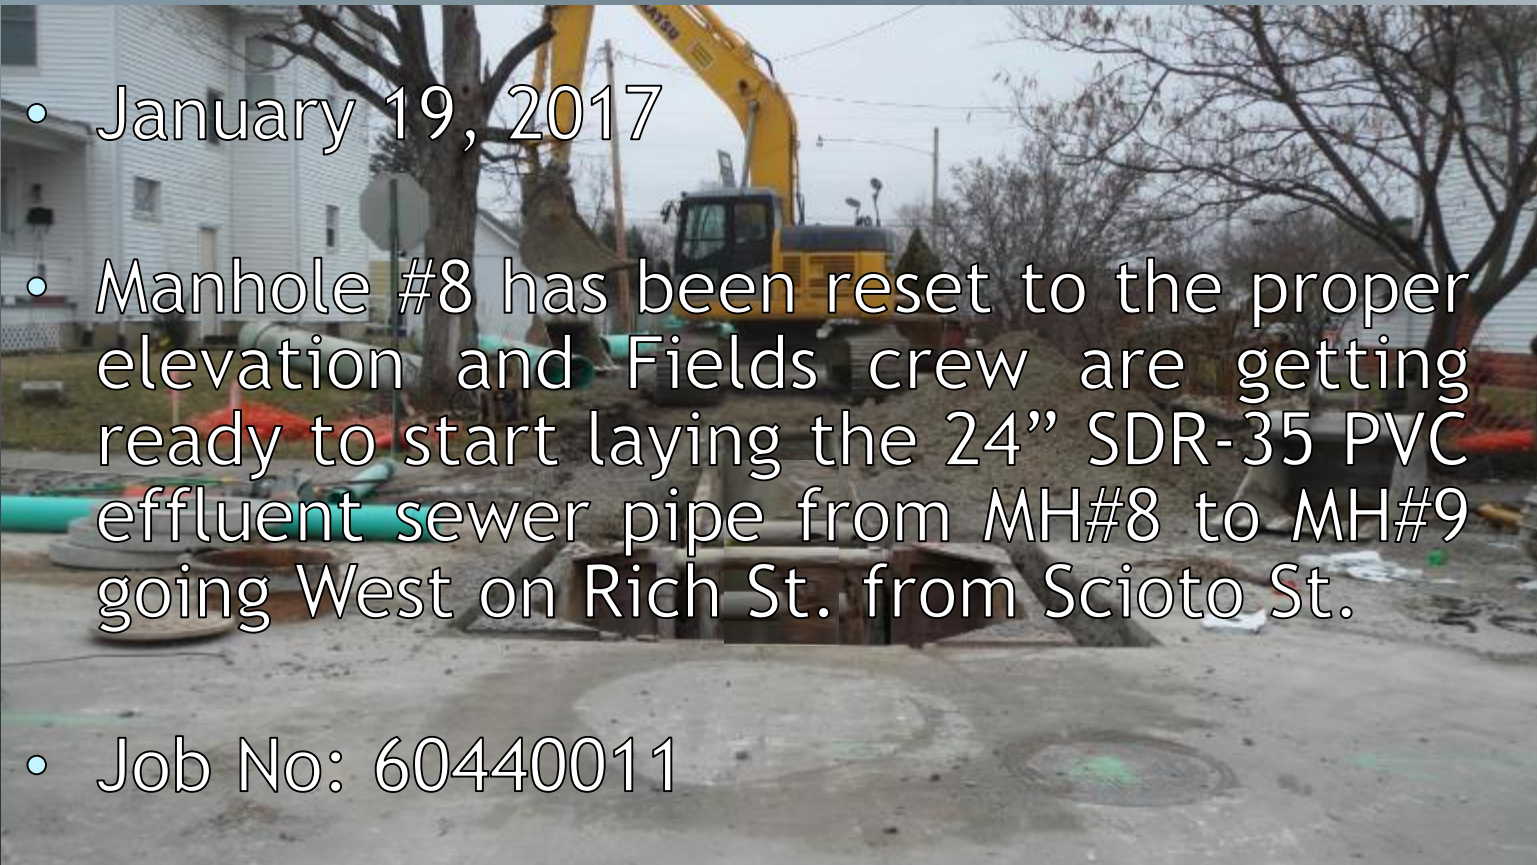
- January 19, 2017
- Manhole #8 has been reset to the proper elevation and Fields crew are getting ready to start laying the 24" SDR-35 PVC effluent sewer pipe from MH#8 to MH#9 going West on Rich St. from Scioto St.
- Job No: 60440011

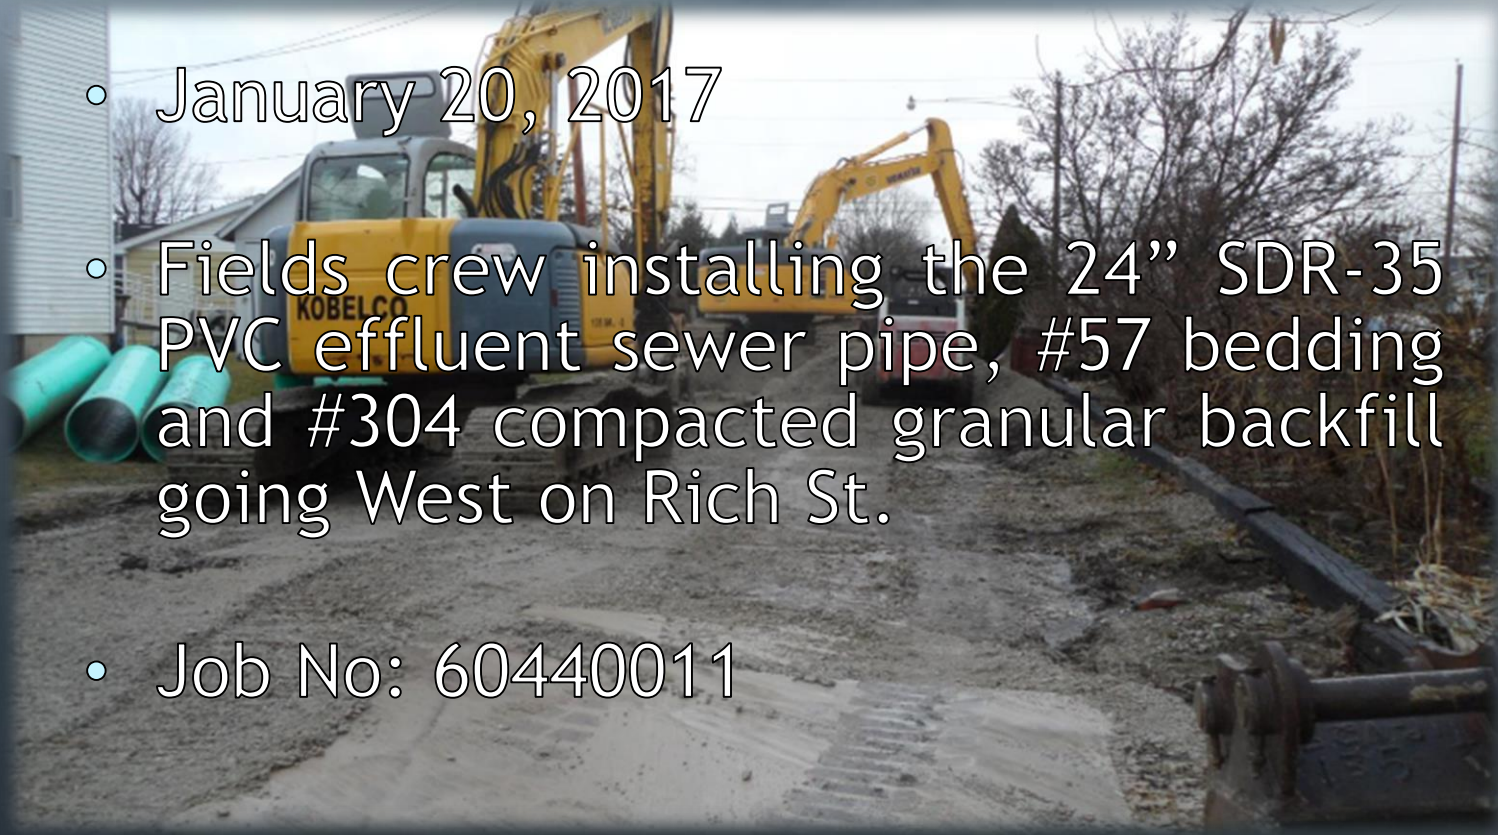
- January 20, 2017
- Fields crew installing the 24" SDR-35 PVC effluent sewer pipe, #57 bedding and #304 compacted granular backfill going West on Rich St.
- Job No: 60440011

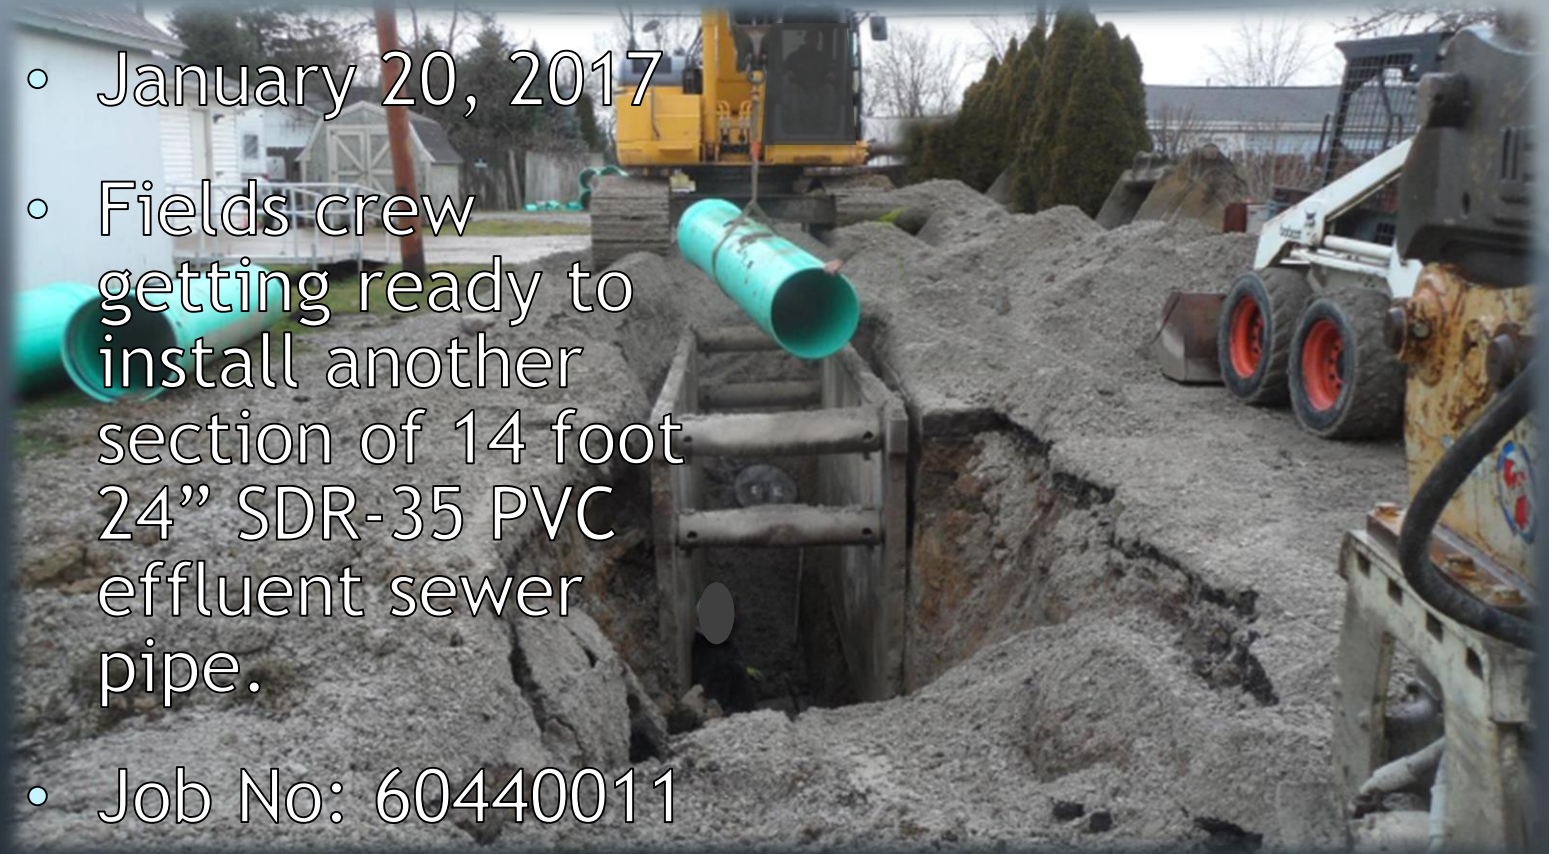
- January 20, 2017
- Fields crew getting ready to install another section of 14 foot 24" SDR-35 PVC effluent sewer pipe.
- Job No: 60440011

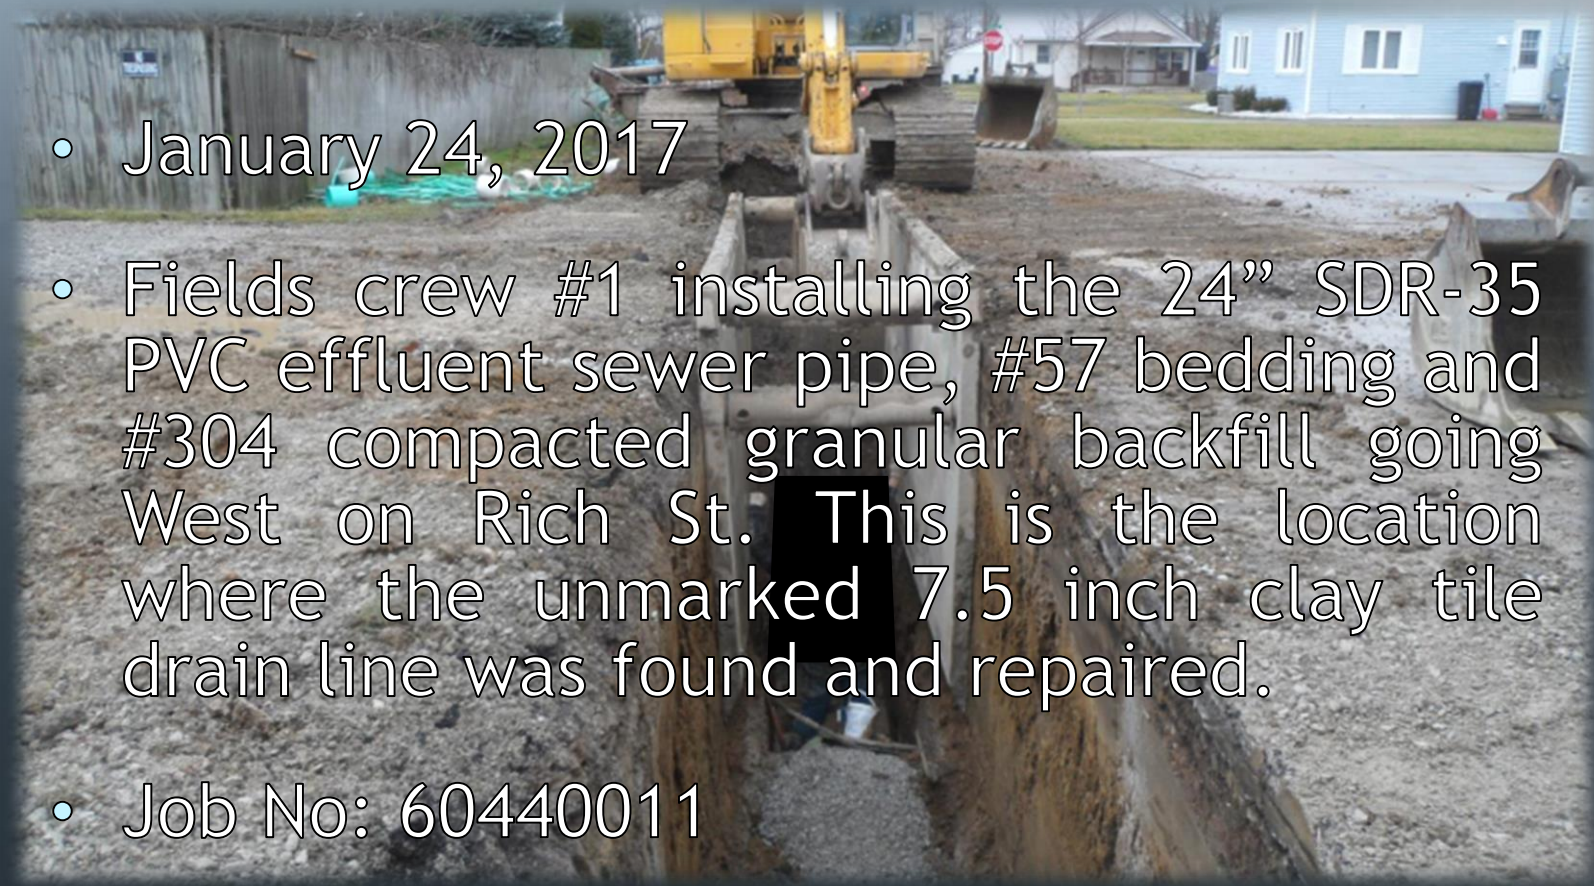
- January 24, 2017
- Fields crew #1 installing the 24" SDR-35 PVC effluent sewer pipe, #57 bedding and #304 compacted granular backfill going West on Rich St. This is the location where the unmarked 7.5 inch clay tile drain line was found and repaired.
- Job No: 60440011

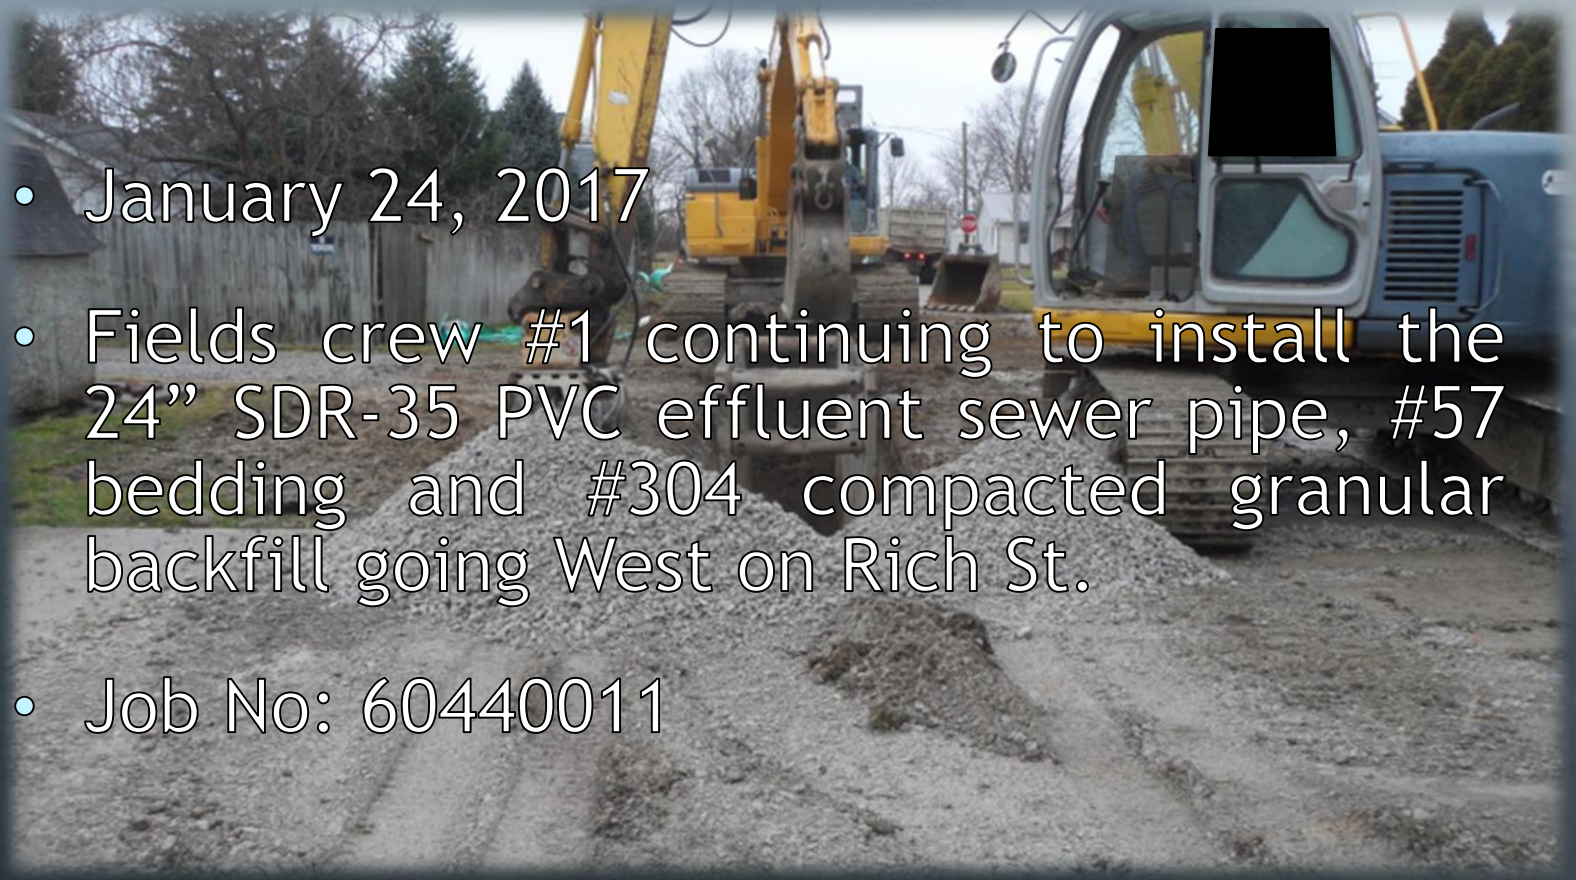
- January 24, 2017
- Fields crew #1 continuing to install the 24" SDR-35 PVC effluent sewer pipe, #57 bedding and #304 compacted granular backfill going West on Rich St.
- Job No: 60440011

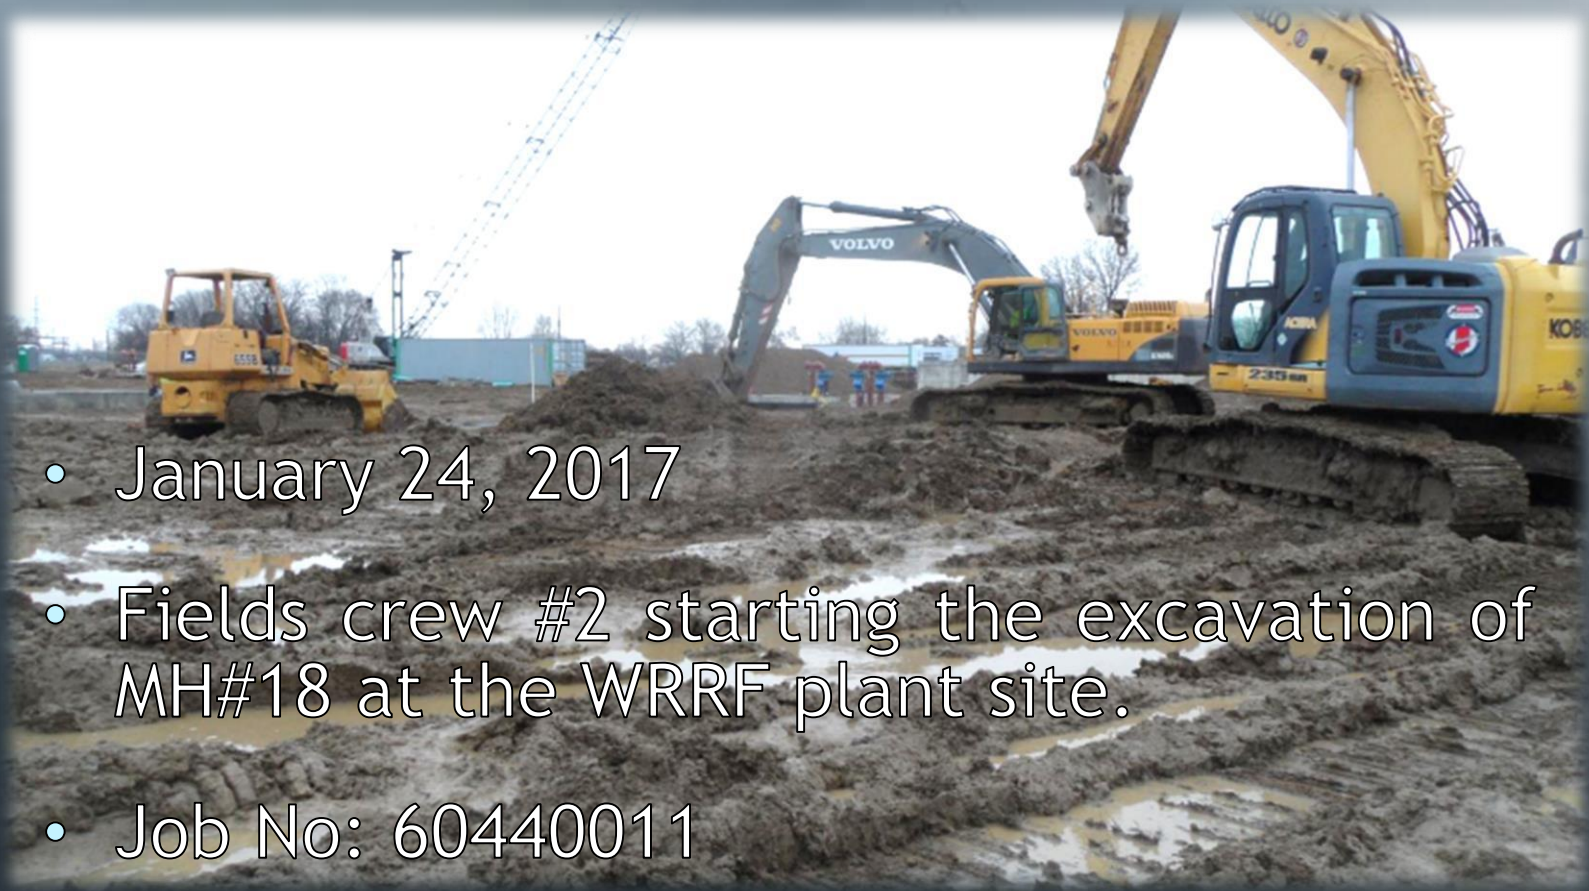
- January 24, 2017
- Fields crew #2 starting the excavation of MH#18 at the WRRF plant site.
- Job No: 60440011

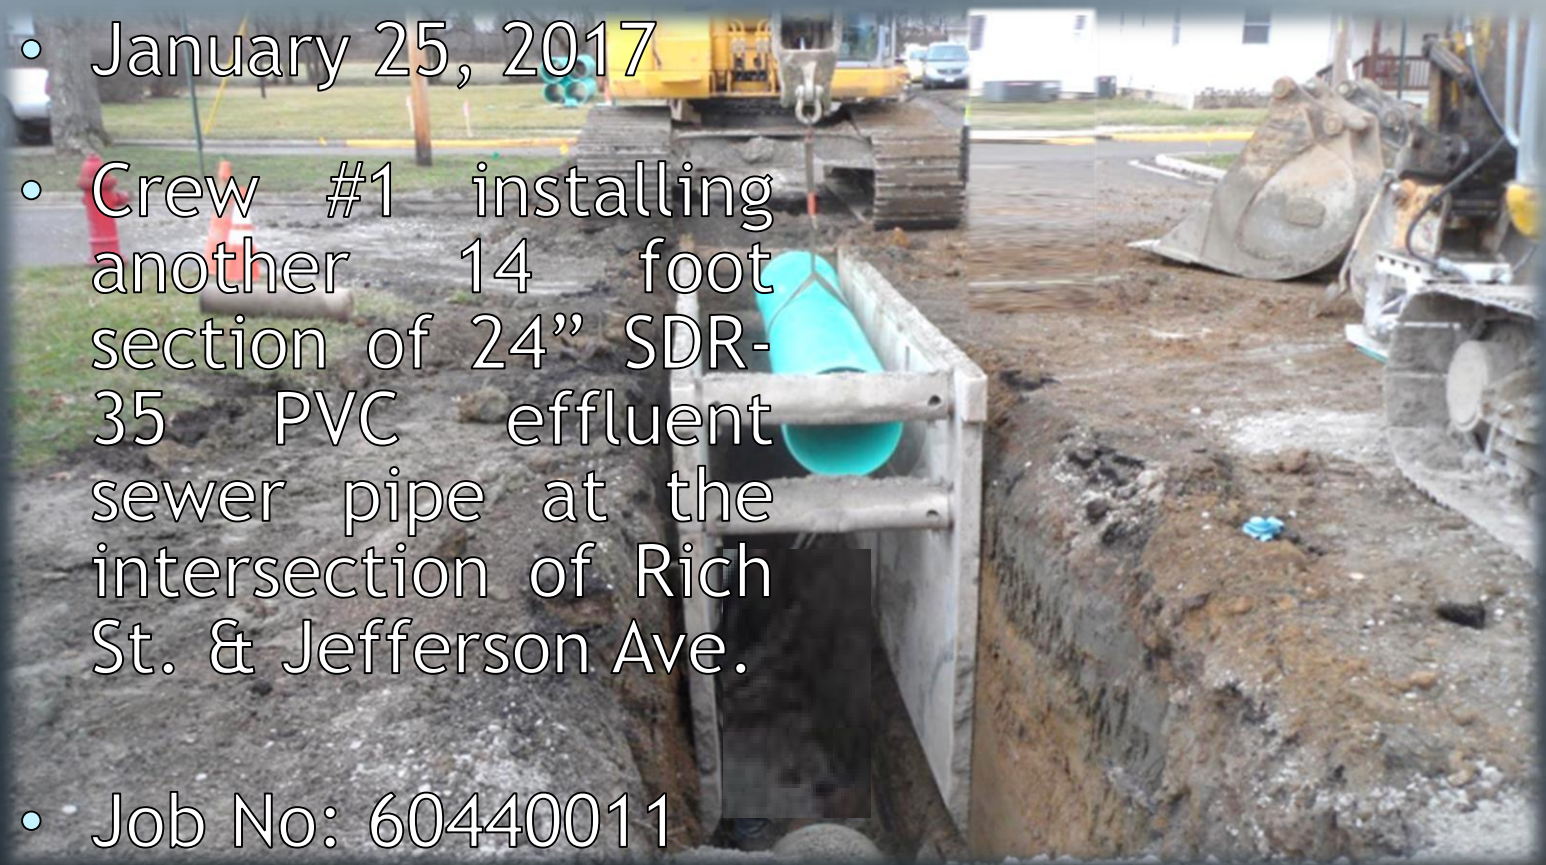
- January 25, 2017
- Crew #1 installing another 14 foot section of 24" SDR-35 PVC effluent sewer pipe at the intersection of Rich St. & Jefferson Ave.
- Job No: 60440011

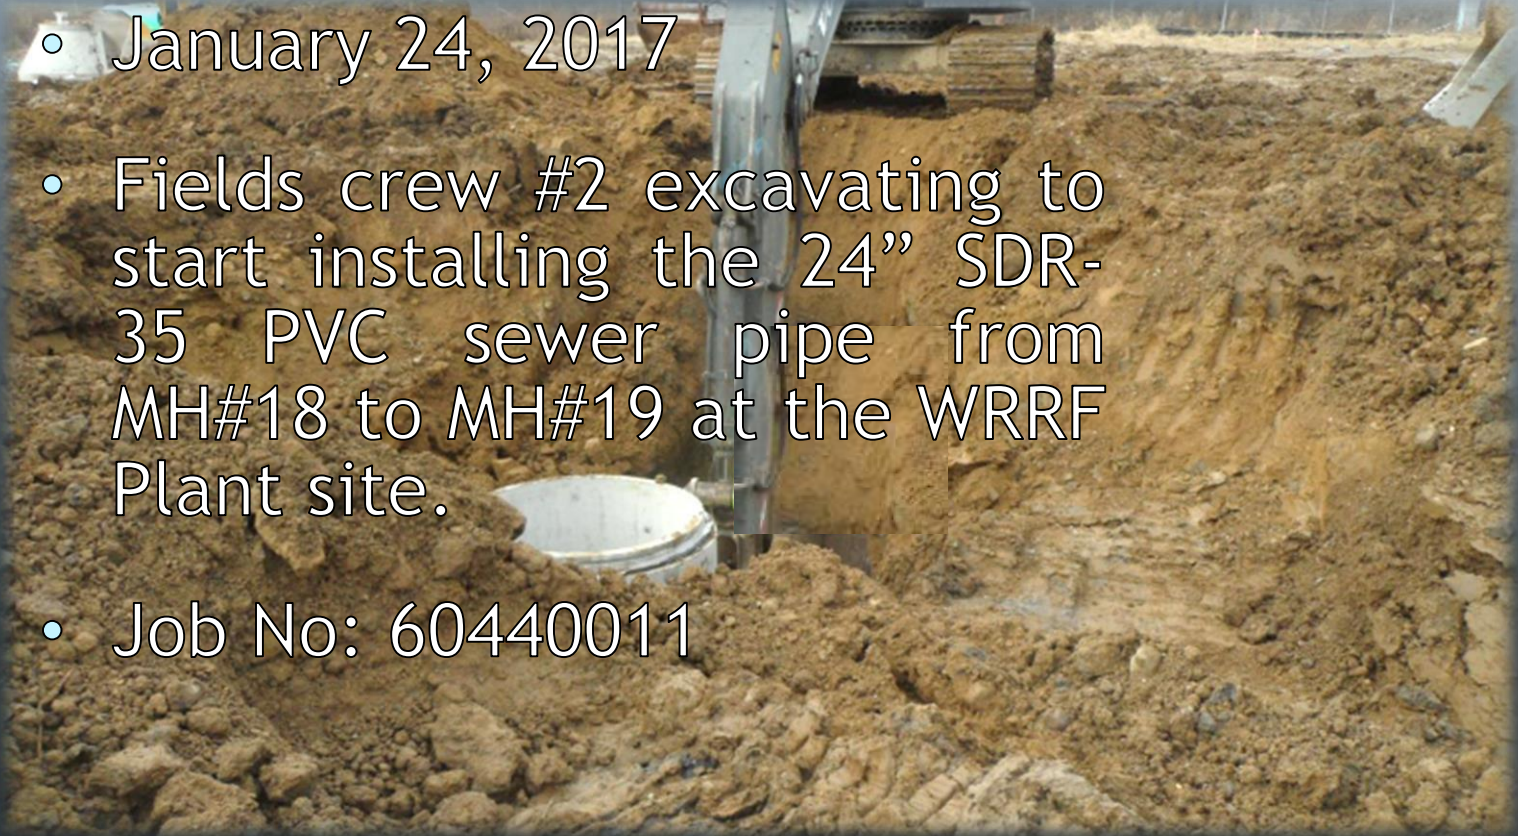
- January 24, 2017
- Fields crew #2 excavating to start installing the 24" SDR-35 PVC sewer pipe from MH#18 to MH#19 at the WRRF Plant site.
- Job No: 60440011

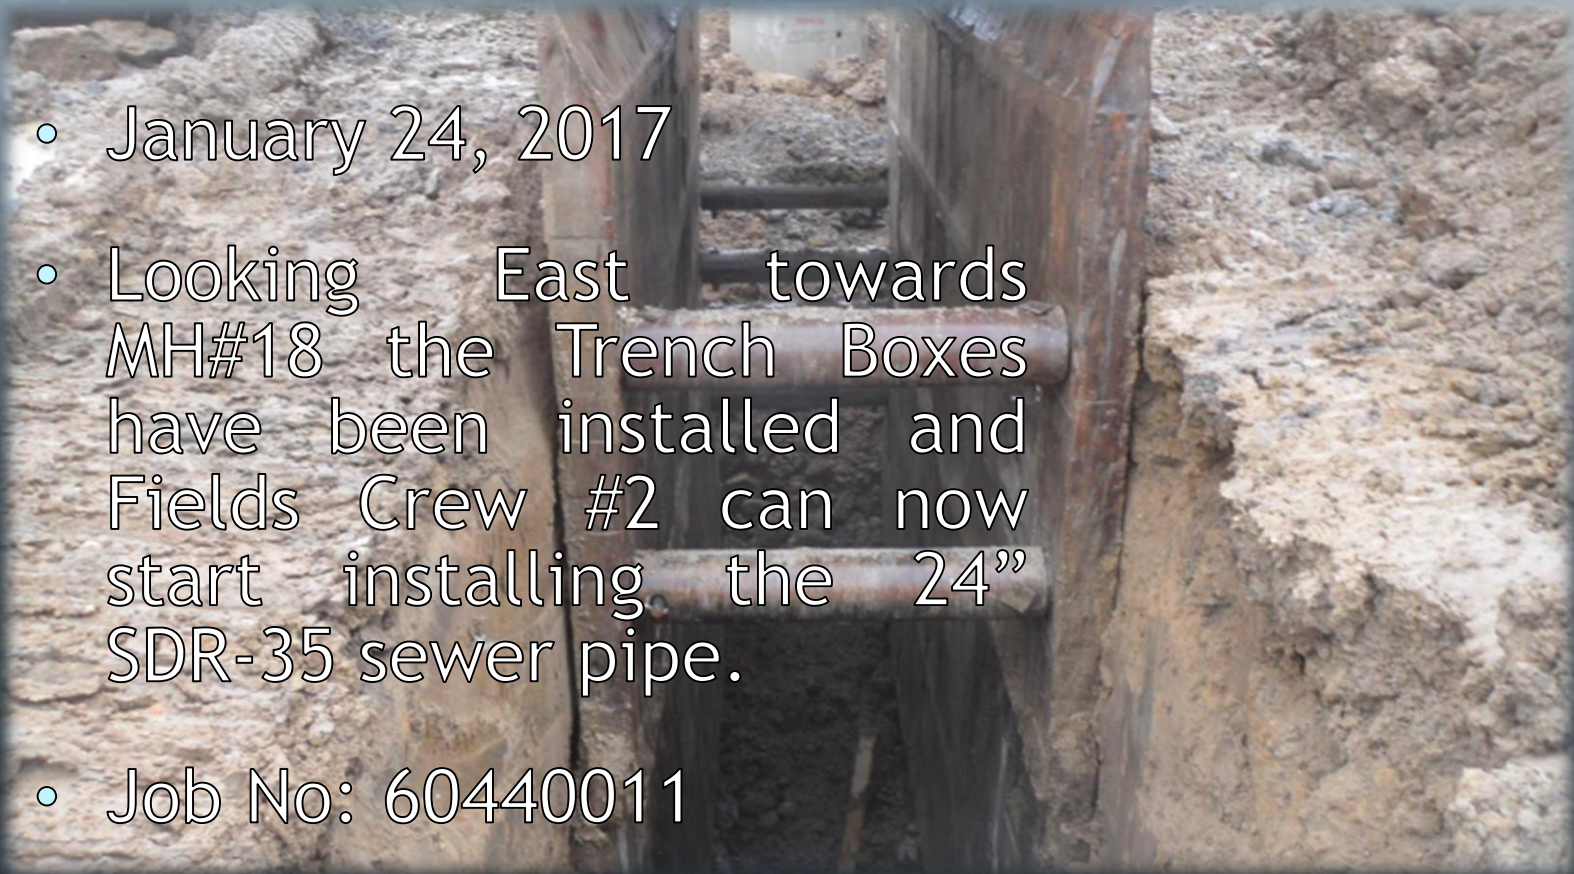
- January 24, 2017
- Looking East towards MH#18 the Trench Boxes have been installed and Fields Crew #2 can now start installing the 24" SDR-35 sewer pipe.
- Job No: 60440011

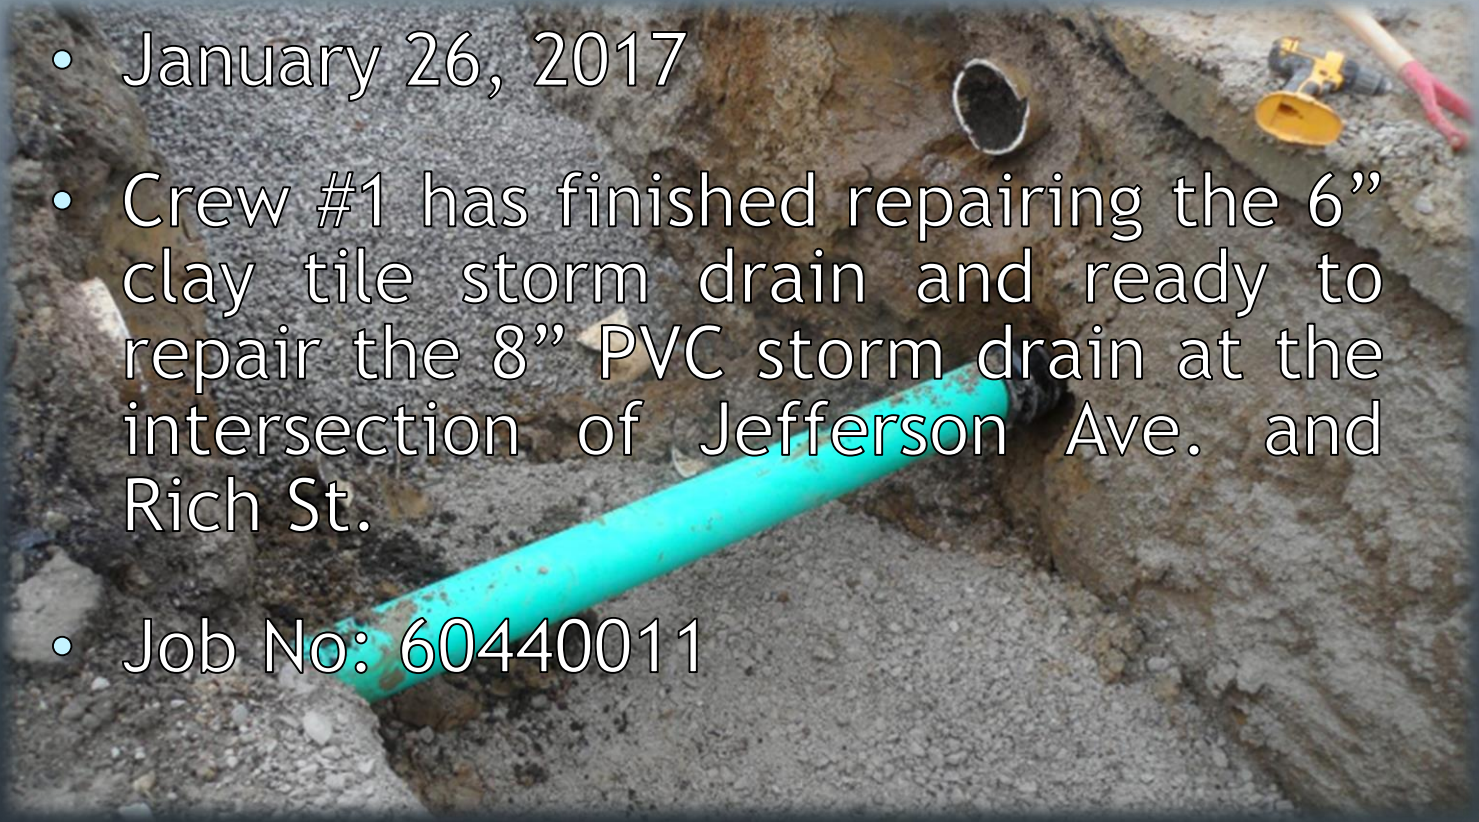
- January 26, 2017
- Crew #1 has finished repairing the 6" clay tile storm drain and ready to repair the 8" PVC storm drain at the intersection of Jefferson Ave. and Rich St.
- Job No: 60440011
