Construction in Photos

January 16 - 31, 2017

Water Resource Recovery Department Village of Ashville Ashville's Water Resource Recovery Facility Part B

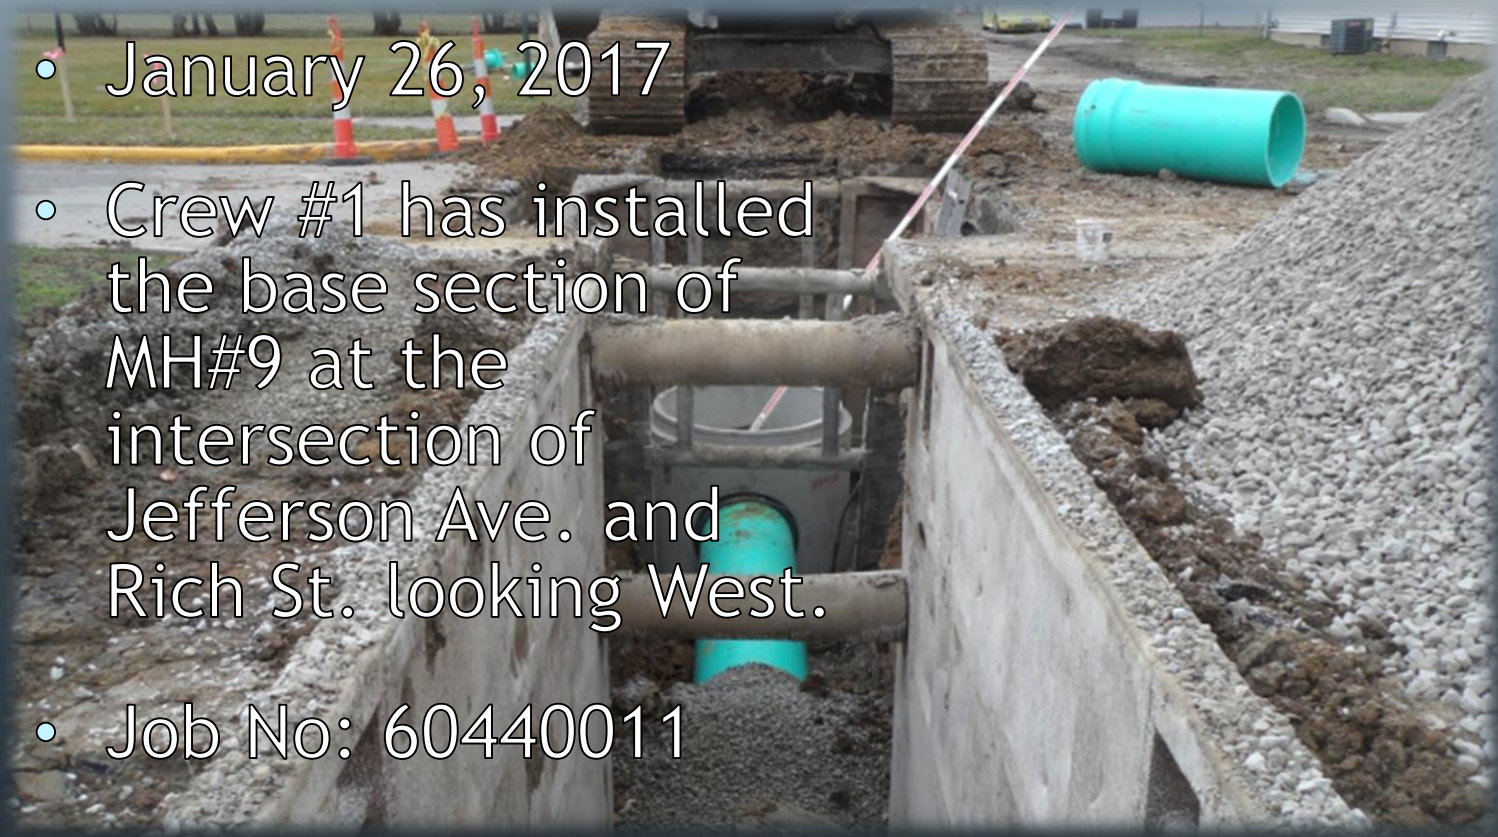
- January 26, 2017
- Crew #1 has installed the base section of MH#9 at the intersection of Jefferson Ave. and Rich St. looking West.
- Job No: 60440011

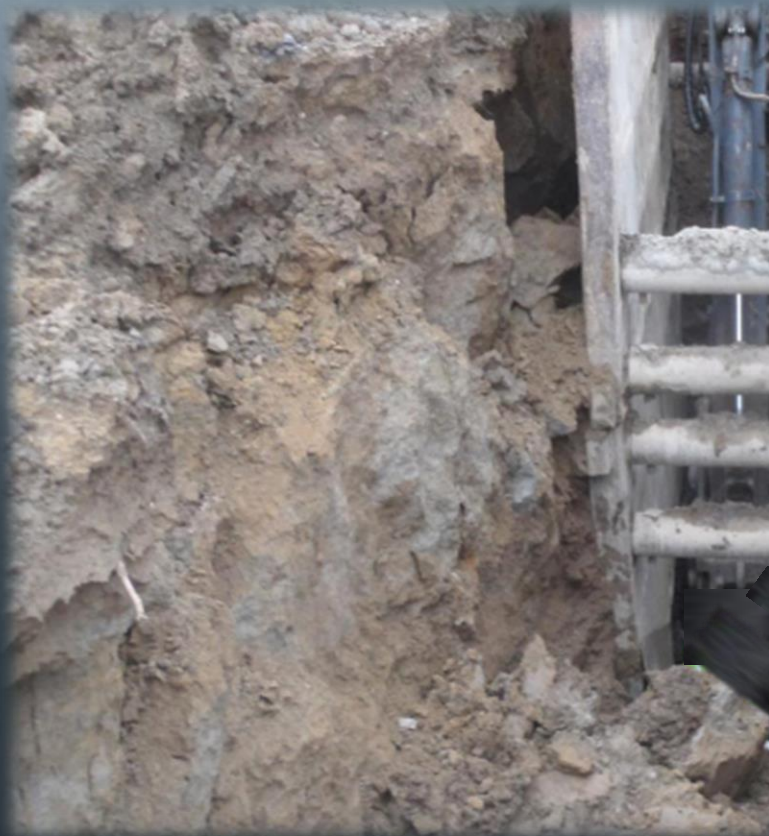
- January 26, 2017
- Crew #2 excavating to install another section of 24" SDR-35 sewer pipe from MH#18 to MH#19 at the Ashville WRRF plant site.
- Job No: 60440011

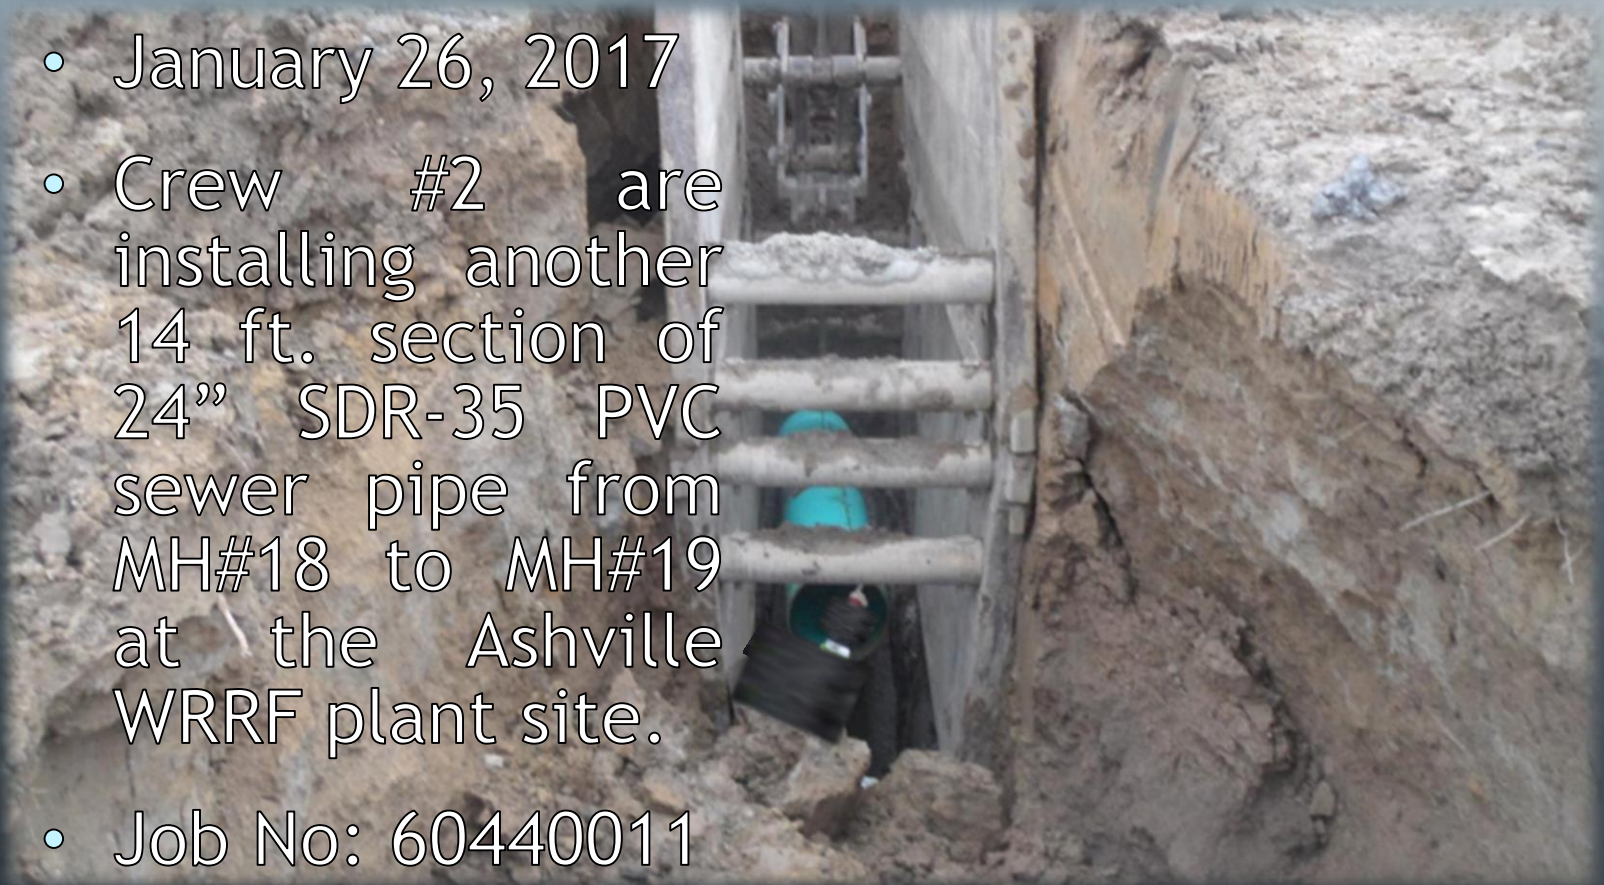
- January 26, 2017
- Crew #2 are installing another 14 ft. section of 24" SDR-35 PVC sewer pipe from MH#18 to MH#19 at the Ashville WRRF plant site.
- Job No: 60440011

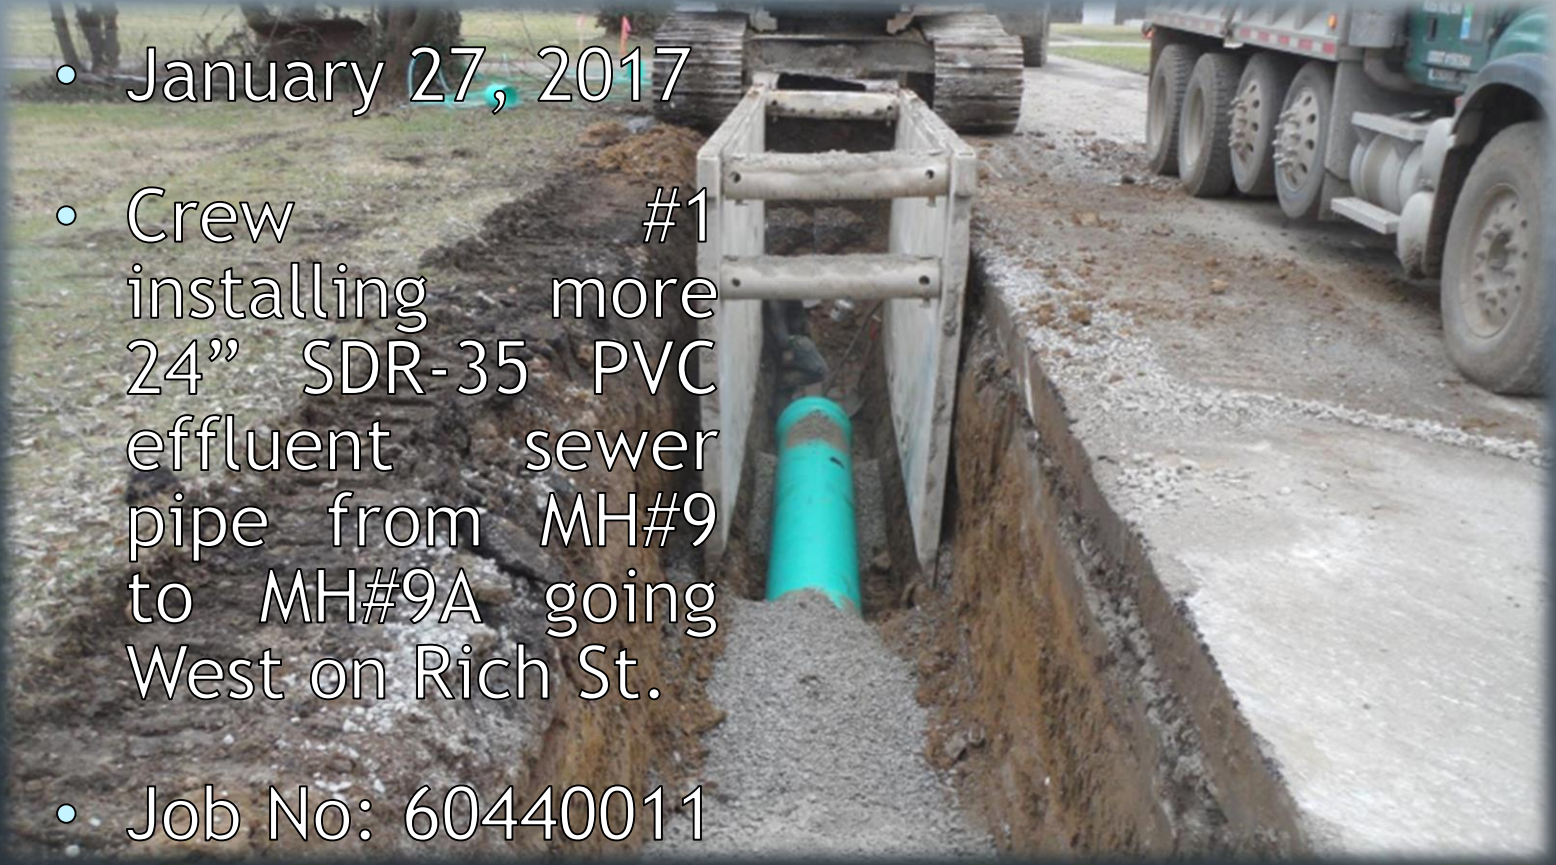
- January 27, 2017
- Crew #1 installing more 24" SDR-35 PVC effluent sewer pipe from MH#9 to MH#9A going West on Rich St.
- Job No: 60440011

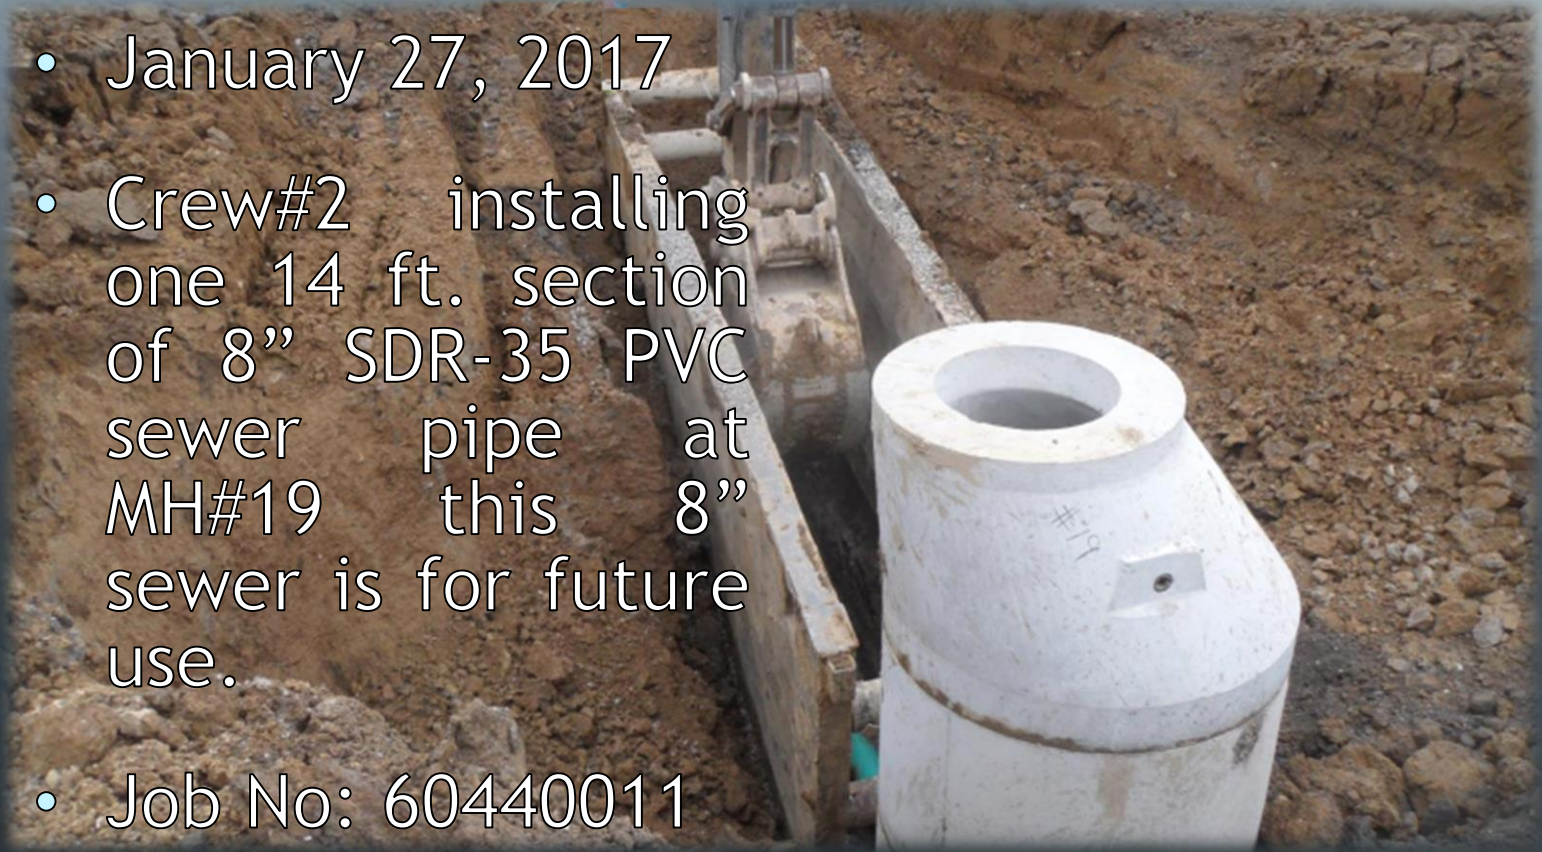
- January 27, 2017
- Crew#2 installing one 14 ft. section of 8" SDR-35 PVC sewer pipe at MH#19 this 8" sewer is for future use.
- Job No: 60440011

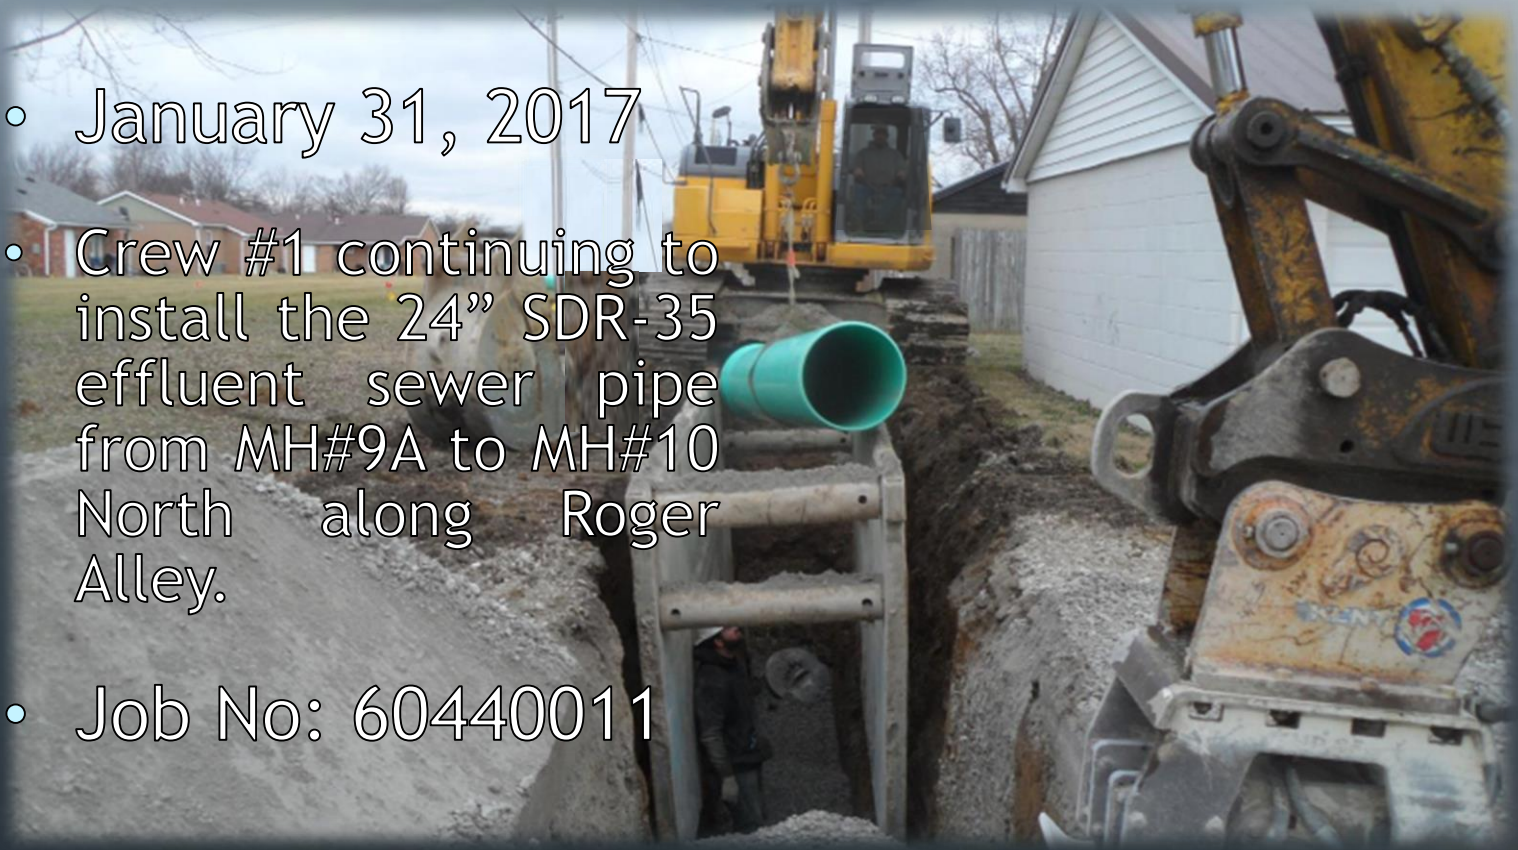
- January 31, 2017
- Crew #1 continuing to install the 24" SDR-35 effluent sewer pipe from MH#9A to MH#10 North along Roger Alley.
- Job No: 60440011

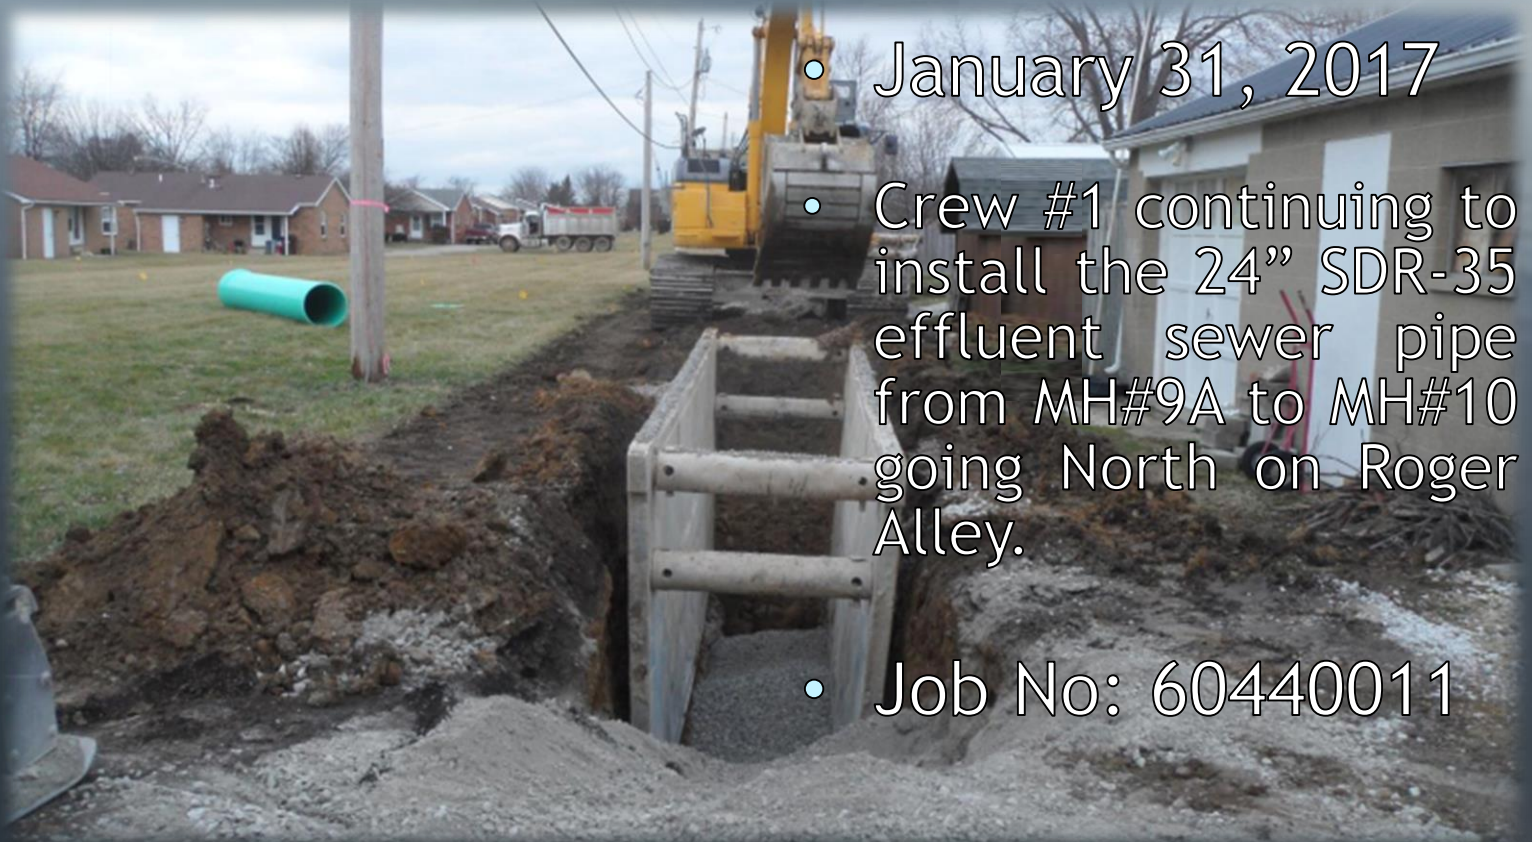
- January 31, 2017
- Crew #1 continuing to install the 24" SDR-35 effluent sewer pipe from MH#9A to MH#10 going North on Roger Alley.
- Job No: 60440011
