Construction in Photos

June 1 - 30, 2017

Water Resource Recovery Department Village of Ashville Ashville's Water Resource Recovery Facility Part B-Job No: 60440011

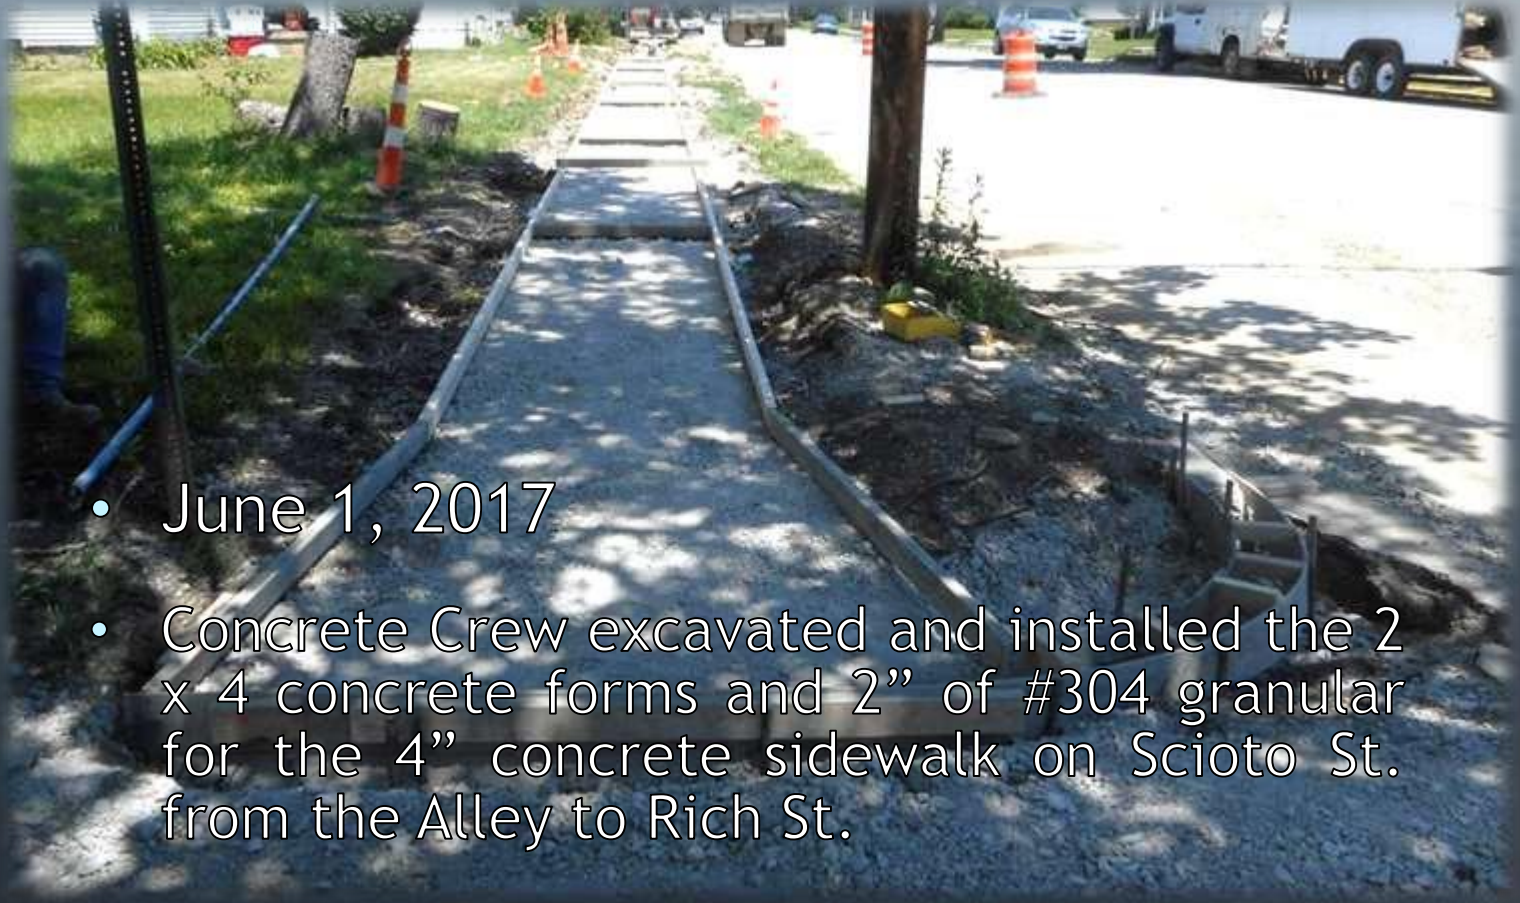
- June 1, 2017
- Concrete Crew excavated and installed the 2 x 4 concrete forms and 2" of #304 granular for the 4" concrete sidewalk on Scioto St. from the Alley to Rich St.

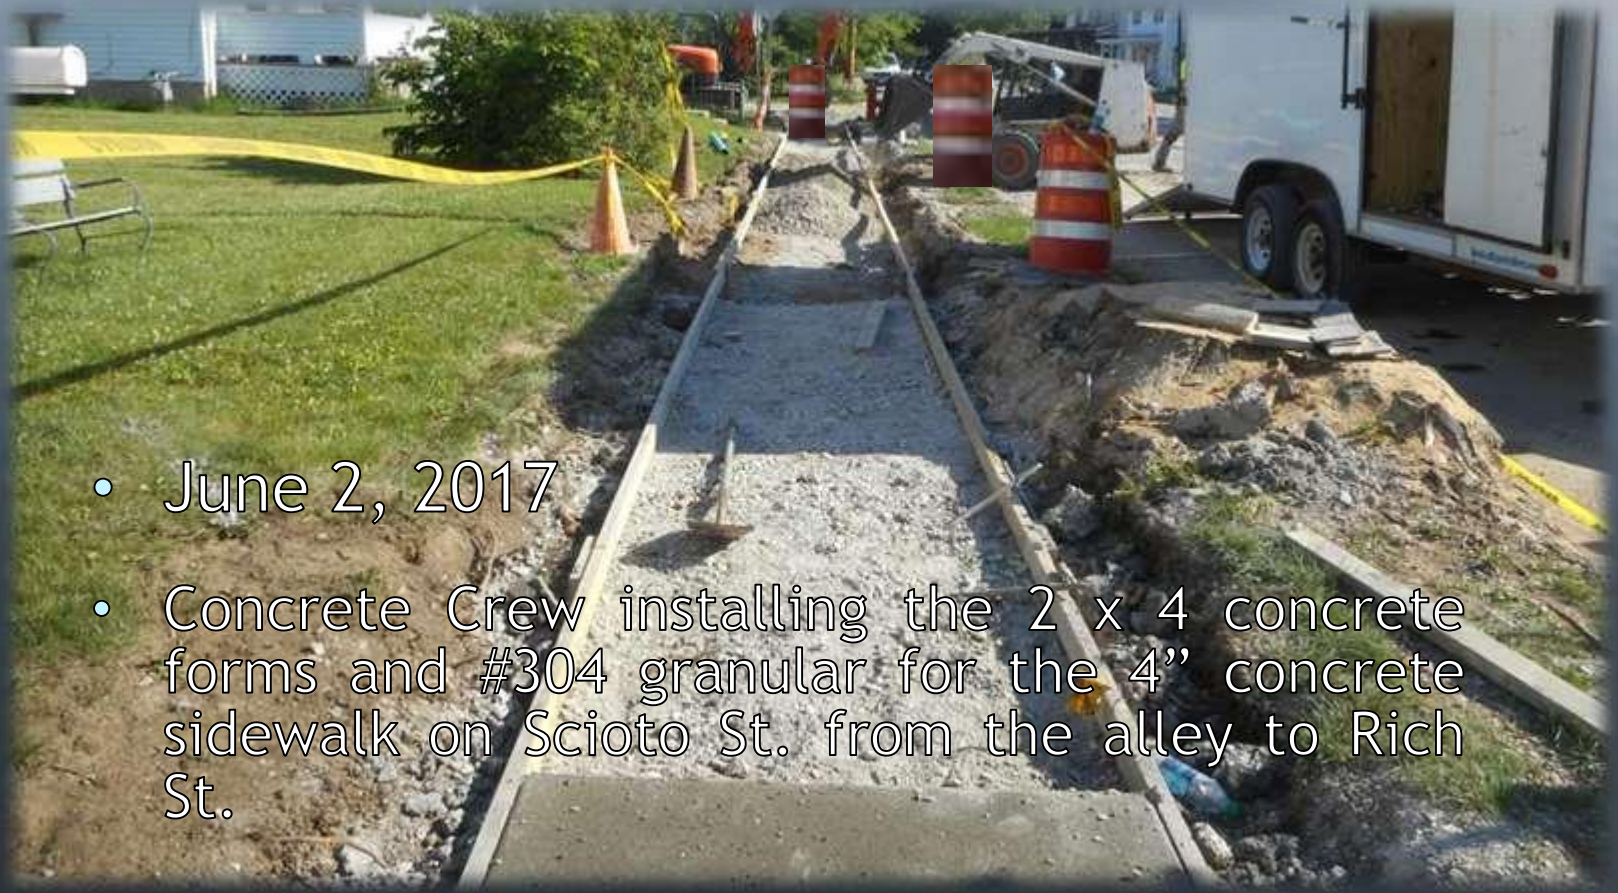
- June 2, 2017
- Concrete Crew installing the 2 x 4 concrete forms and #304 granular for the 4" concrete sidewalk on Scioto St. from the alley to Rich St.

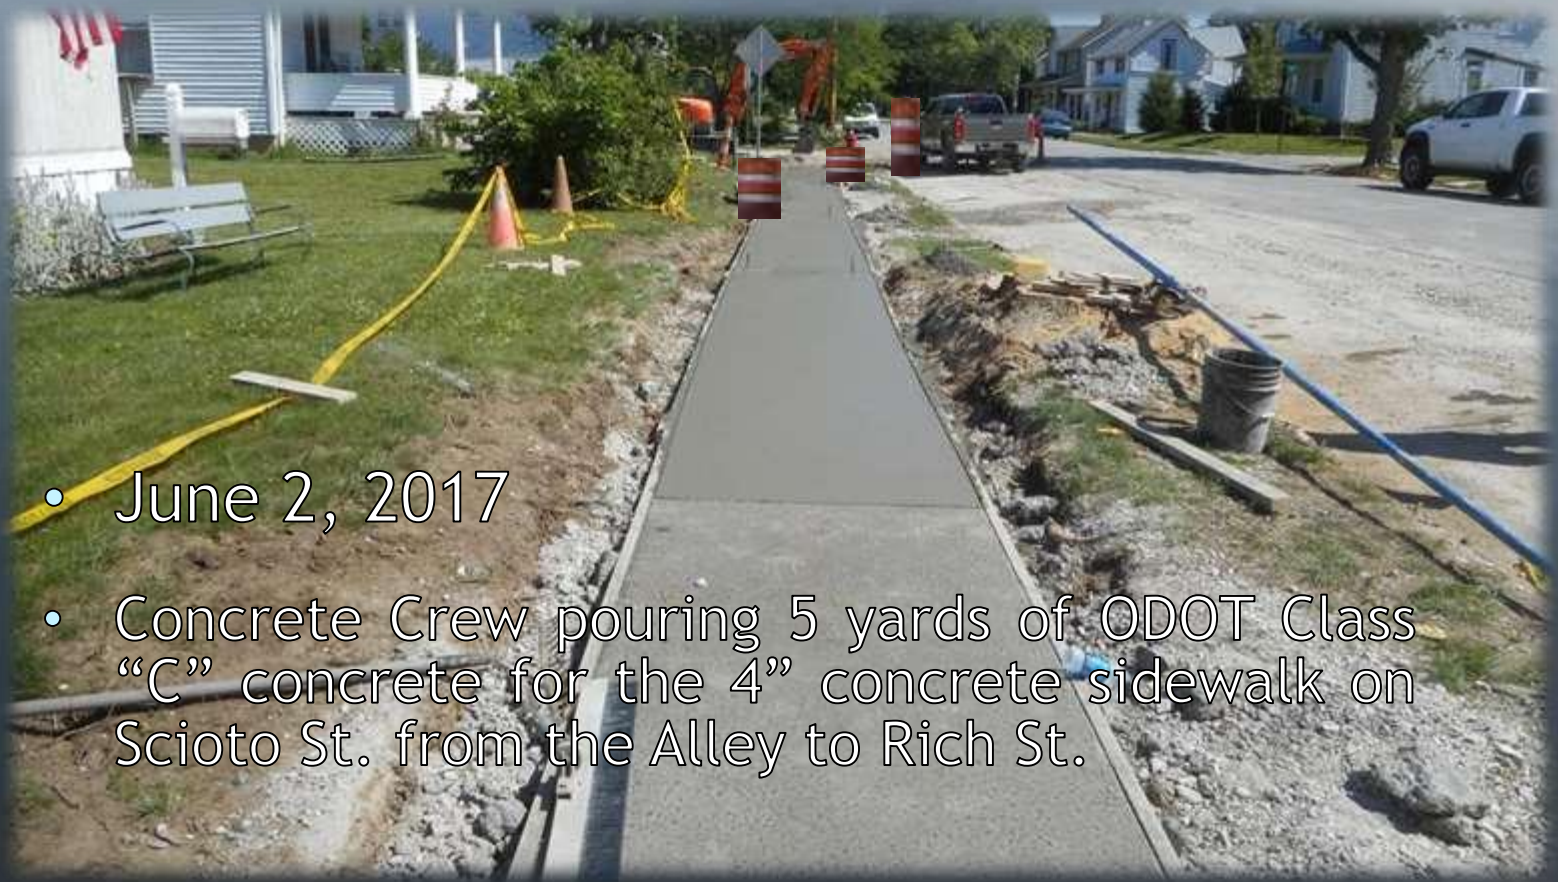
- June 2, 2017
- Concrete Crew pouring 5 yards of ODOT Class "C" concrete for the 4" concrete sidewalk on Scioto St. from the Alley to Rich St.

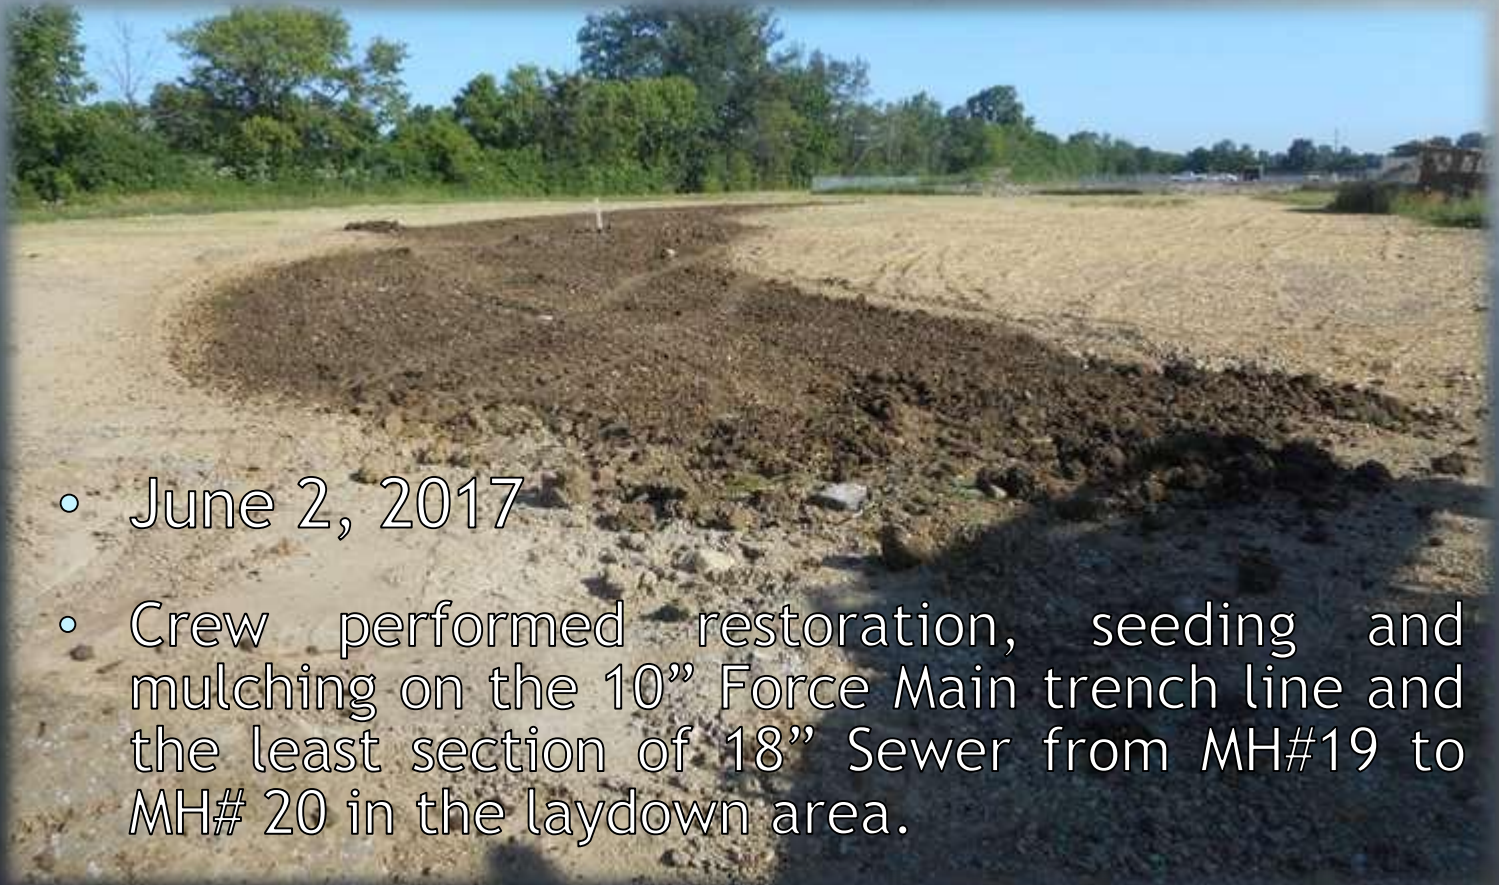
- June 2, 2017
- Crew performed restoration, seeding and mulching on the 10" Force Main trench line and the least section of 18" Sewer from MH#19 to MH# 20 in the laydown area.

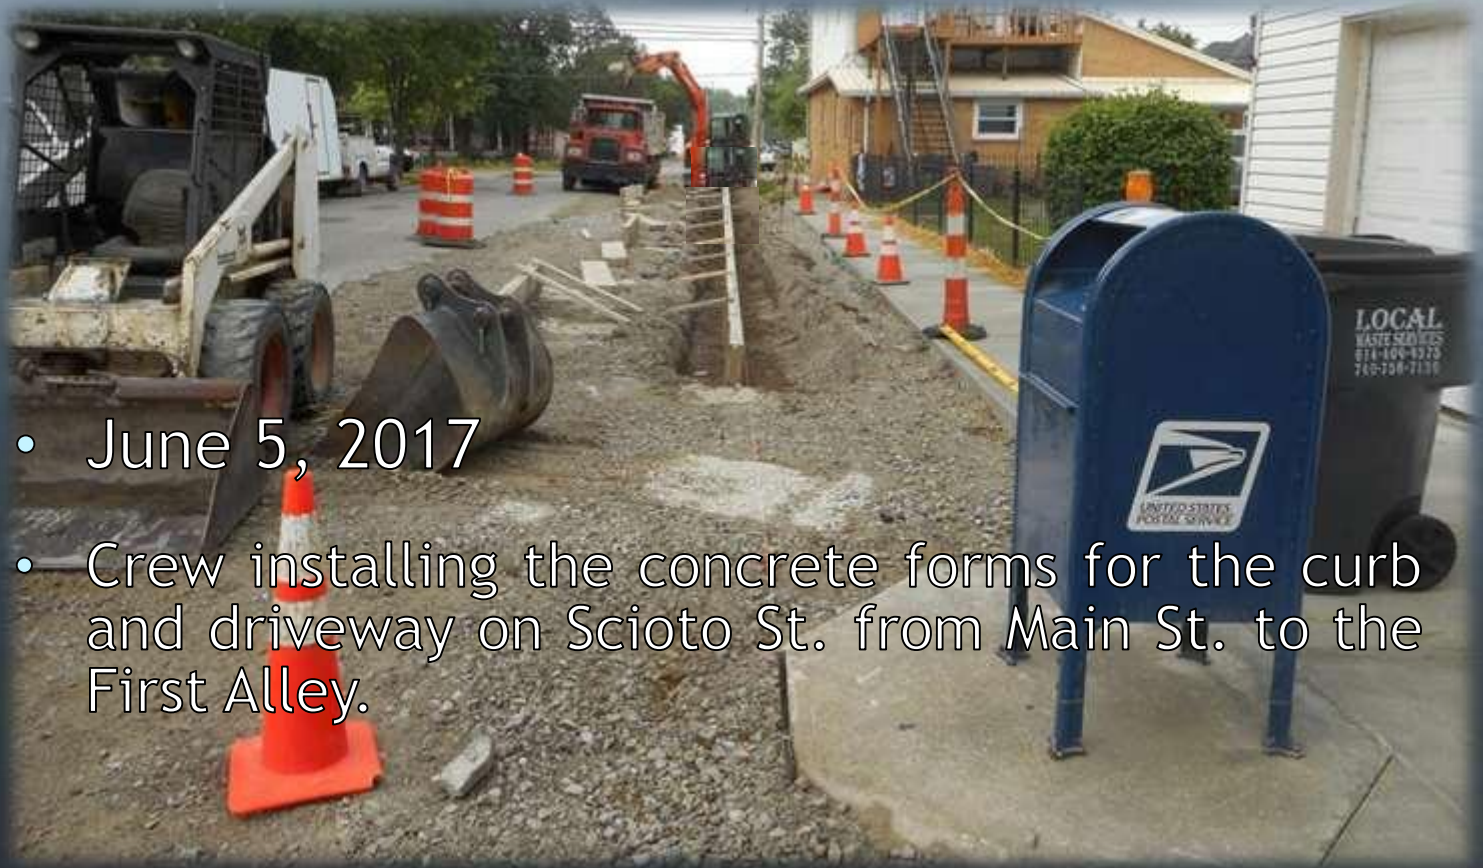
- June 5, 2017
- Crew installing the concrete forms for the curb and driveway on Scioto St. from Main St. to the First Alley.

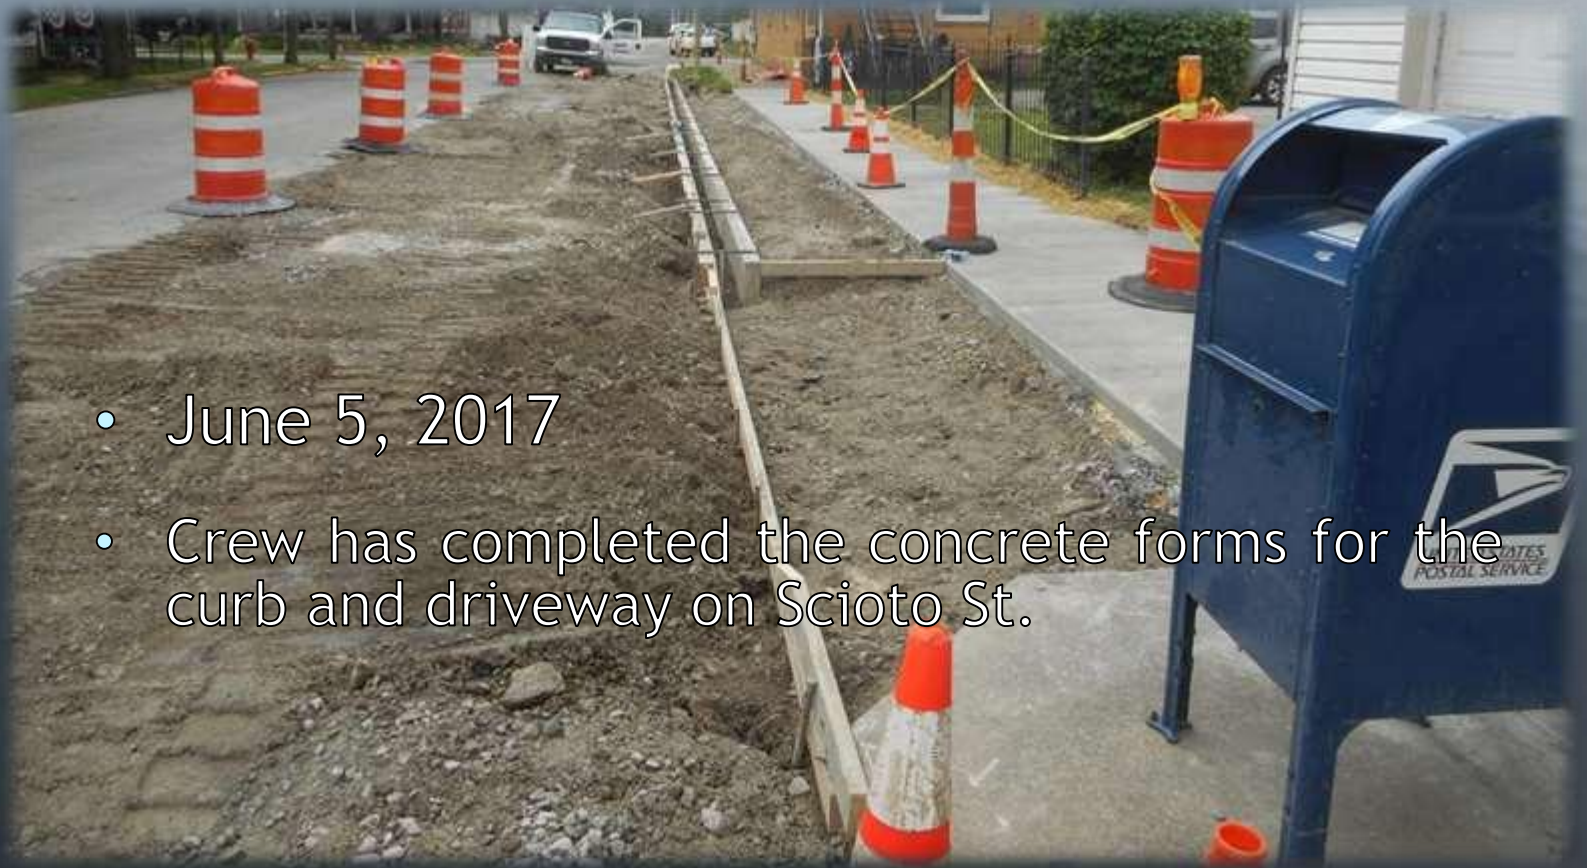
- June 5, 2017
- Crew has completed the concrete forms for the curb and driveway on Scioto St.

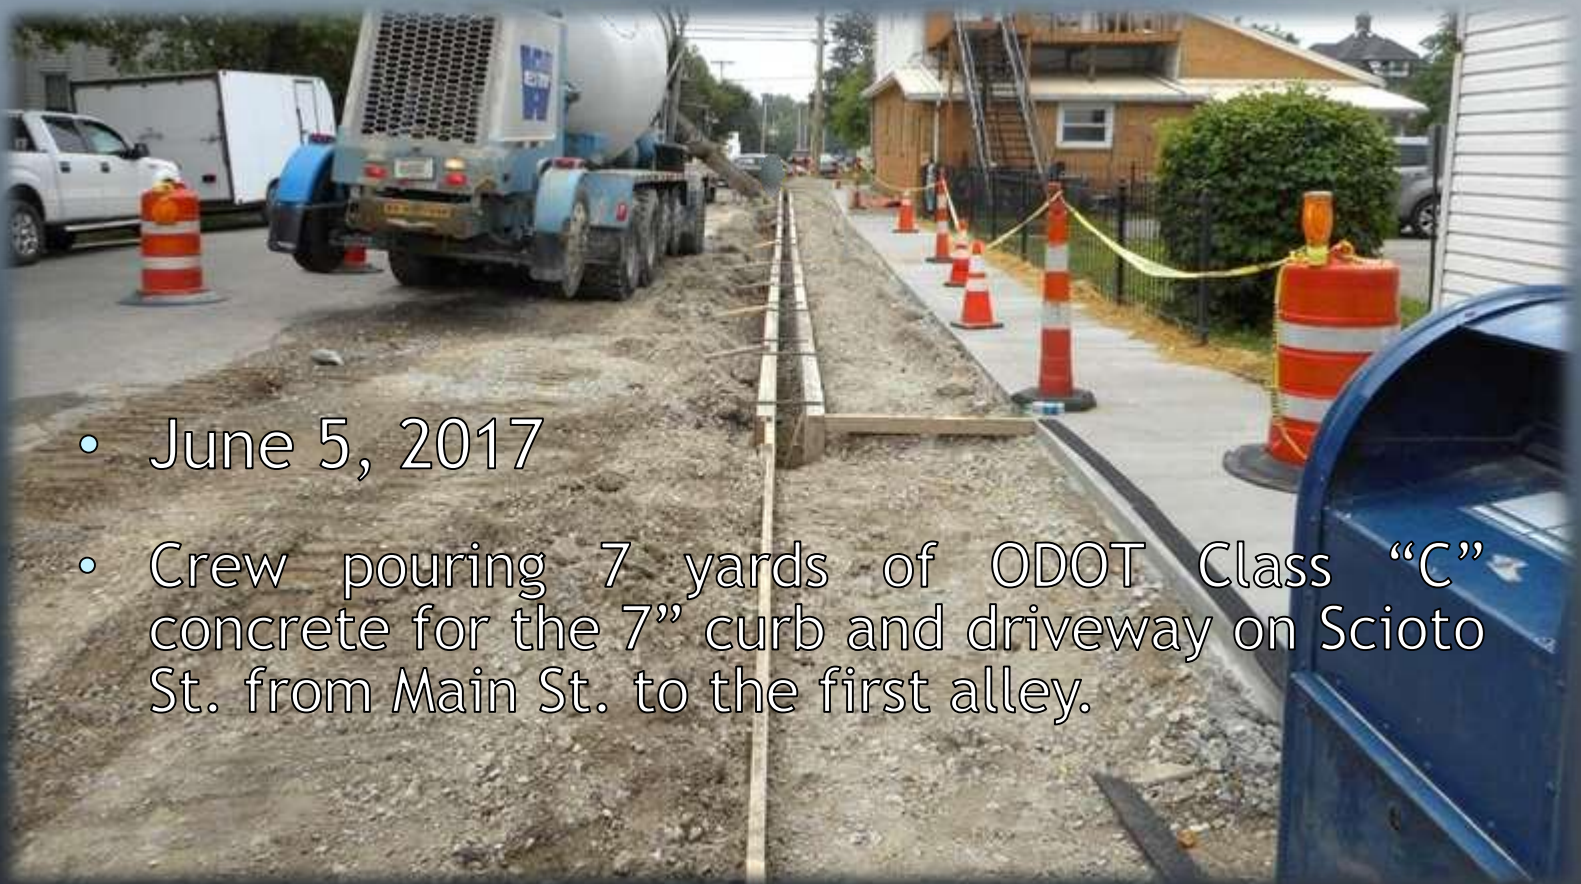
- June 5, 2017
- Crew pouring 7 yards of ODOT Class "C" concrete for the 7" curb and driveway on Scioto St. from Main St. to the first alley.

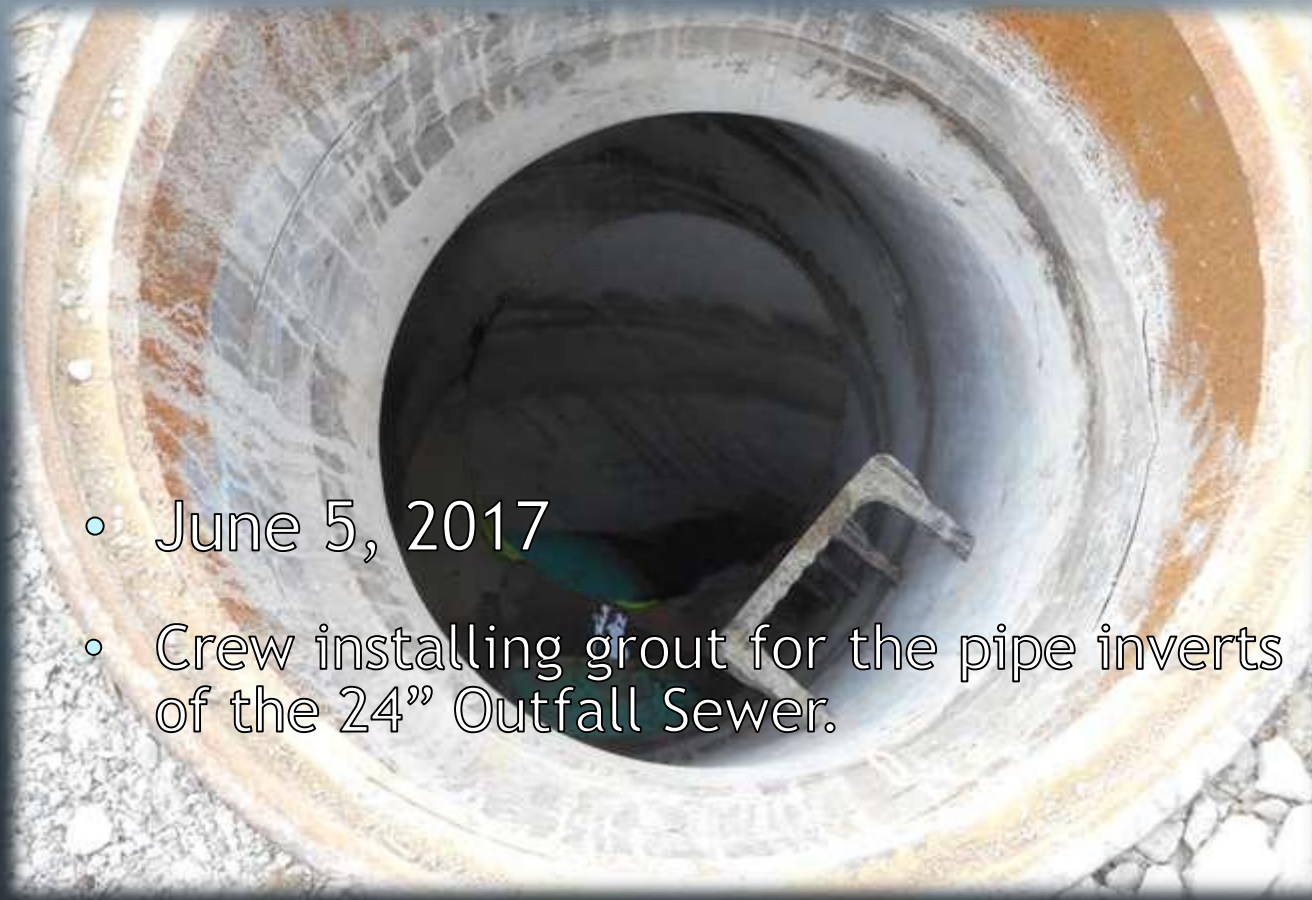
- June 5, 2017
- Crew installing grout for the pipe inverts of the 24" Outfall Sewer.

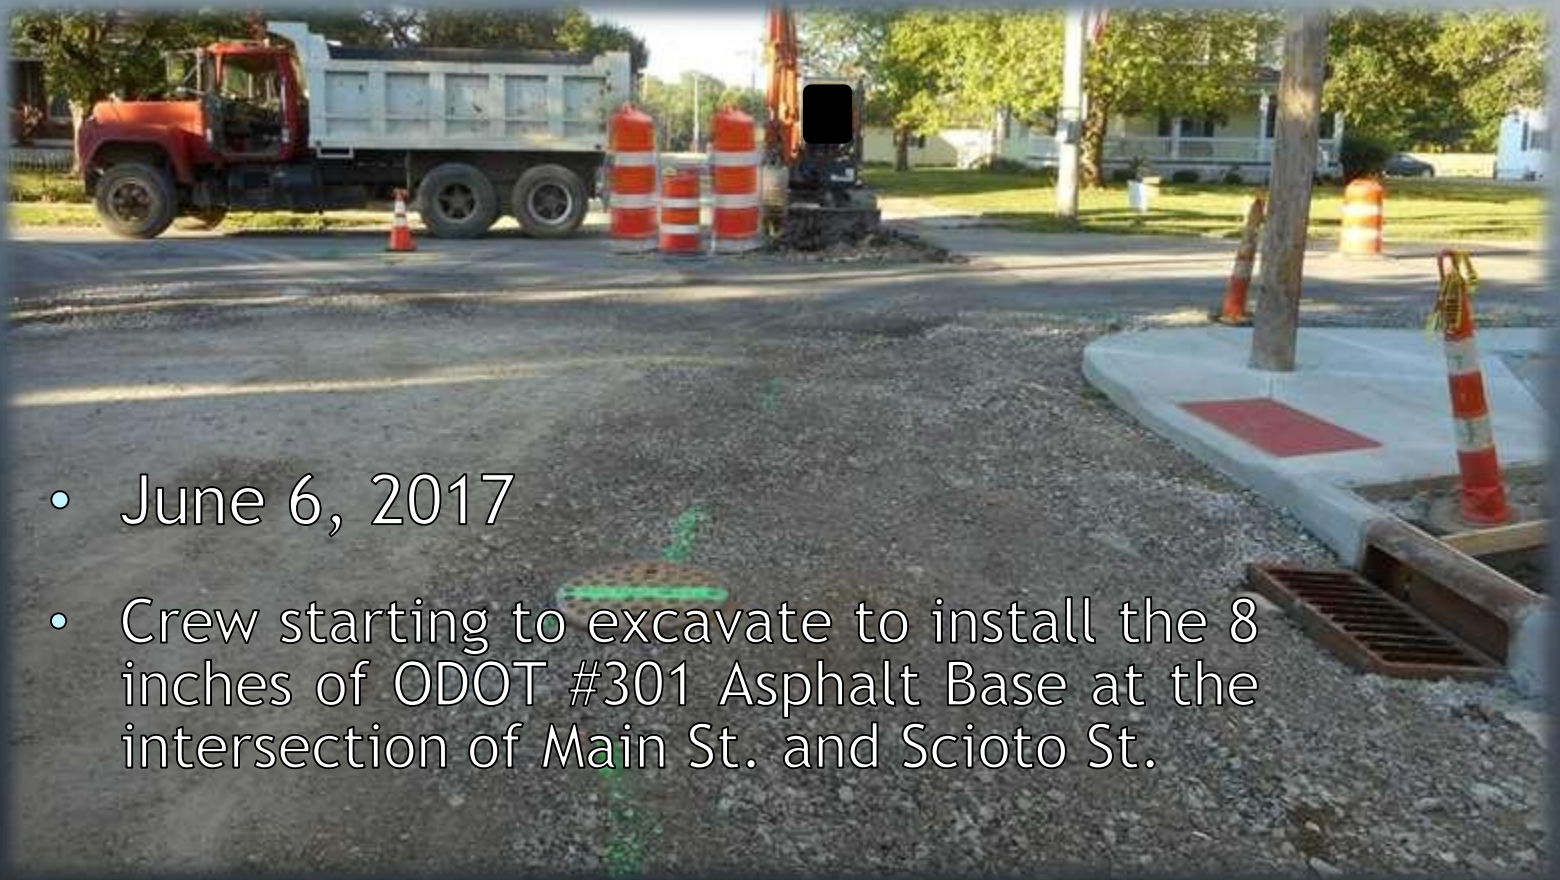
- June 6, 2017
- Crew starting to excavate to install the 8 inches of ODOT #301 Asphalt Base at the intersection of Main St. and Scioto St.

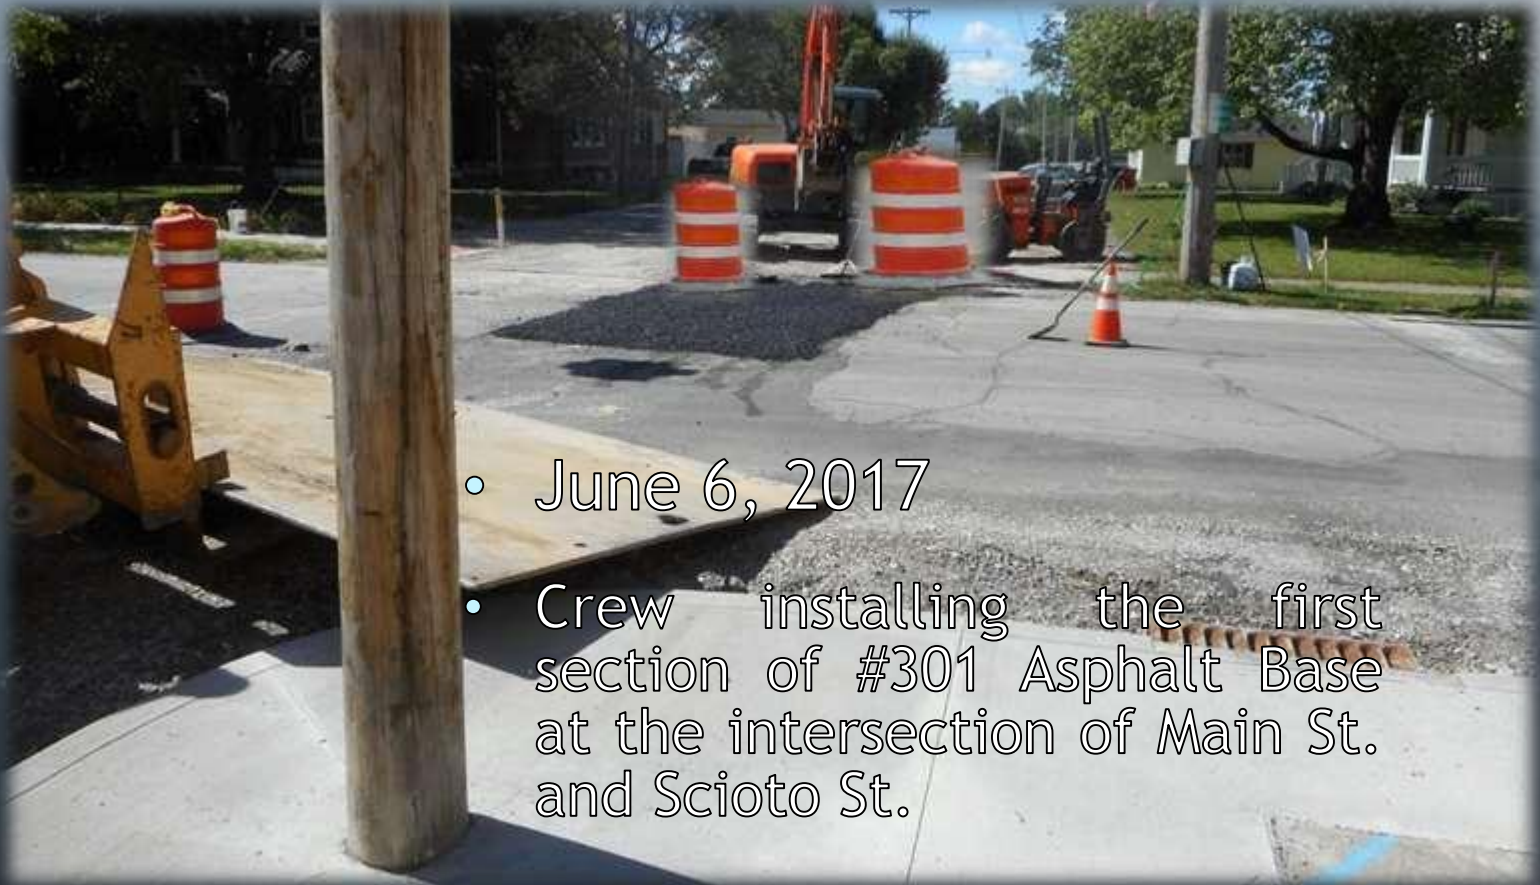
- June 6, 2017
- Crew installing the first section of #301 Asphalt Base at the intersection of Main St. and Scioto St.

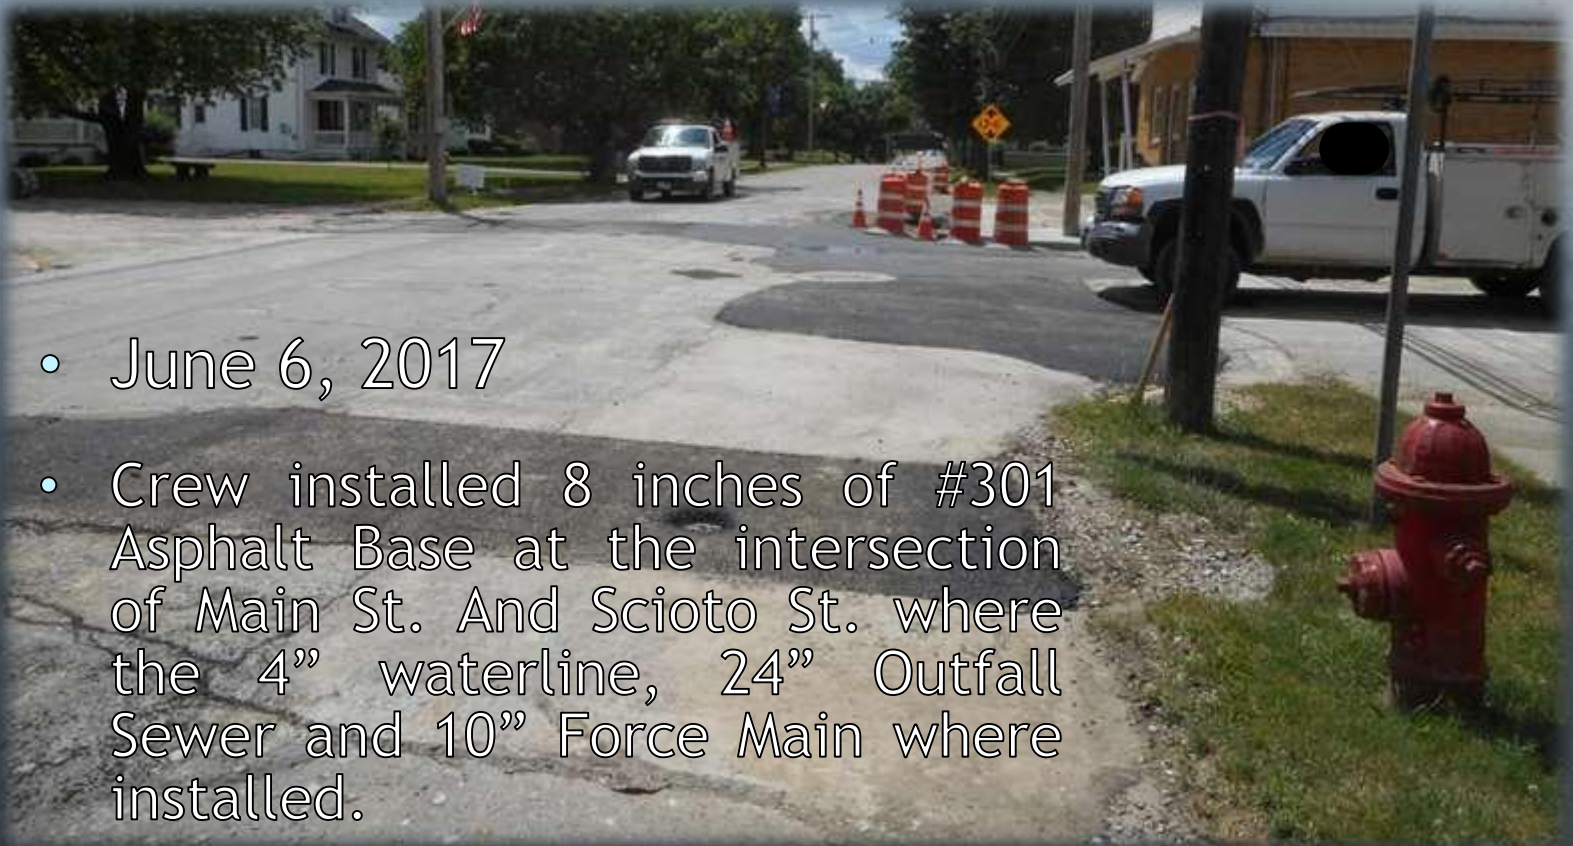
- June 6, 2017
- Crew installed 8 inches of #301 Asphalt Base at the intersection of Main St. And Scioto St. where the 4" waterline, 24" Outfall Sewer and 10" Force Main were installed.

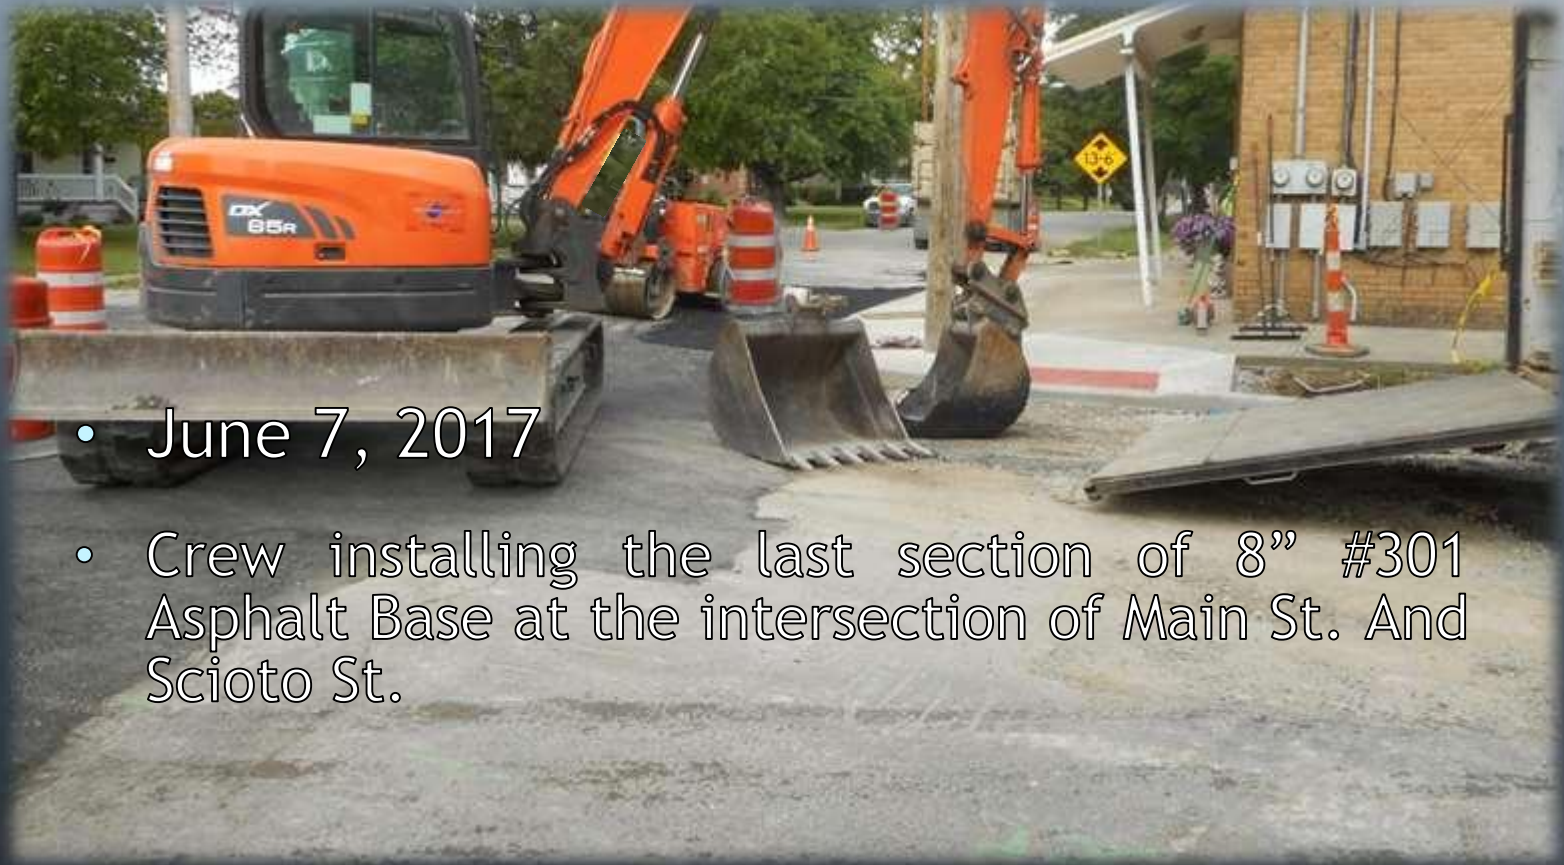
- June 7, 2017
- Crew installing the last section of 8" #301 Asphalt Base at the intersection of Main St. And Scioto St.

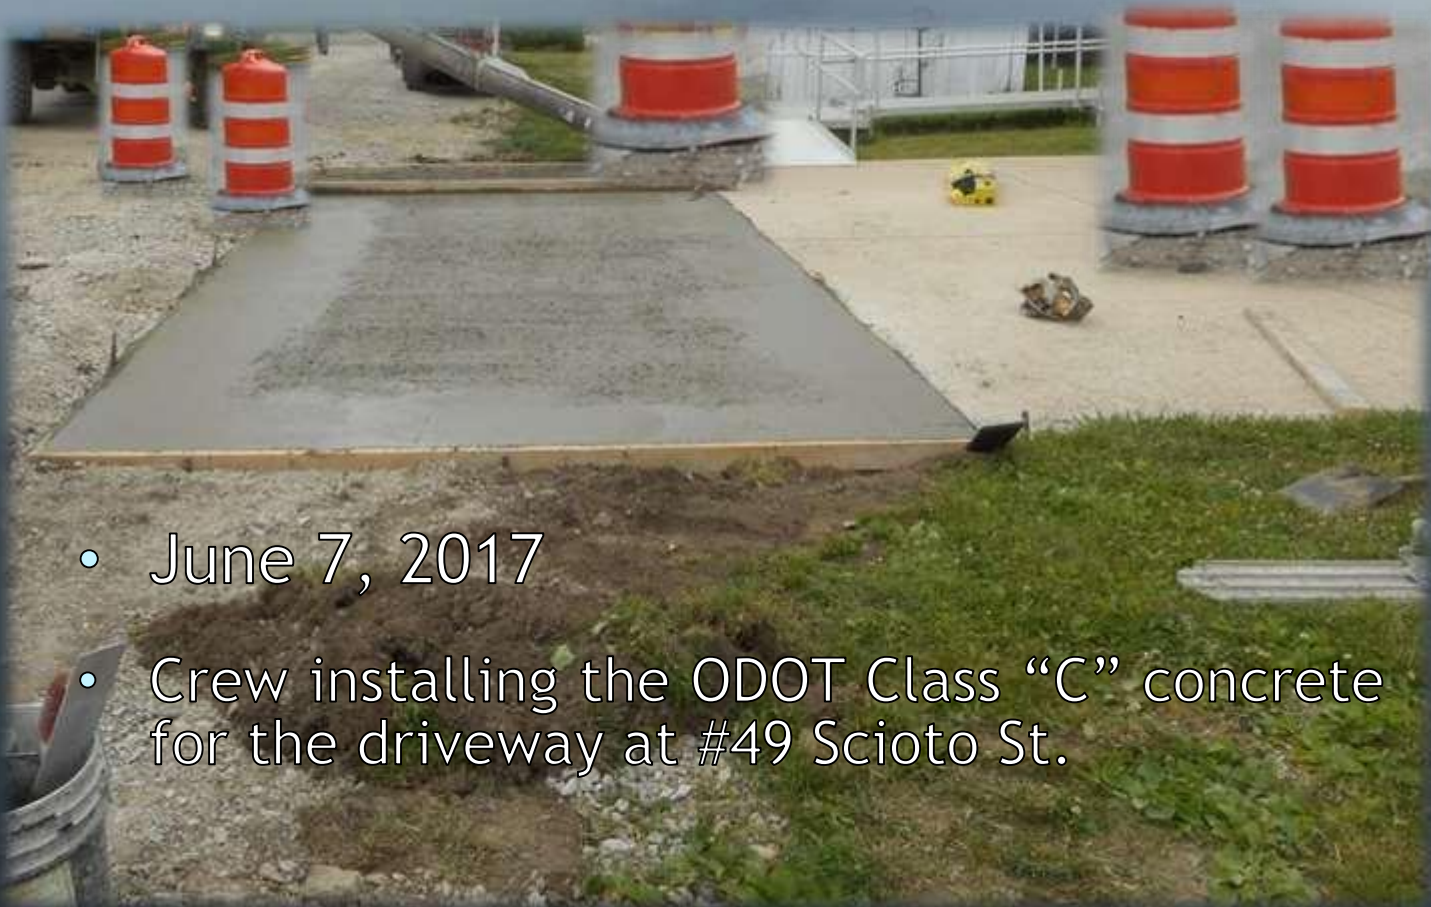
- June 7, 2017
- Crew installing the ODOT Class "C" concrete for the driveway at #49 Scioto St.

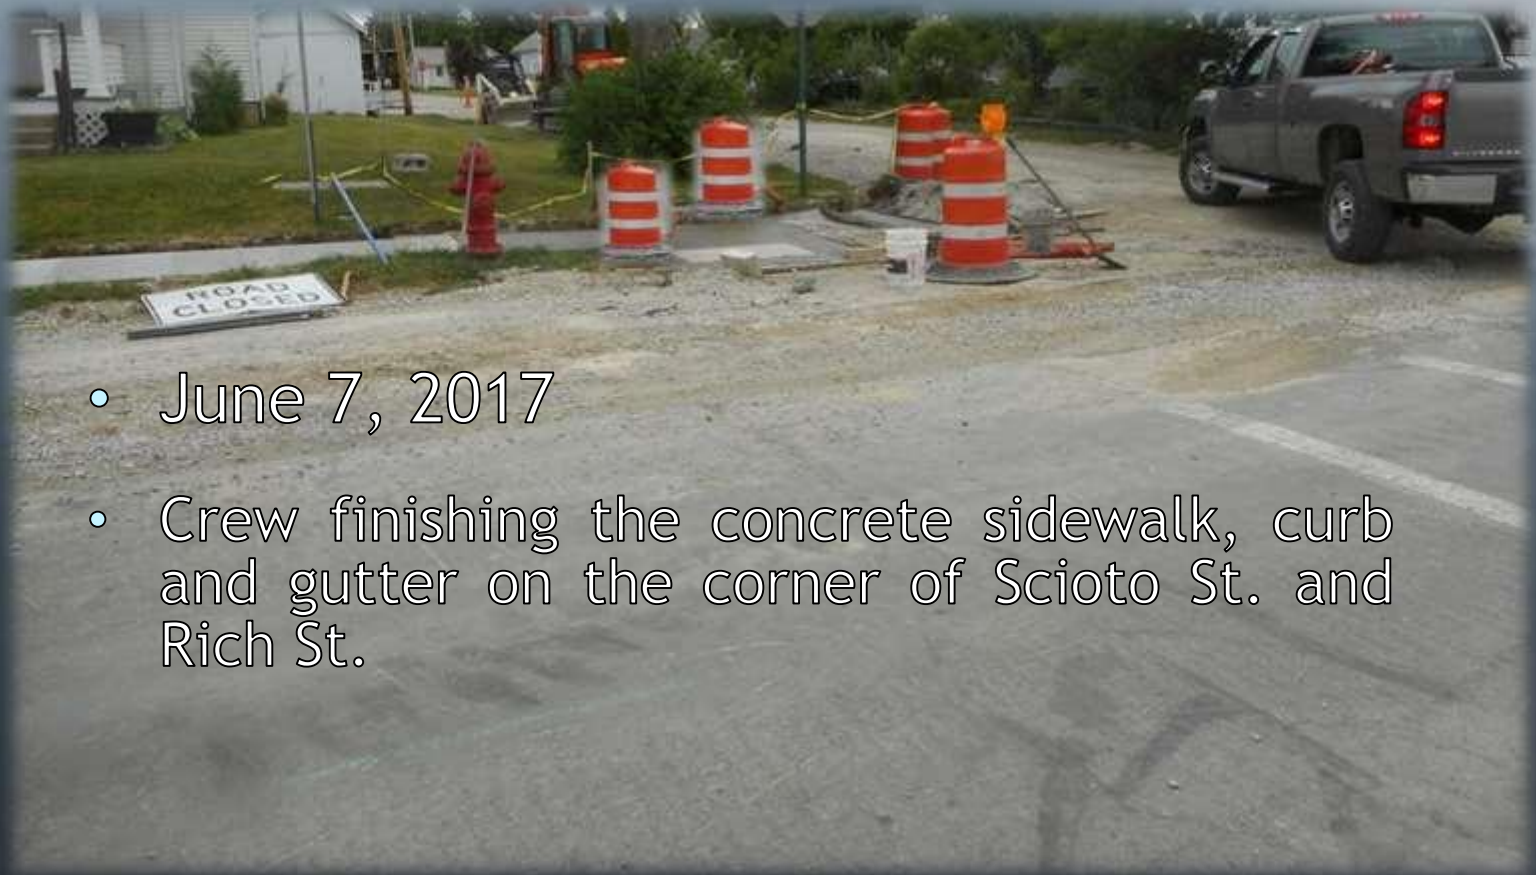
- June 7, 2017
- Crew finishing the concrete sidewalk, curb and gutter on the corner of Scioto St. and Rich St.

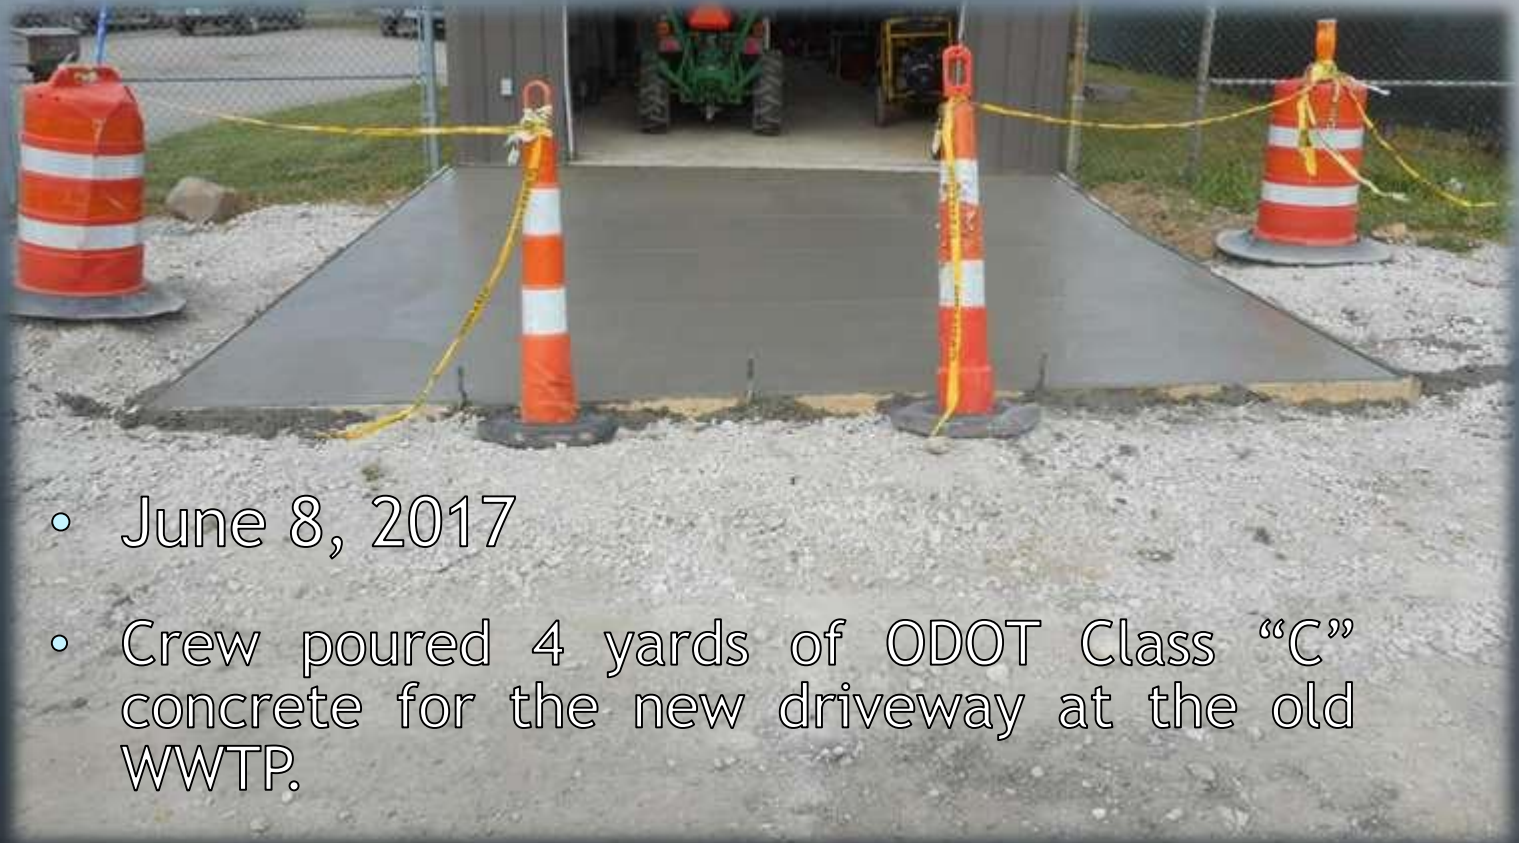
- June 8, 2017
- Crew poured 4 yards of ODOT Class "C" concrete for the new driveway at the old WWTP.

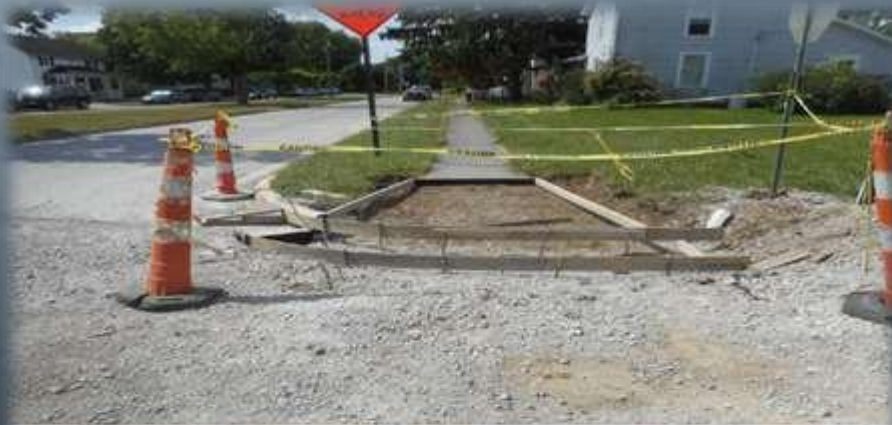
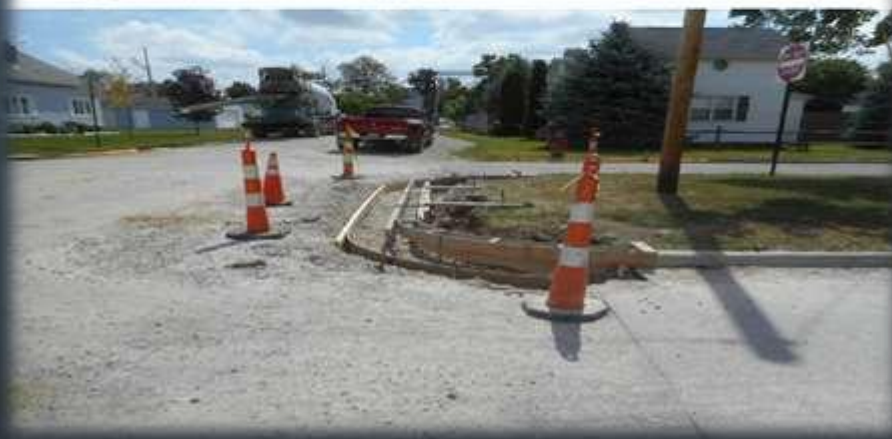
- June 8, 2017
- Crew installed the concrete forms for the sidewalk and curb/gutter at the intersection of Jefferson St. and Rich St.

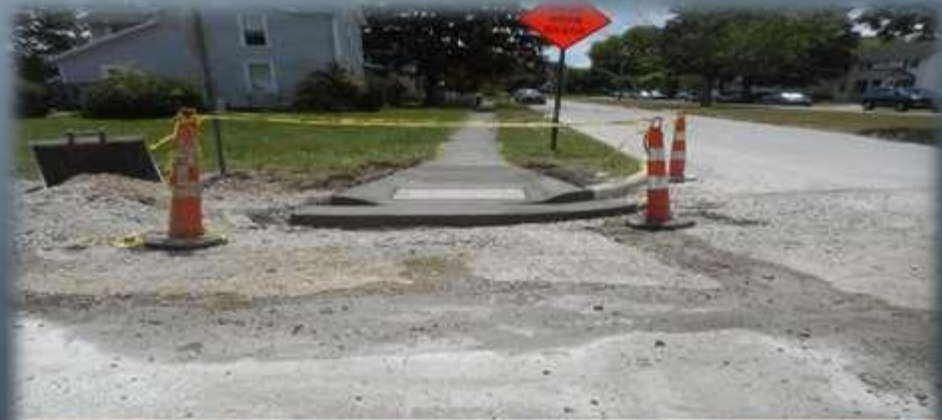
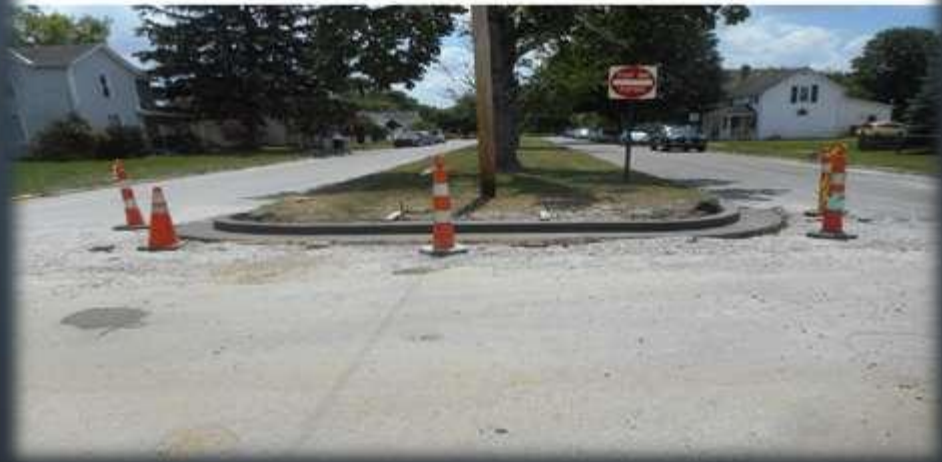
- June 8, 2017
- Crew poured 4 yards of ODOT Class "C" concrete for the sidewalk and curb/gutter at the intersection of Jefferson St. and Rich St.
