Construction in Photos

June 1 - 30, 2017

Water Resource Recovery Department Village of Ashville Ashville's Water Resource Recovery Facility Part B-Job No: 60440011

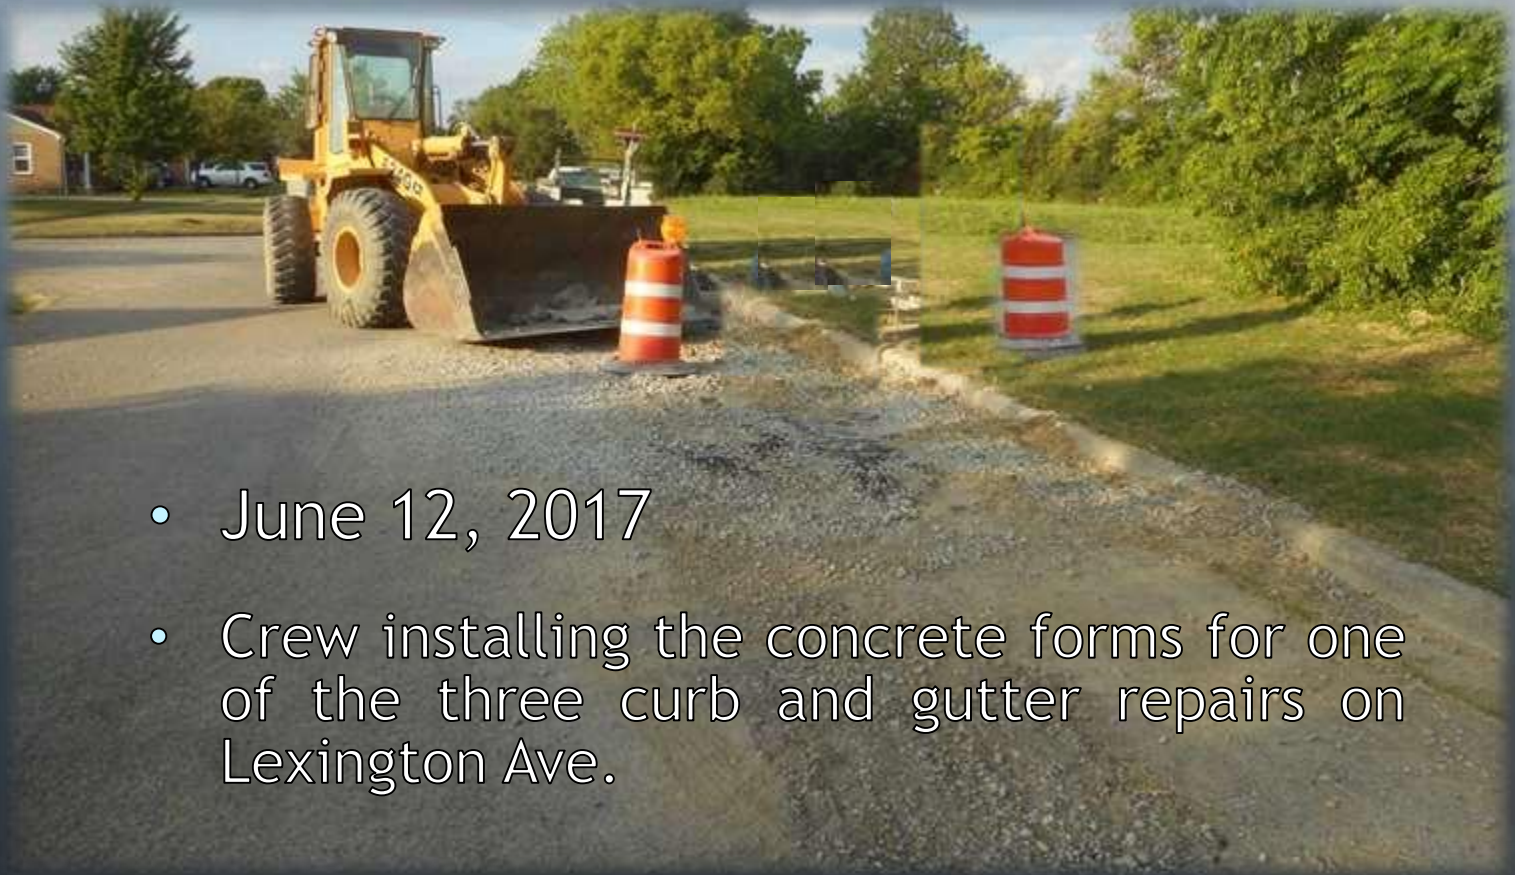
- June 12, 2017
- Crew installing the concrete forms for one of the three curb and gutter repairs on Lexington Ave.

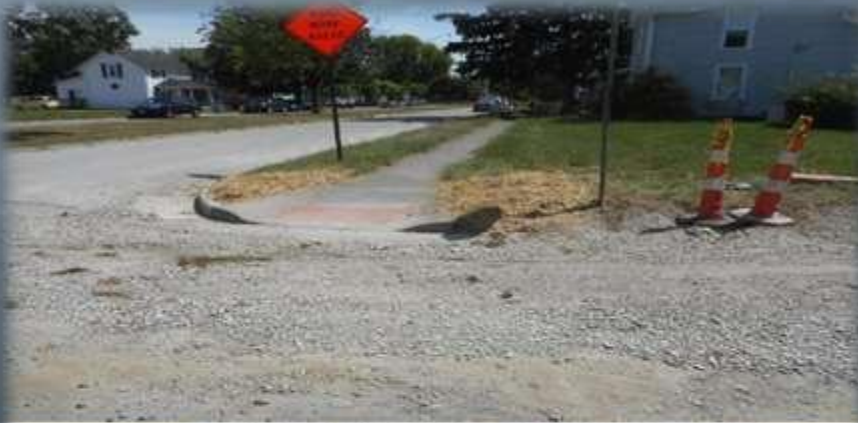
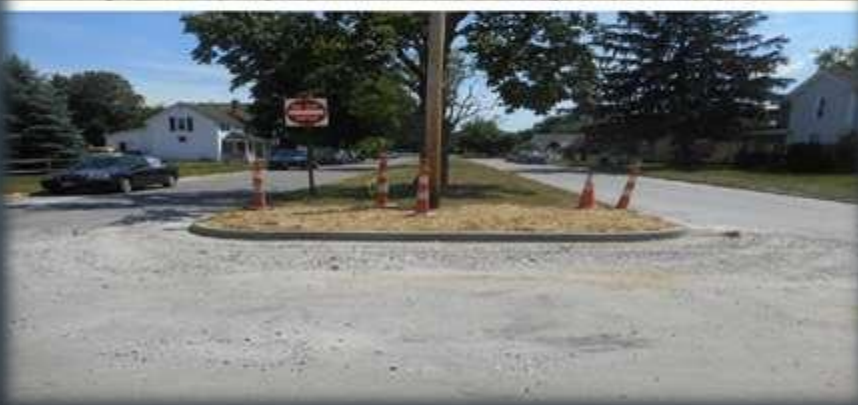
- June 12, 2017
- Crew seeding and Mulching the sidewalk and curb/gutter at the intersection of Jefferson Ave. and Rich St.

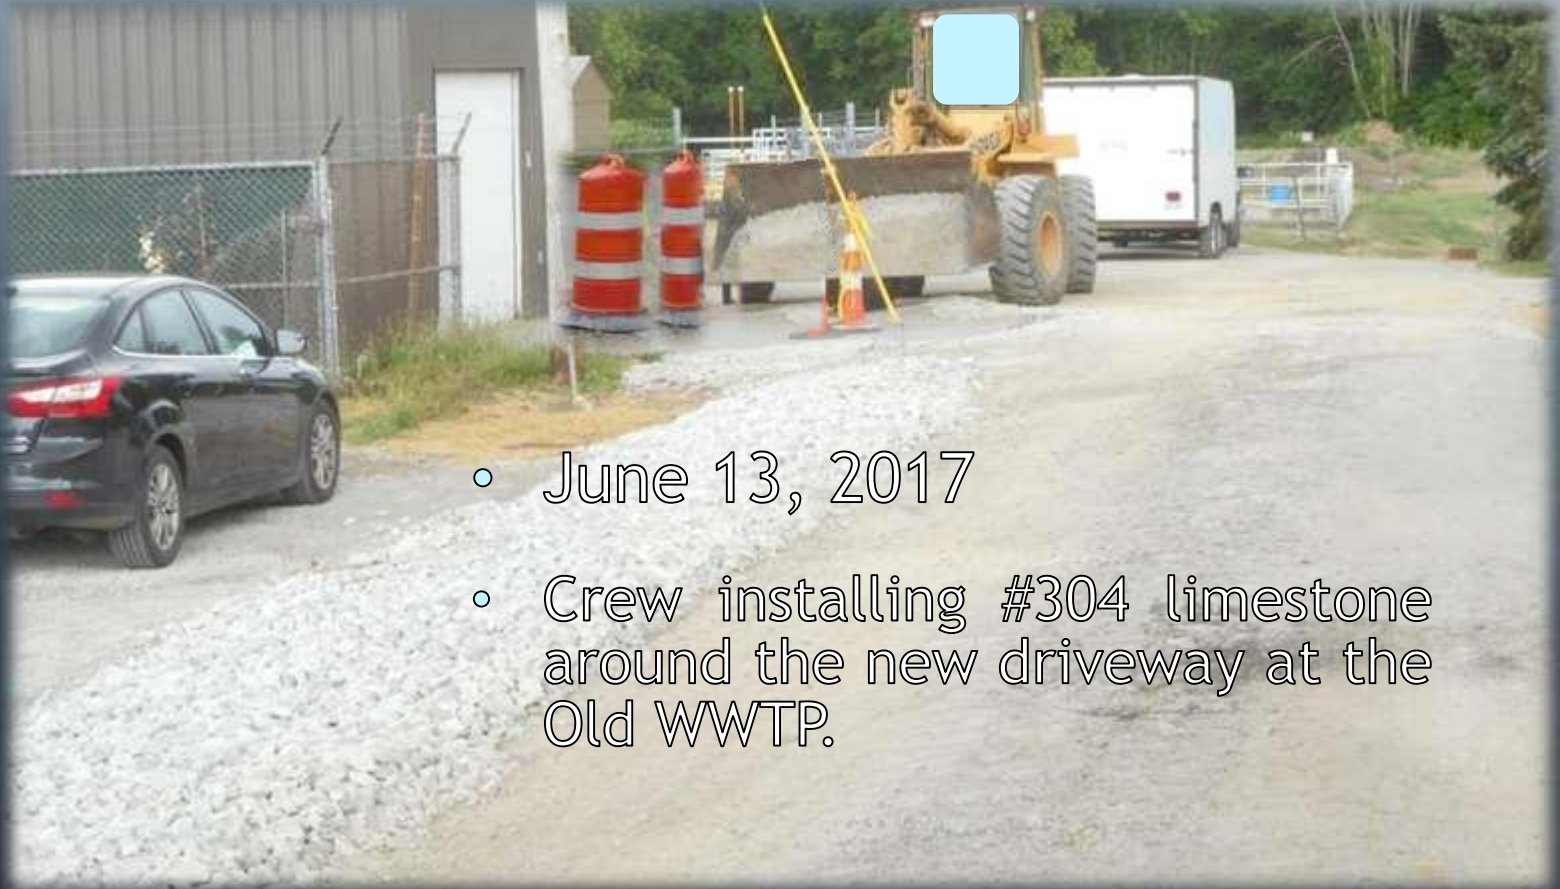
- June 13, 2017
- Crew installing #304 limestone around the new driveway at the Old WWTP.

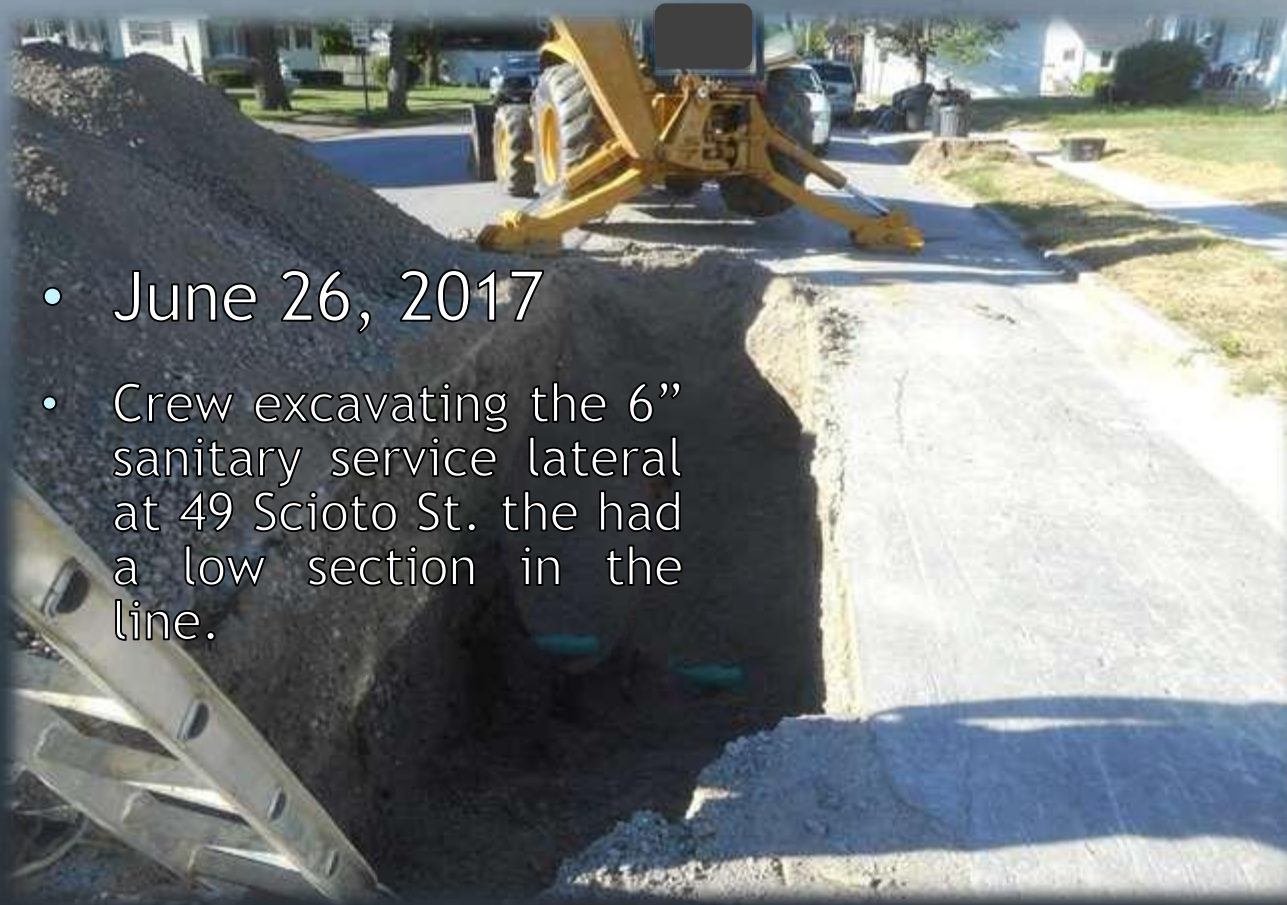
- June 26, 2017
- Crew excavating the 6" sanitary service lateral at 49 Scioto St. the had a low section in the line.

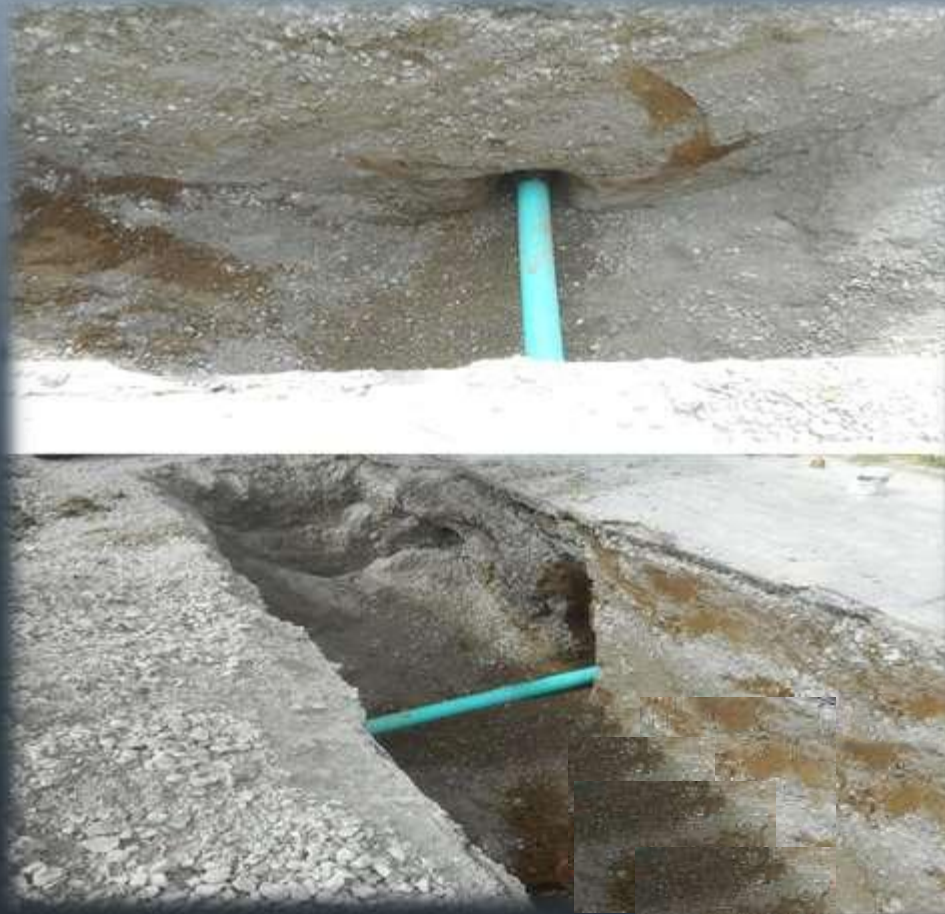
- June 26, 2017
- Crew has removed the old 6" SDR-35 PVC sewer pipe and installed this new 6" SDR-35 PVC sewer pipe at 49 Scioto St.

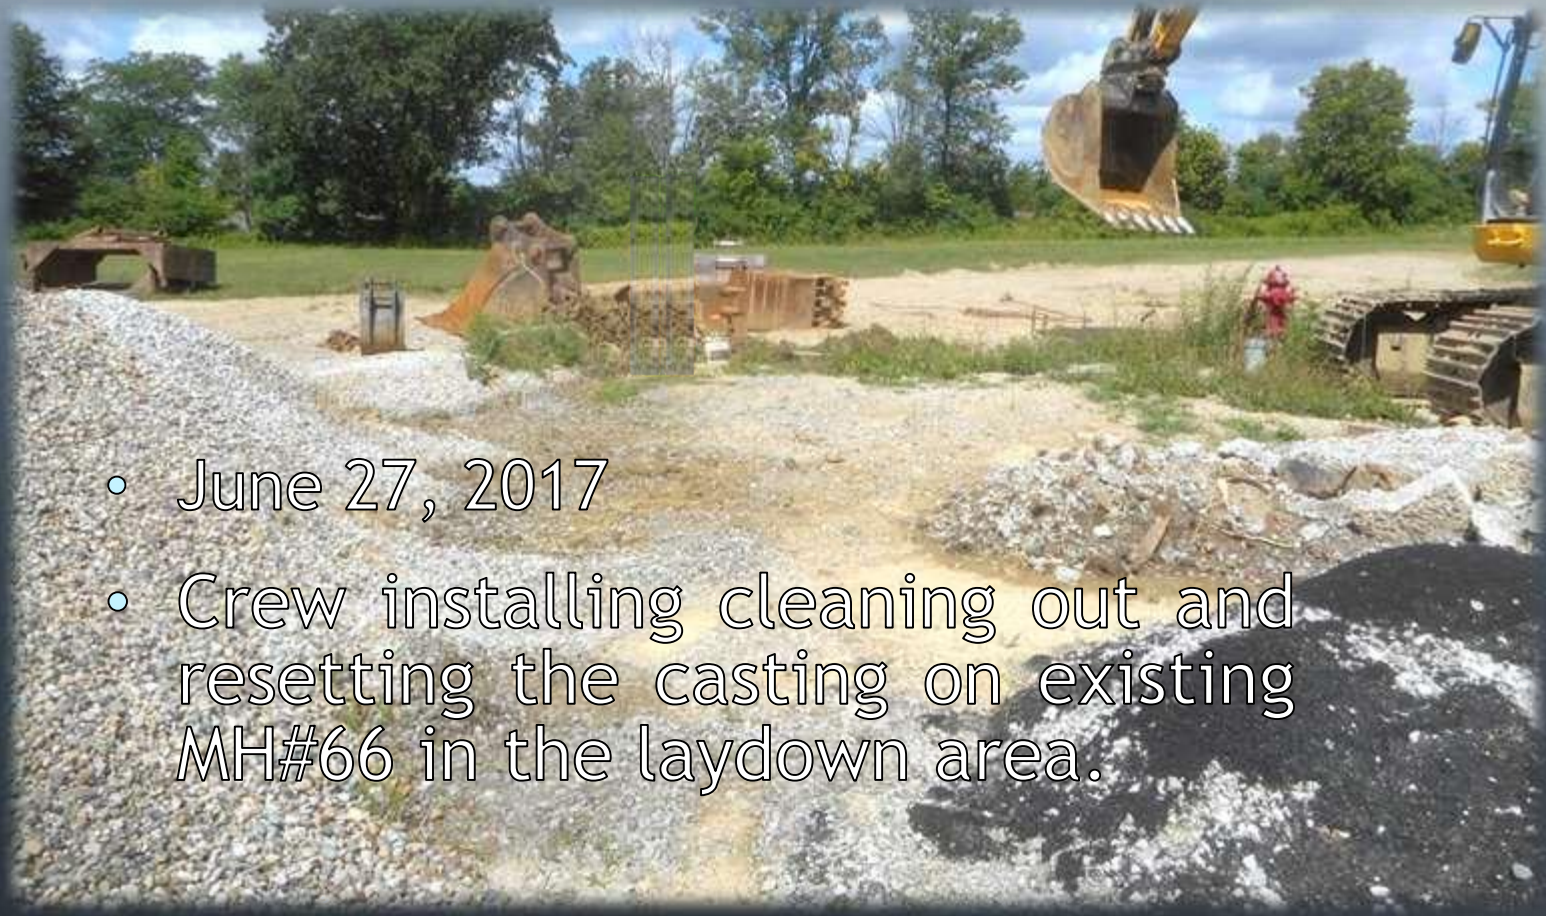
- June 27, 2017
- Crew installing cleaning out and resetting the casting on existing MH#66 in the laydown area.

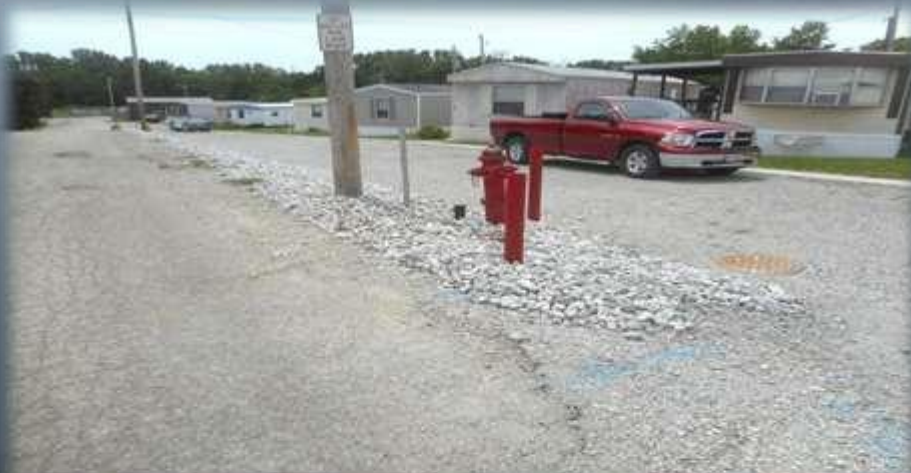
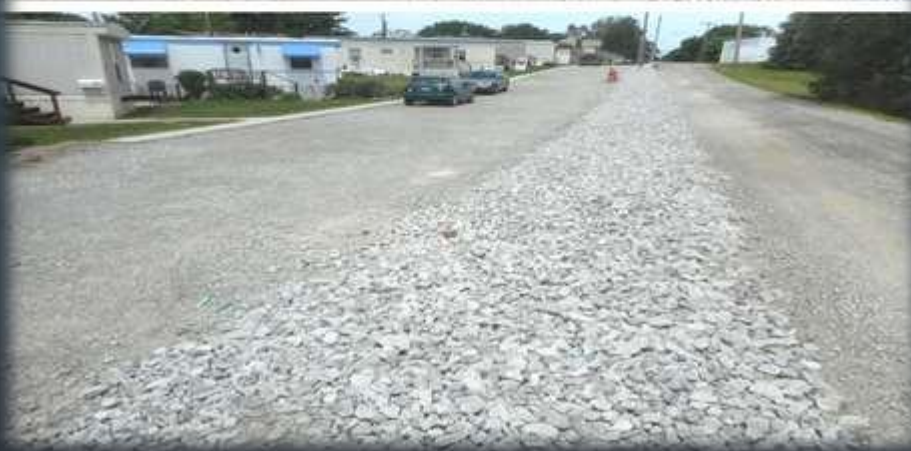
- June 27, 2017
- Fields located and raised the two curb boxes on the Haddox property.

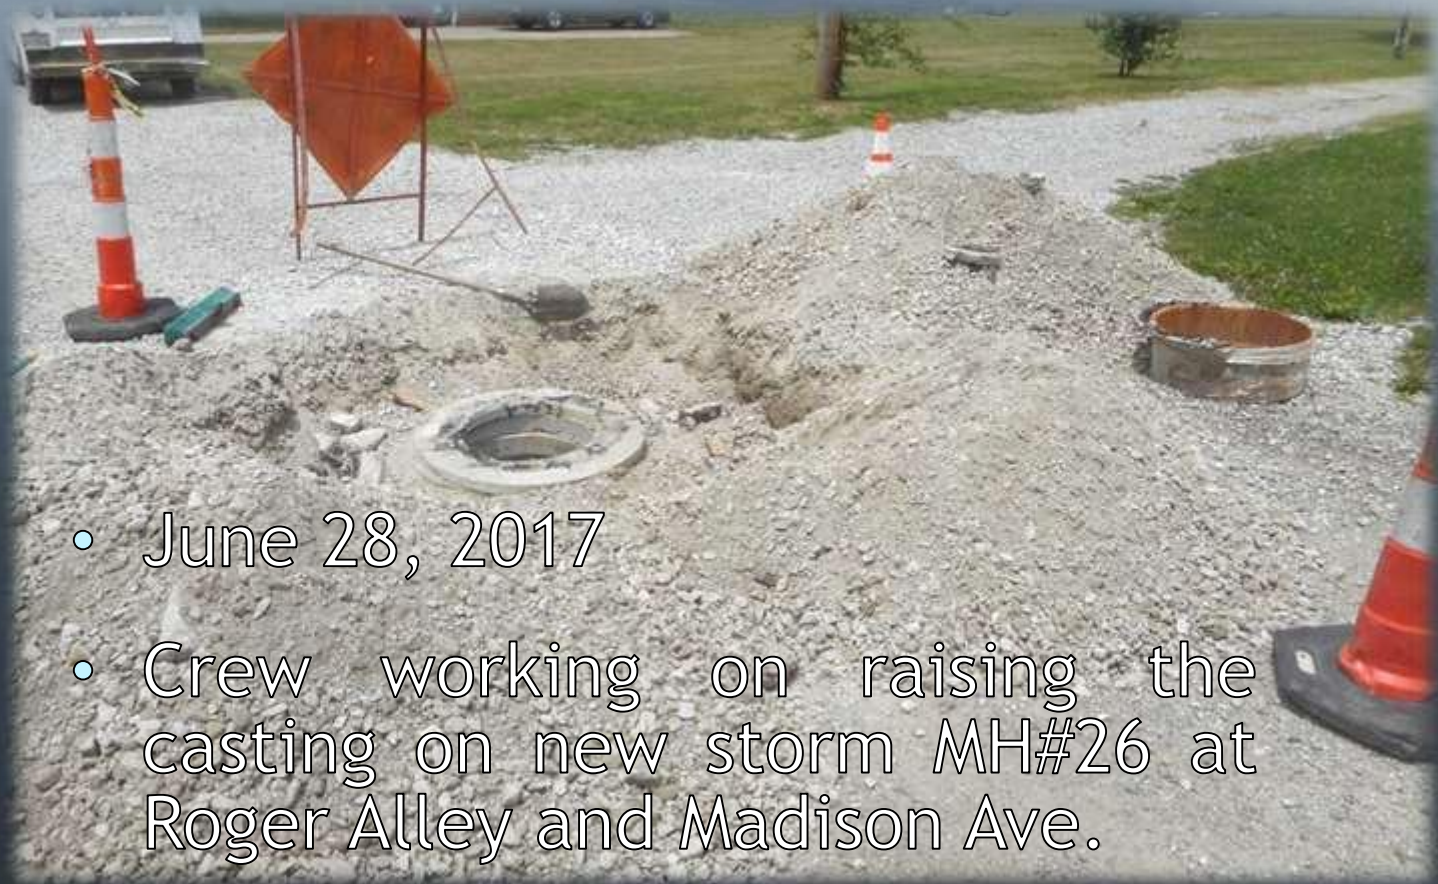
- June 28, 2017
- Crew working on raising the casting on new storm MH#26 at Roger Alley and Madison Ave.

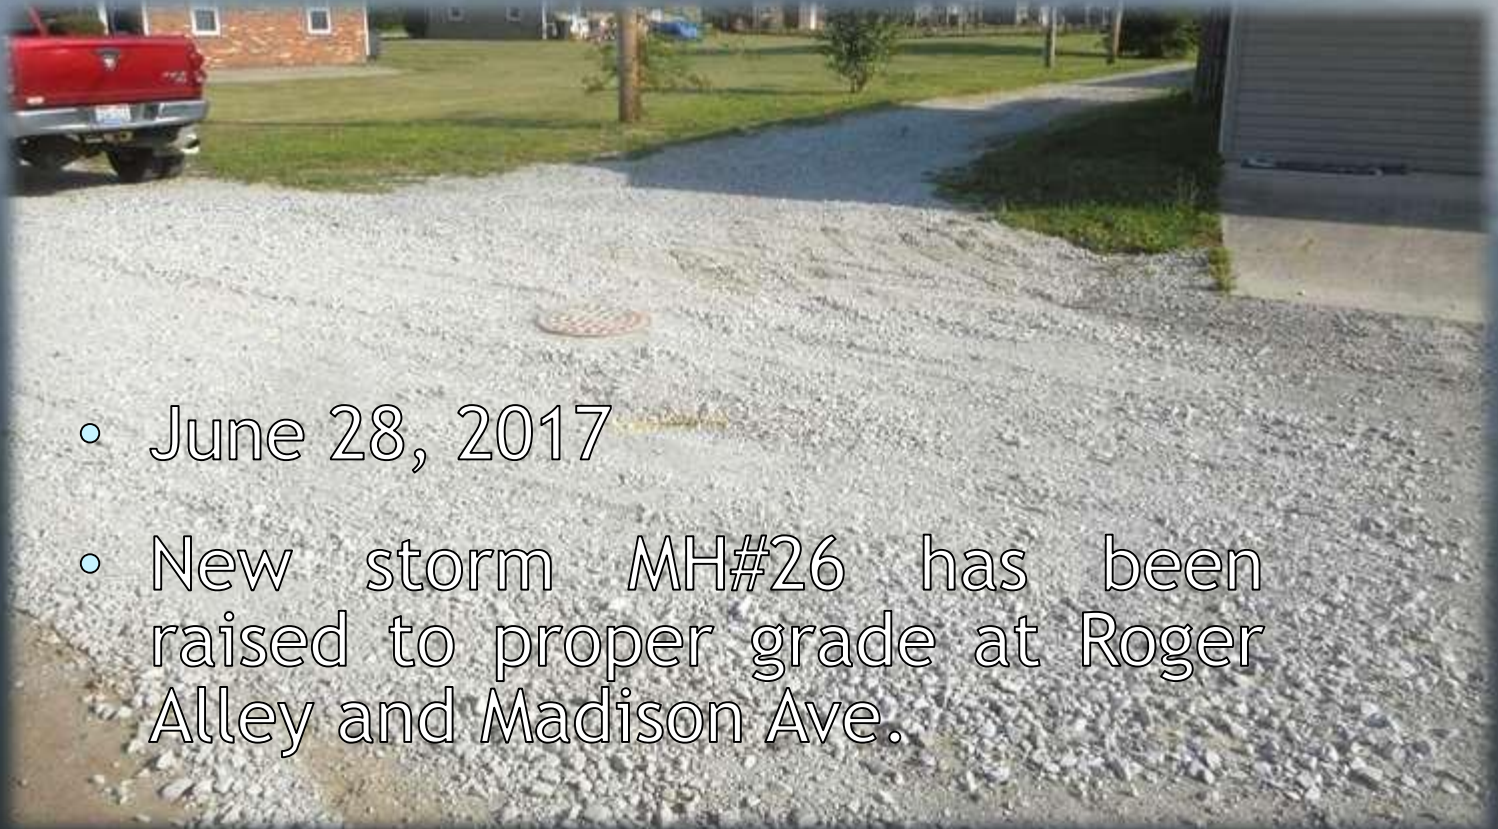
- June 28, 2017
- New storm MH#26 has been raised to proper grade at Roger Alley and Madison Ave.
